The 29th May 2012 Emilia Romagna Earthquake

EPICentre Field Observation Report

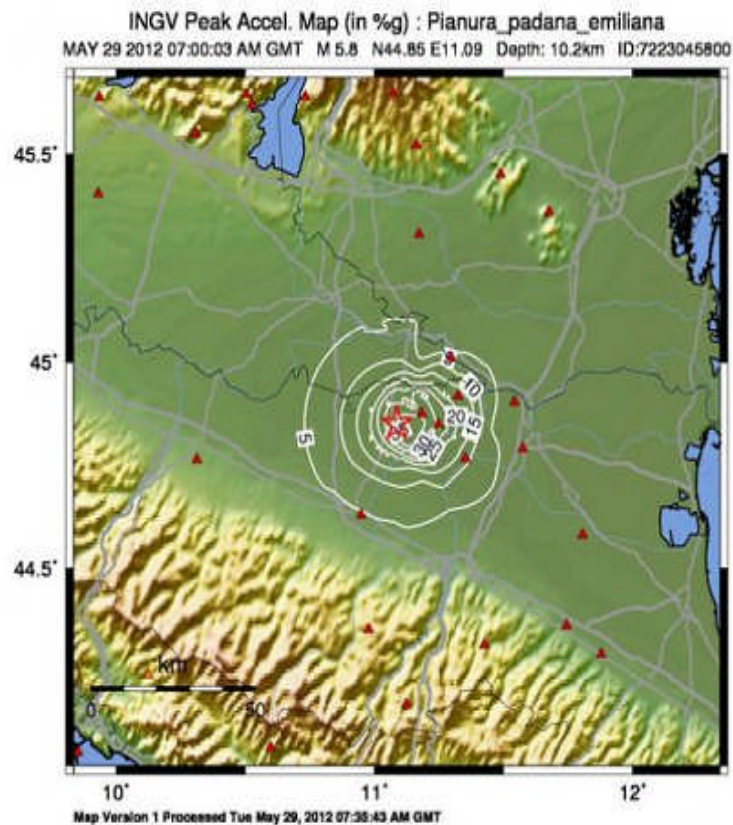
Figure 2.5 – PGA contour map for May 29th event (INGV, 2012d).

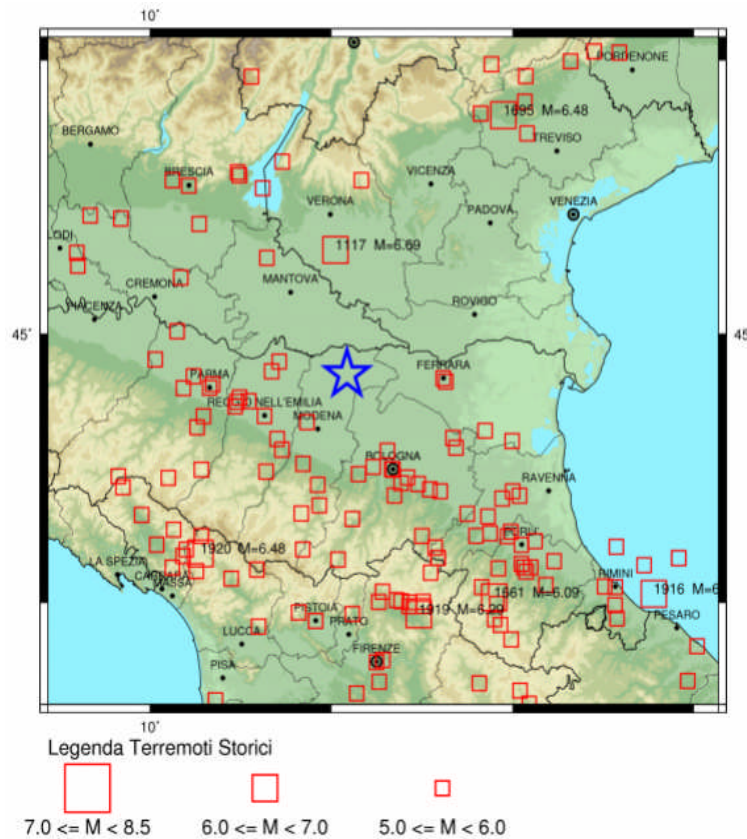
Figure 2.6 – INGV historical earthquake catalogue (INGV 2012d).

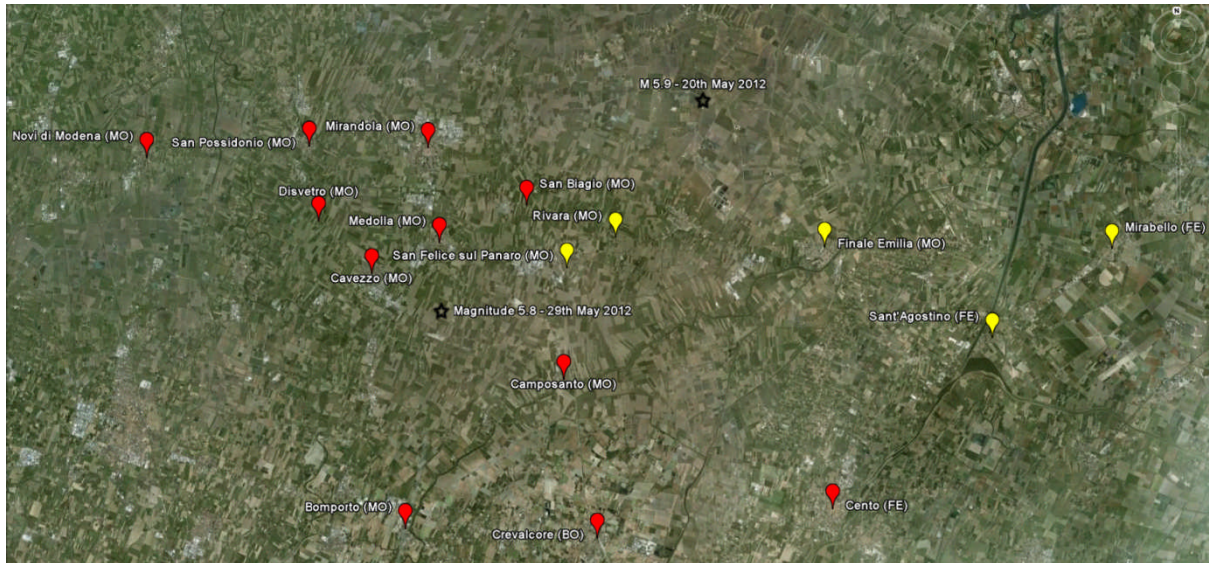
Figure 3.1 – Path of the mission: Towns and villages visited only in the 2nd mission (red) and revisited in the 2nd mission (yellow), epicentres of the two events (black stars) (MO:Modena, FE- Ferrara, BO: Bologna).

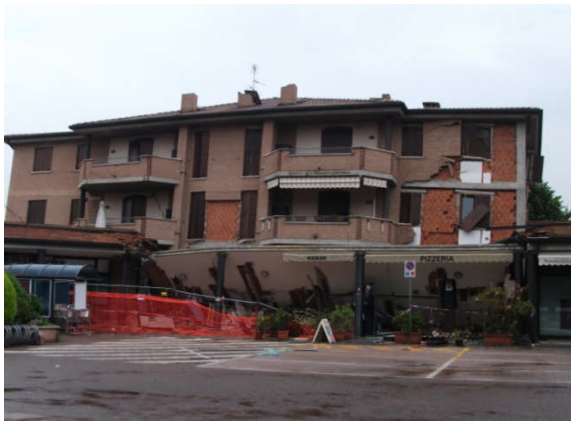
Figure 4.1 - RC building collapsed in Cavezzo with hollow clay brick infill: a) RC structure with deformed bars; b) inadequate reinforcement joint detail; c) RC structure with plain bars; d) joint detail.

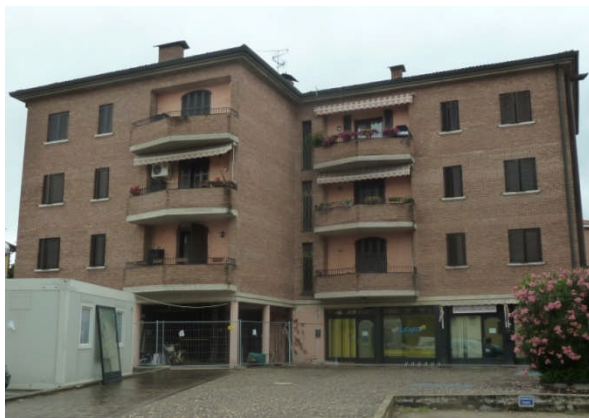
Shear failure at the top of the ground floor columns was observed in a four storey RC building in Cavezzo (Figure 4.3). Several columns of the building suffered shear failure which led to an unstable structure. At the time of the reconnaissance, steel column elements were observed to have been placed to prop-up the floor at locations of damaged columns in an attempt to prevent the building from collapsing in aftershocks, (Figure 4.3b). The shear failure of the columns may be attributed to the large spacing between stirrups, which were closed with 90° hooks instead of 135°. Parts of the masonry infill walls of the ground floor were also seen to have collapsed.

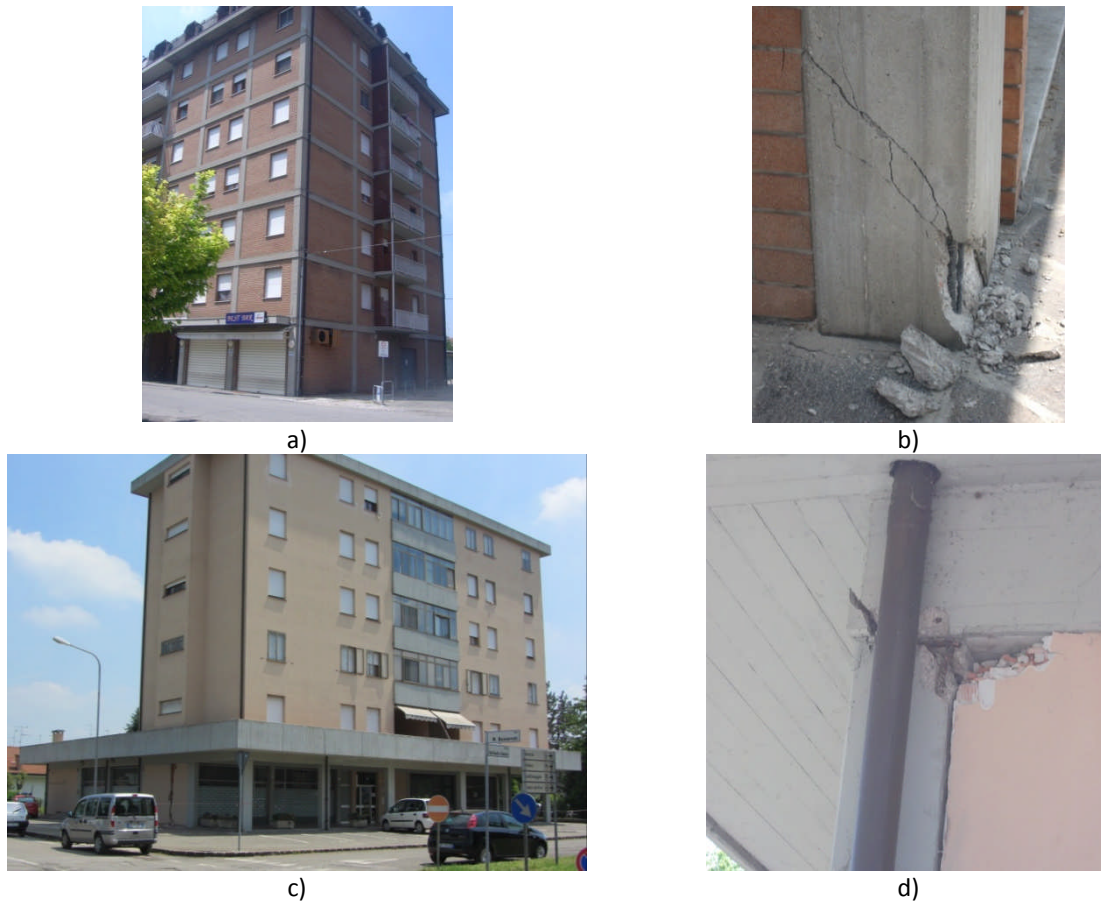
Figure 4.4 - RC buildings in Novi de Modena with hollow clay brick infill: a) overview of building A; b) shear fail in building A; c) overview of building B; d) plastic hinge at the columns in building B.

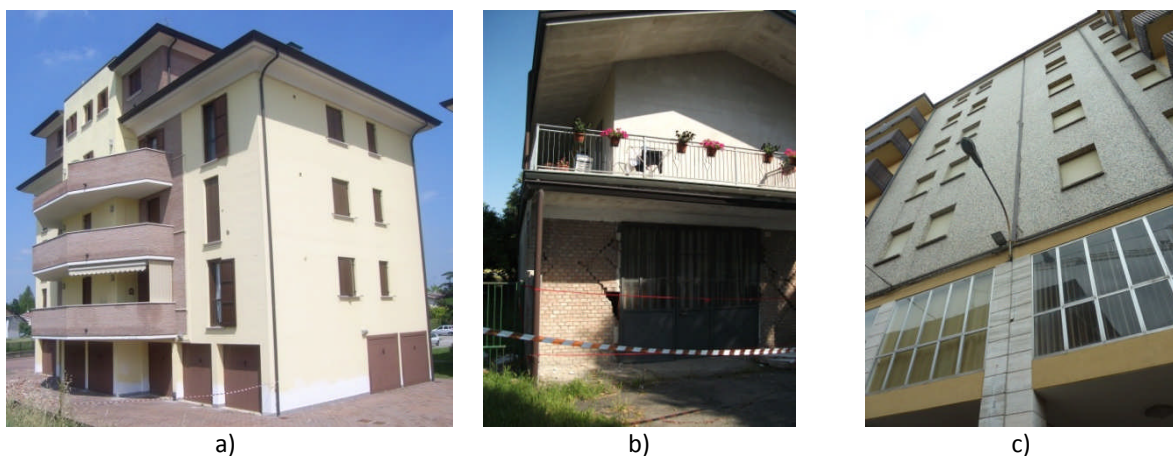
Figure 4.5 - RC buildings with non-structural damage: a) balcony wall fail in Concordia b) infill masonry fail in San Possidonio; c) lower damage due to pounding in Cento.

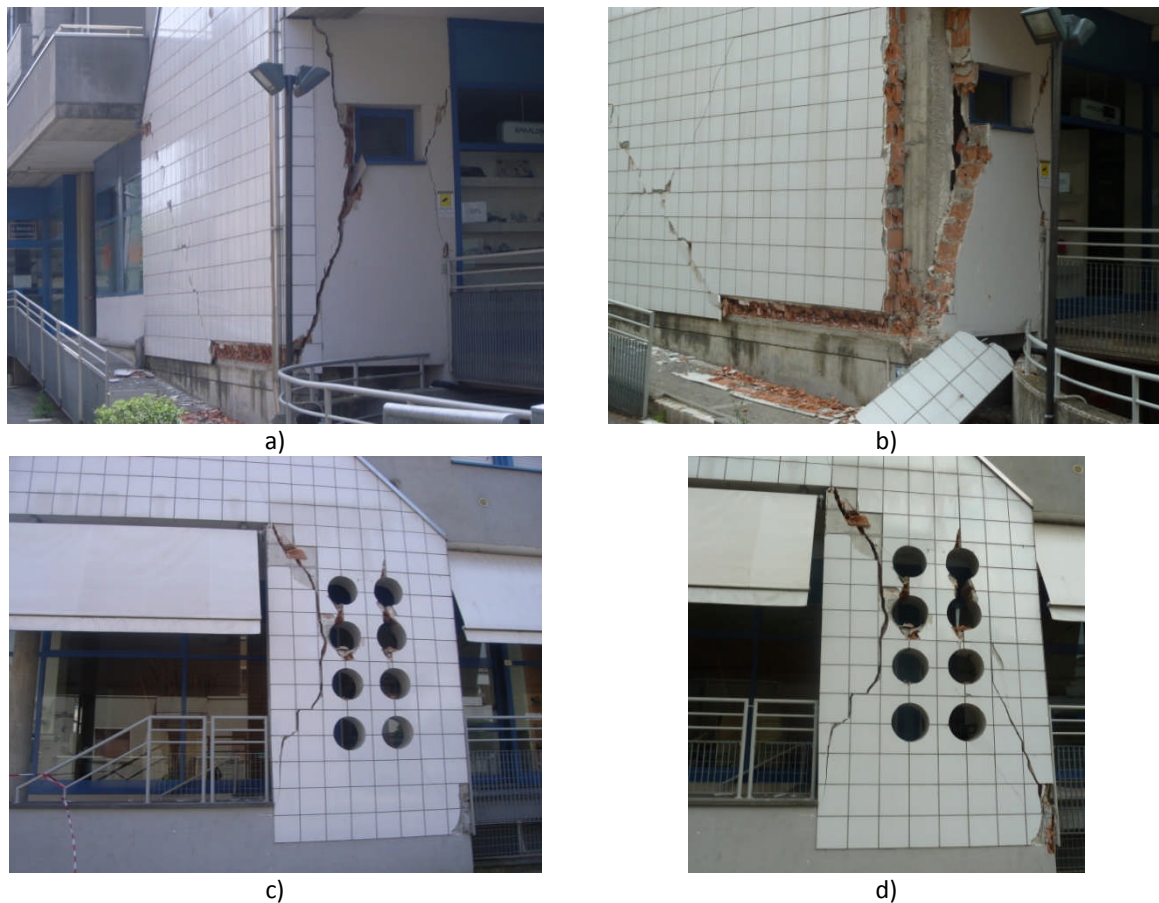
Figure 4.6 - Building in Finale Emilia with damage in the hollow clay brick infill: a) and c) 20/05/12 earthquake; b) and d) 29/05/2012 earthquake.

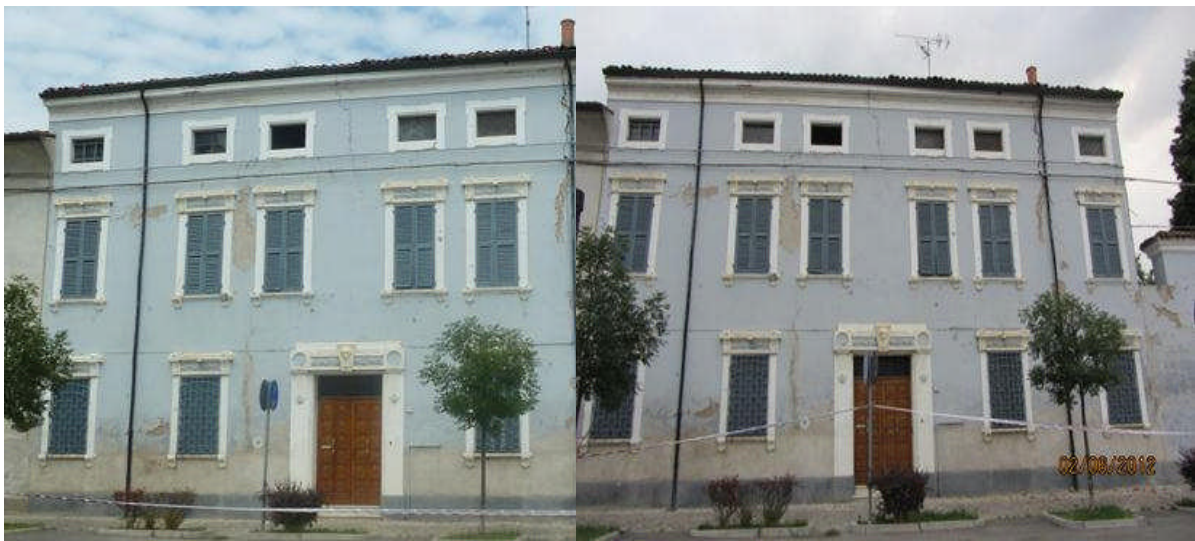
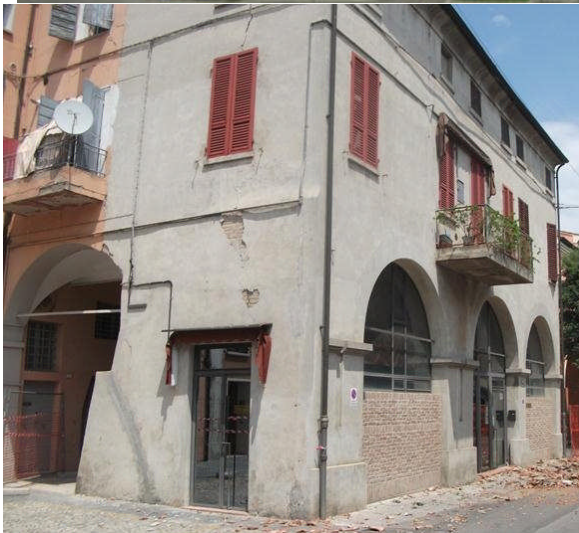
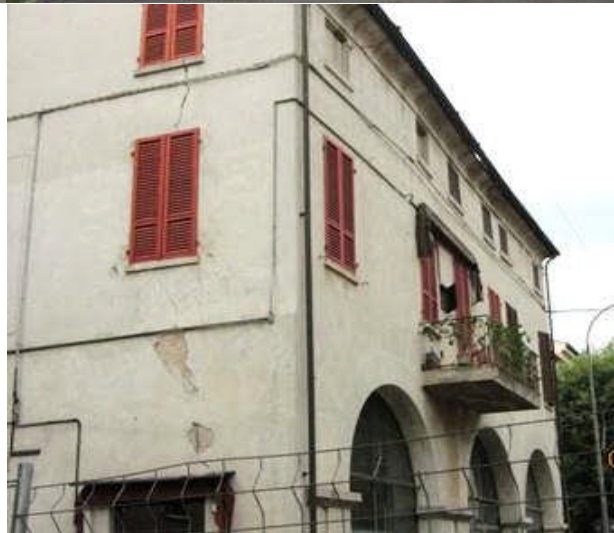
Figure 4.8 – Two masonry buildings in Finale Emilia. Comparison of damage sustained in the 20/05/12 event (left) and after the 29/05/12 earthquake (right).

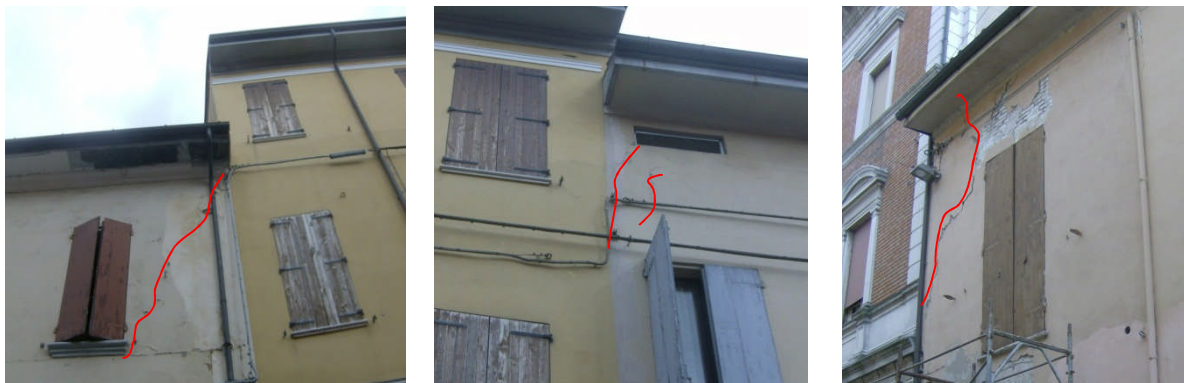
Figure 4.9 – Pounding effect due to different heights of buildings (Cento).

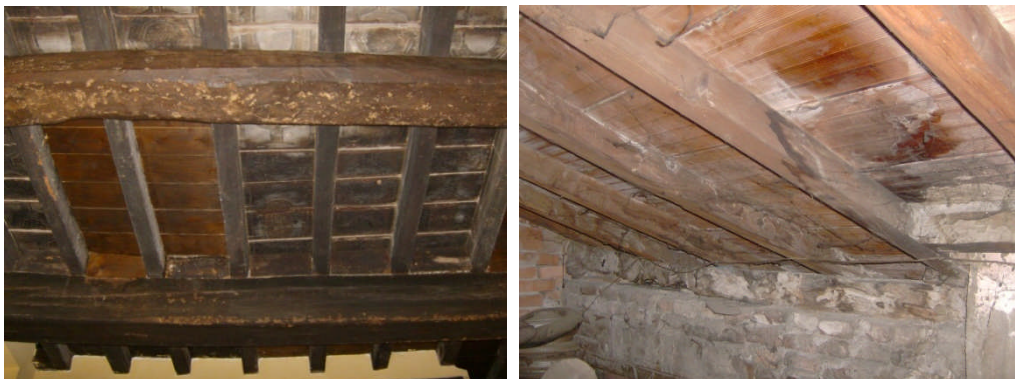
Figure 4.11: Timber floor and timber roofs.

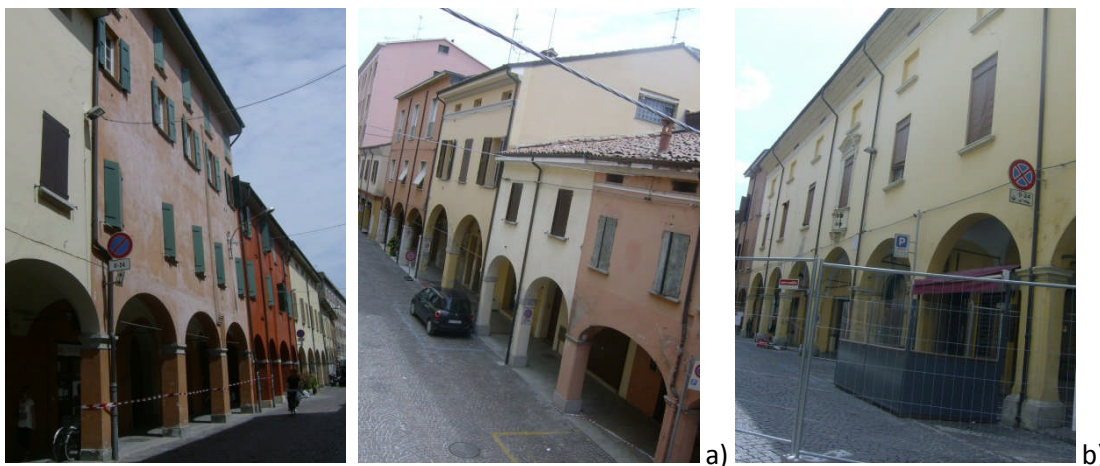
Figure 4.13: Porticoes in a) Via Malagodi and in b) Via Provenzali in the historical centre of Cento.

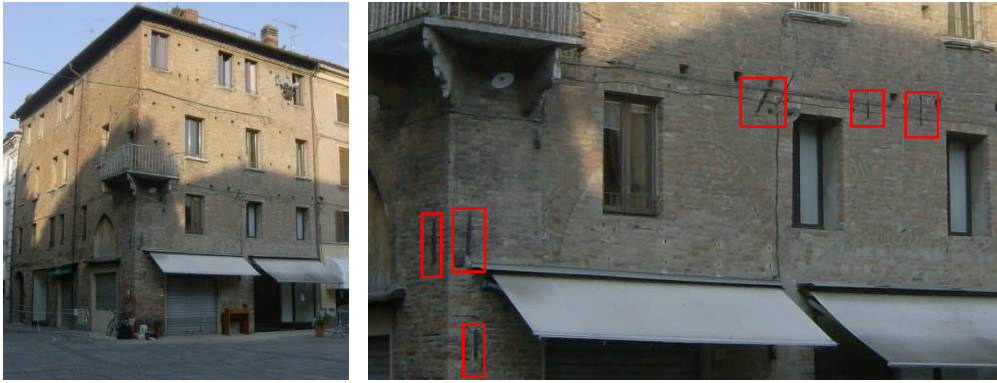
Figure 4.14: Metallic elements on the façades of the buildings on the corner between Piazza Costituente and Via Volturno in Mirandola.

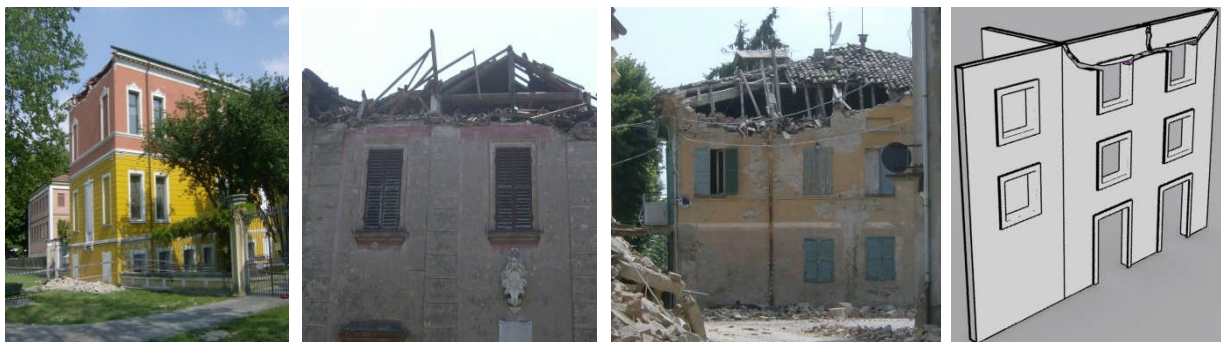
Figure 4.16: Examples of out of plane of the top level in Mirandola and Rivara and sketch related to the identified mechanism (D'Ayala and Speranza, 2003).

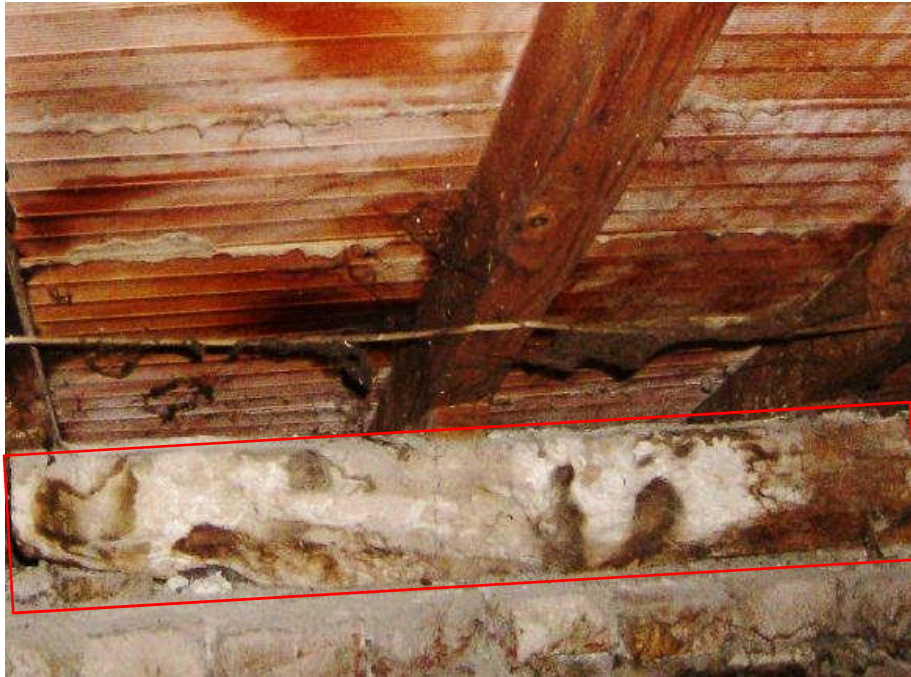
In some buildings, for which more detailed inspection has been carried out, timber plates, often used to keep the bottom of the rafters in place, were observed. However, it is also observed that the presence of these plates can cause out-of-plane failure of the top storey façade if the timber plates are damaged or not well connected along the top of the wall to ensure diaphragmatic behaviour (see Figure 4.17).

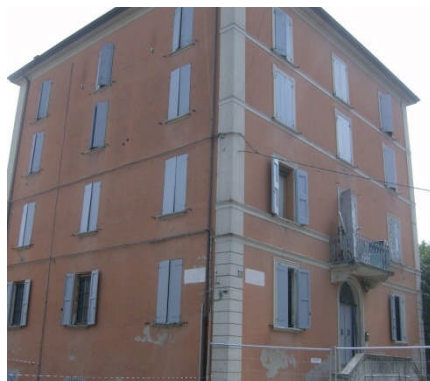
Figure 4.18: Typical quoins on both edges of the facades. The building on the corner between Via Guglielmo Marconi and Via Costa in Crevalcore has suffered shear failure in the spandrels.

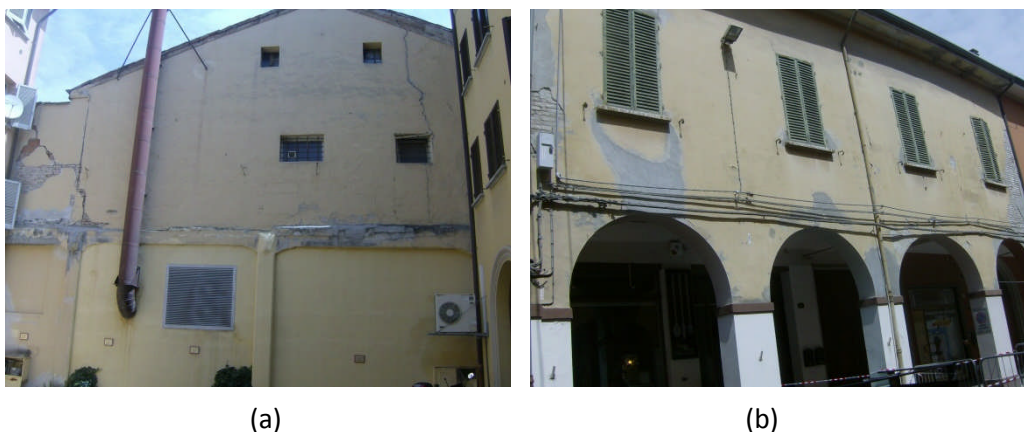
(a) (b)
Figure 4.19: Malagodi street n.8 in Cento a) South west and b) north west façade.

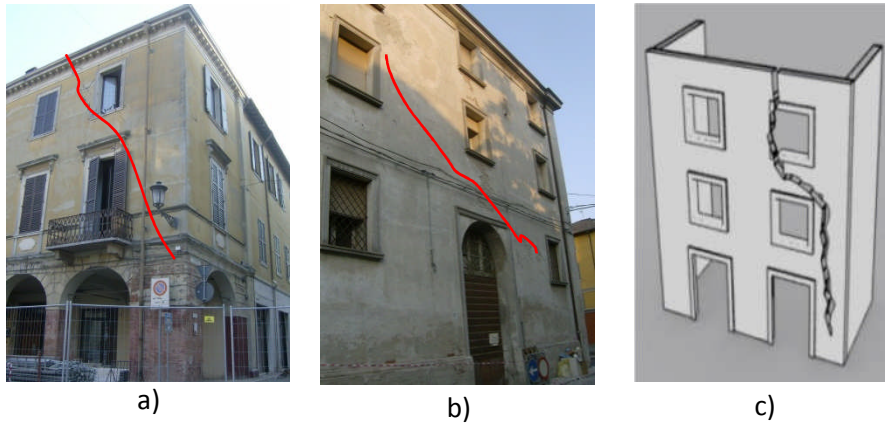
Figure 4.20: Examples of in plane in a) and b) Giovanni Pico Street in Mirandola and c) sketch related to the identified mechanism (D’Ayala and Speranza, 2003).

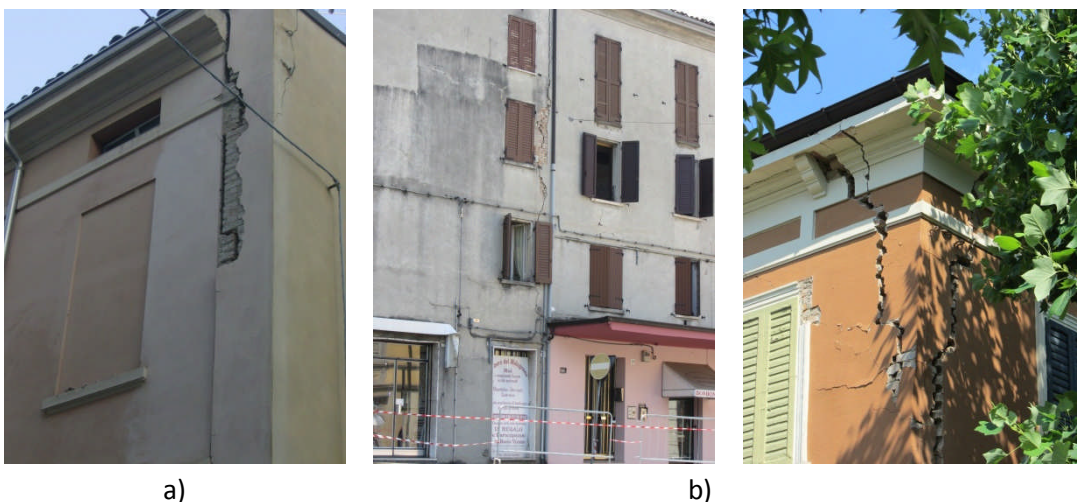
Figure 4.21: Examples of out of plane in Mirandola and Novi di Modena.

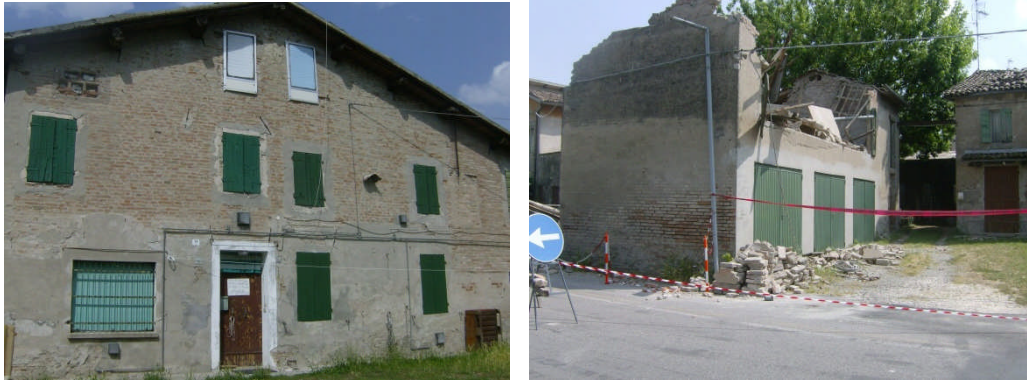
Moreover, it has been observed that some of these houses are vacant and others are completely abandoned to their decay, since the lack of maintenance and low quality of their masonry fabric has contributed to decrease the structural performance to seismic events, see Figure 4.23.

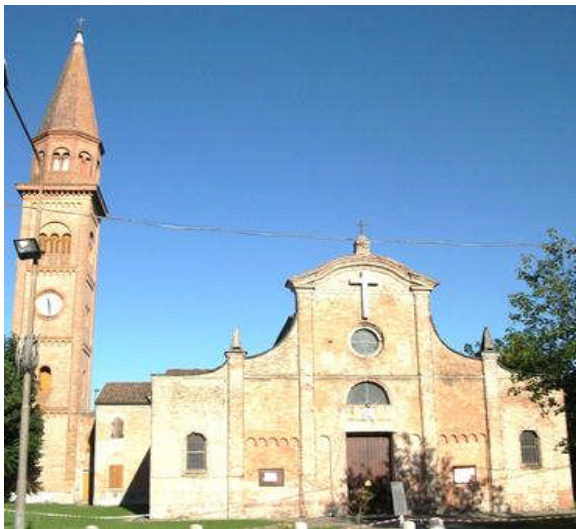
Figure 4.24 – Undamaged church of Pieve Matildica in Sorbara.

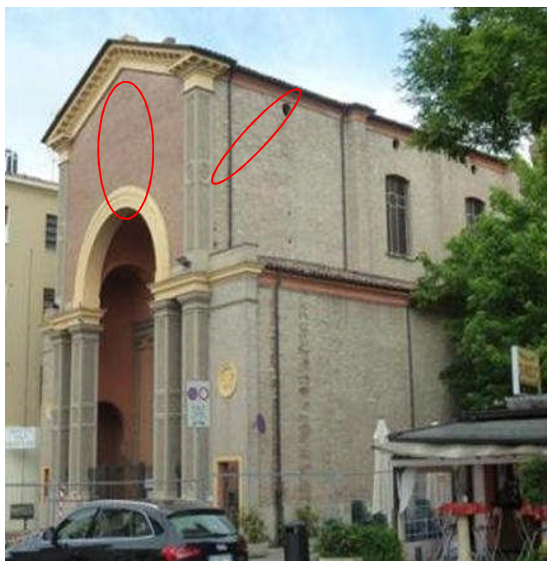
4.26 - Slight damage in a church in Cento

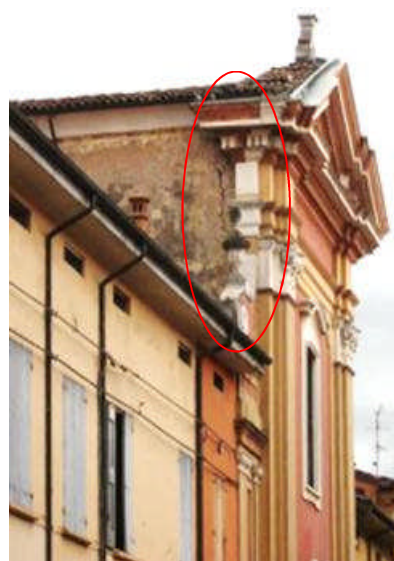
4.27 Out of plane failure of the façade in a church in Cento.

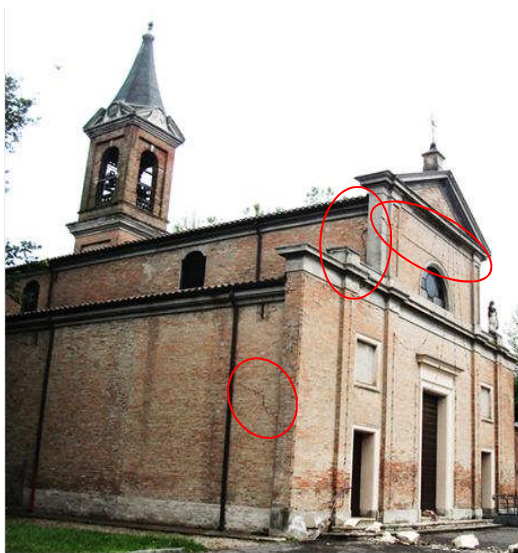
The church of San Michele in Novi di Modena (Figure 4.28) was surveyed from a distance due to lack of access. Extensive diagonal cracks on the south and east side were noted. The church of Cavezzo (Figure 4.29a) suffered moderate damage with extensive cracks on the south wall and a vertical crack on the wall indicating out-of-plane failure of the façade. A dislodged statue was also observed and extensive shear cracks seen on a masonry extension (Figure 4.29b). A vertical crack was noted on the façade of the church of San Lorenzo in Casumaro Finalese.

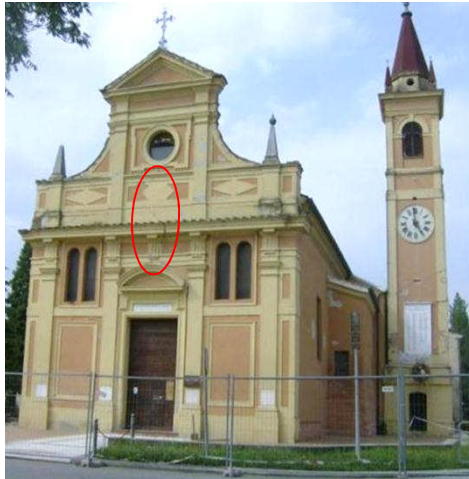
Figure 4.30 - Church of San Lorenzo in Casumaro Finalese.

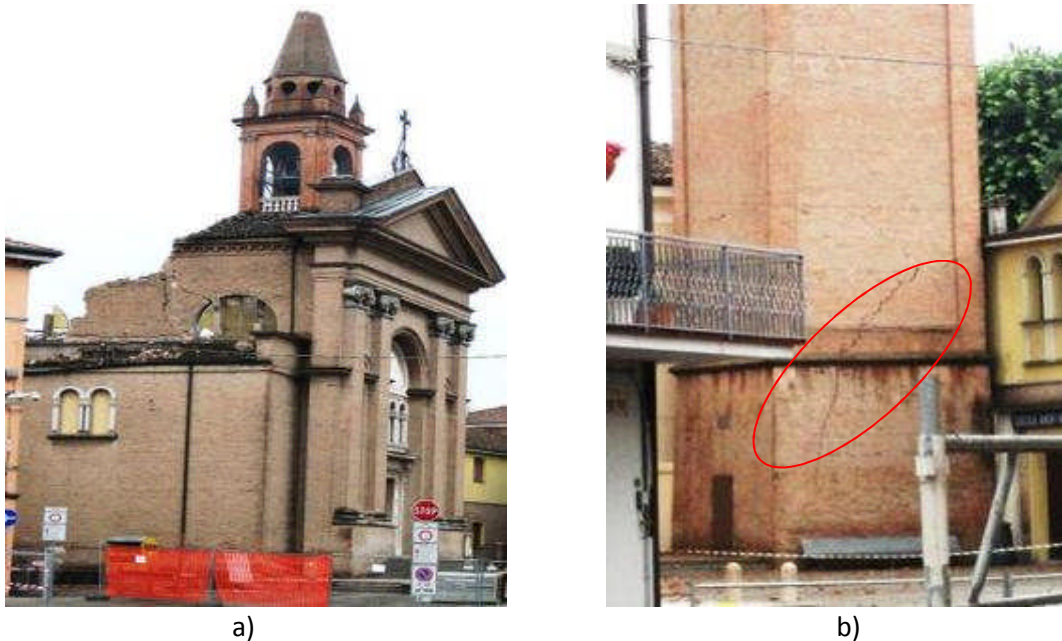
Figure 4.31 - Church in Cavezzo: a) Partial collapse of the church, dislodged decoration from the bell tower, b) extensive and large shear cracks on the bell tower.

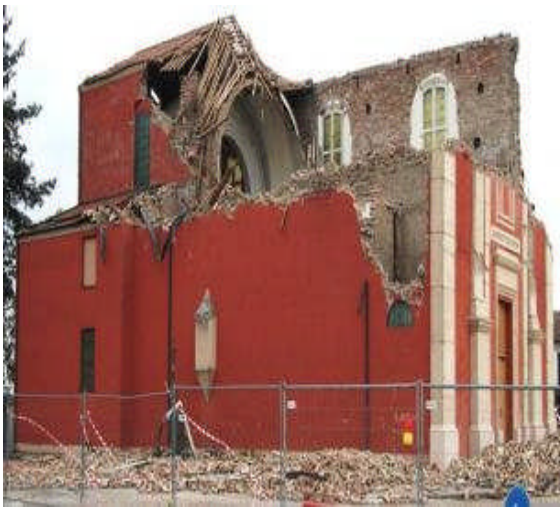
Figure 4.32 - Church in Disvetro: a) partial collapse, collapse of gable; b) vertical crack on the connection the façade to the north wall.

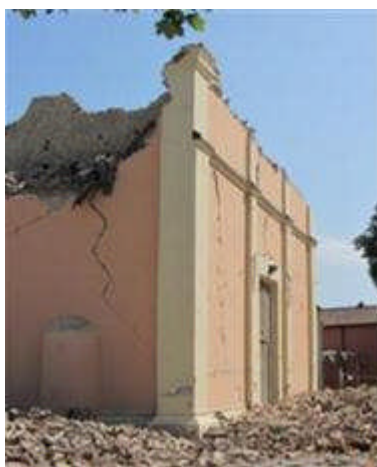
Figure 4.33 - Church of San Martino in Buonacompra: a) Partial collapse of the church, b) extensive and large shear cracks on the bell tower.

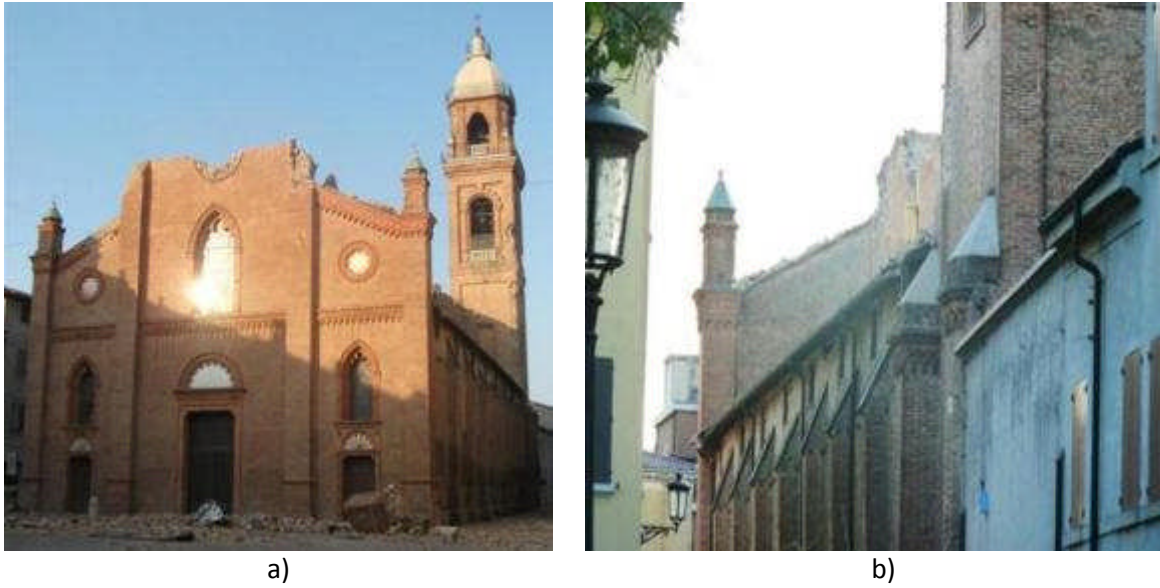
Figure 4.36 – Cathedral of Santa Maria Maggiore in Mirandola: a) collapse of the gable of the façade; b) collapse of the roof.

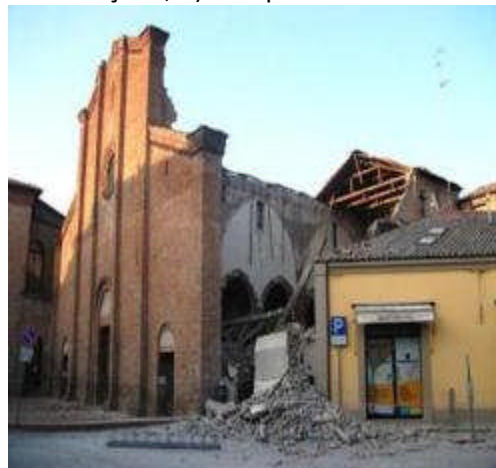
Figure 4.37 – Dislodged decorations from the façade and partial collapse of the roof and south side of the church of San Francesco in Mirandola.

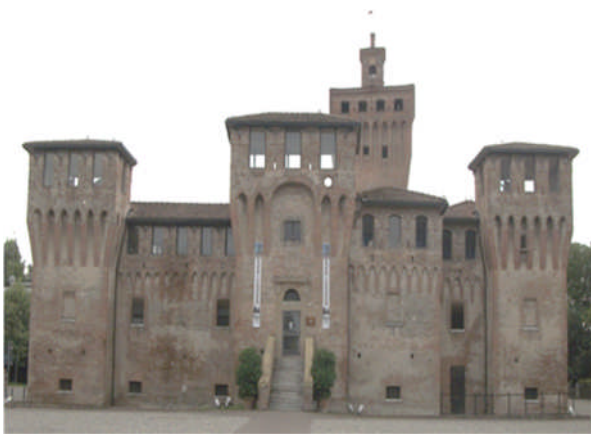
Figure 4.40 – Undamaged castle in Cento.

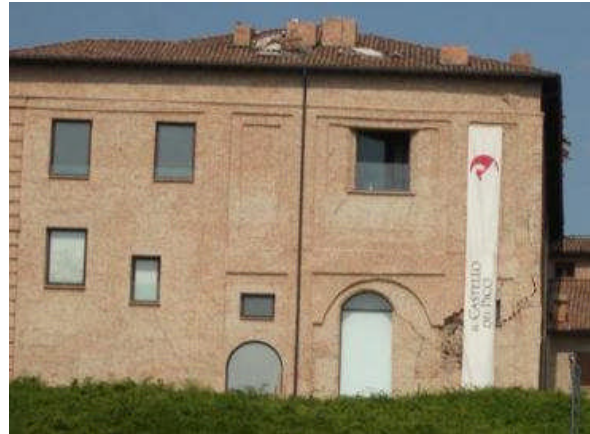
Figure 4.41 – Severe damage suffered by Castello dei Pico in Mirandola.

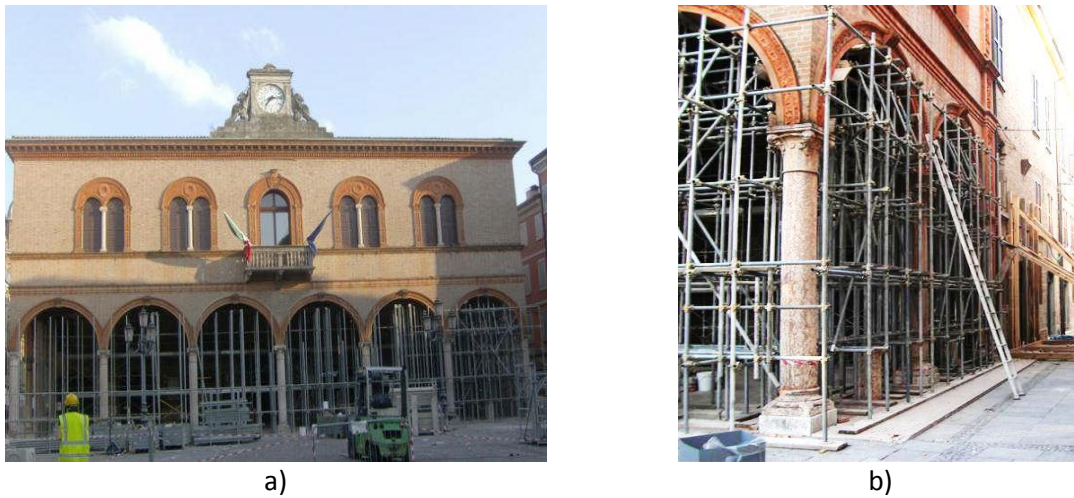
Figure 4.44 – Town hall in Mirandola: a) general view, b) side.

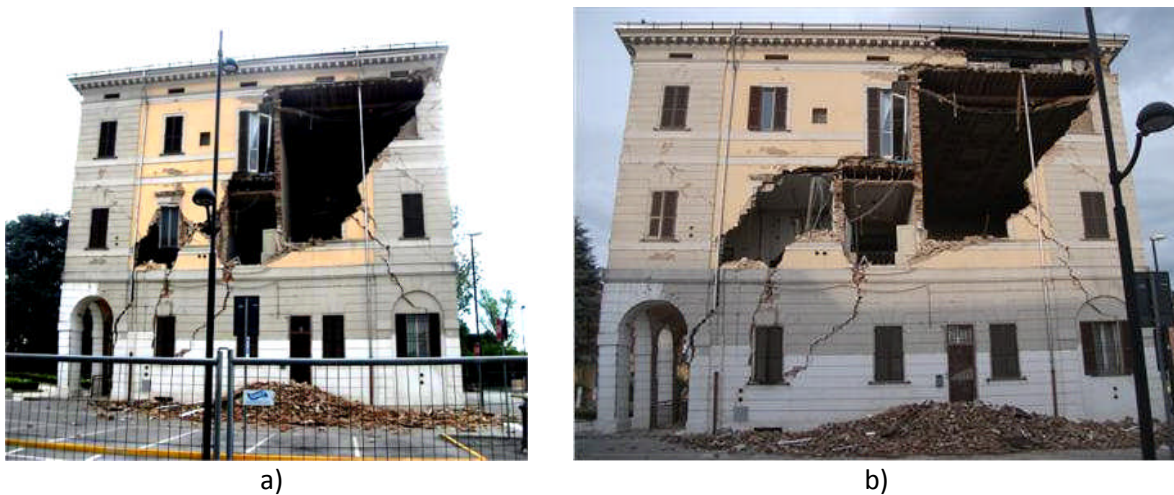
Figure 4.45 – View of the most damaged side of the town hall in S. Agostino: a) after the 20/05/12 event, b) after the 29/05/12 event.

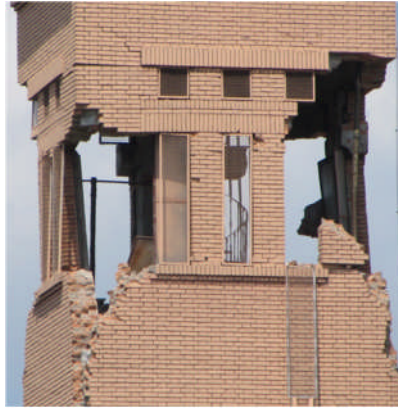
Figure 4.46 – Severely damaged tower in Concordia.

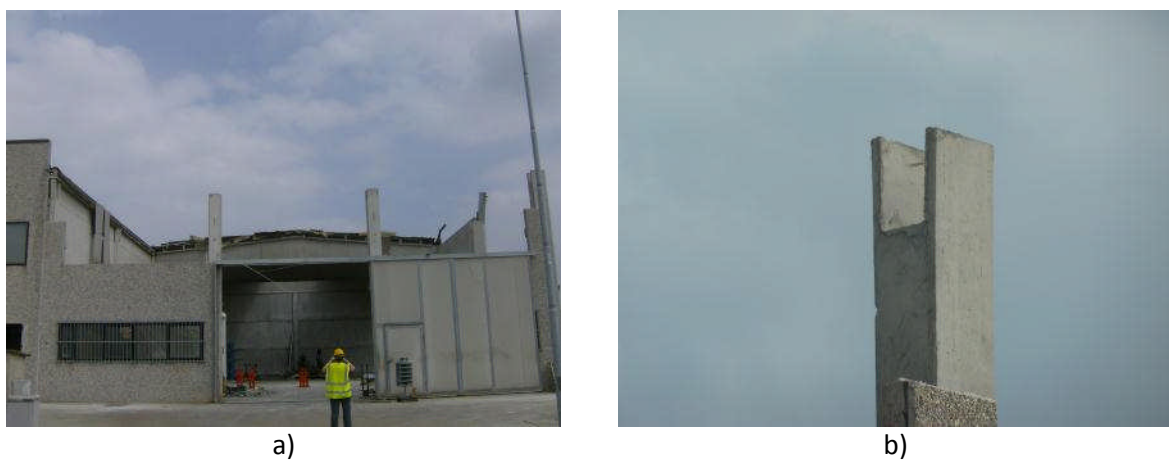
Figure 4.49 – a) Collapsed double T beam roof and prestressed concrete Beam of a warehouse at Casumaro b) Detail of a failed shear key connection.

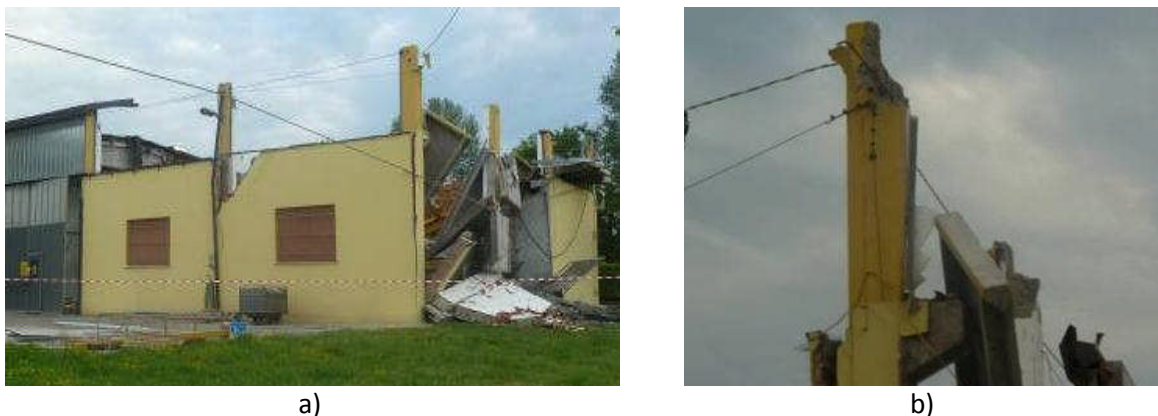
Figure 4.50 - Industrial buildings close to San Carlo: a) overview of the pre-cast structure; b) joint detail.

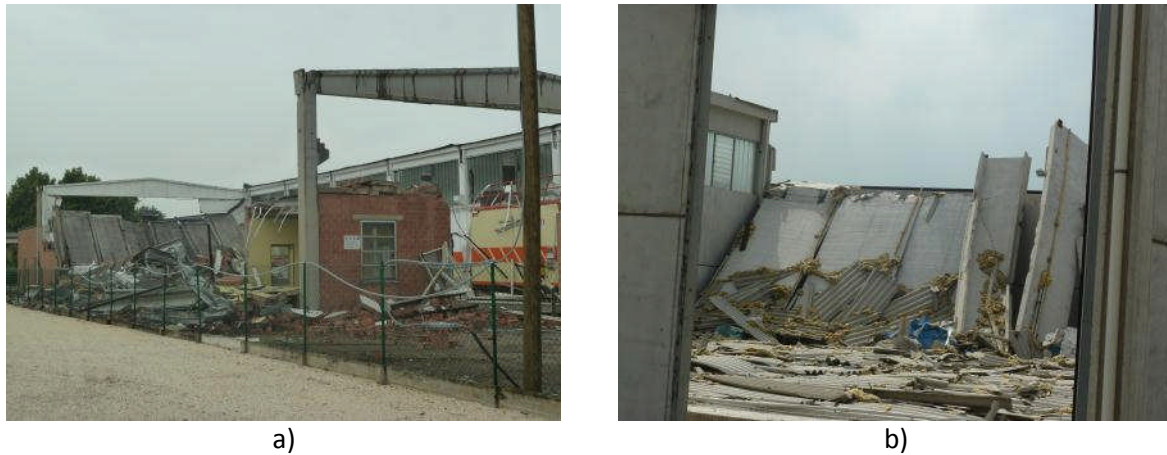
Figure 4.51 – Double T-beams as a roofing system spanning in the longitudinal direction a) warehouse in San Giacomo Rancole b) warehouse in Casumaro.

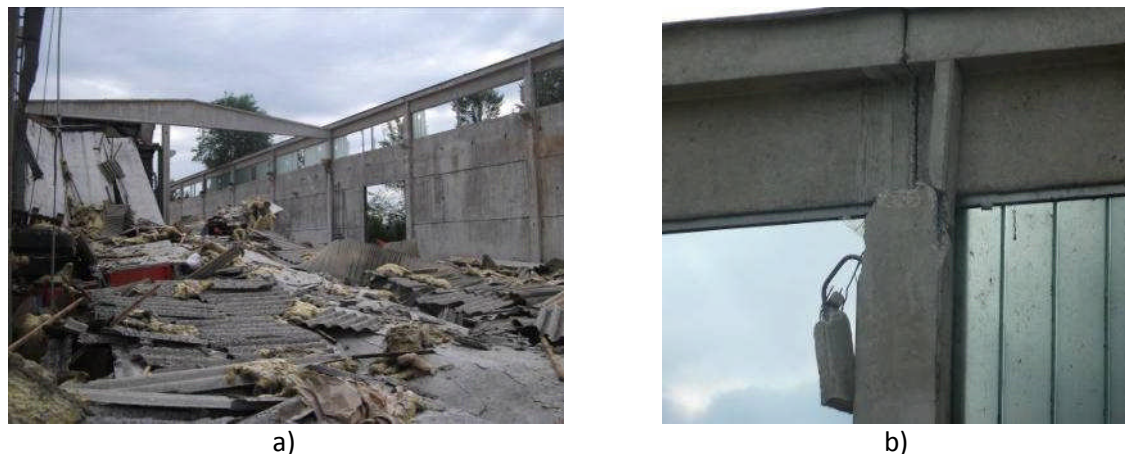
Figure 4.52 - Industrial building in Sant Agostino: a) overview; b) joint failed detail.

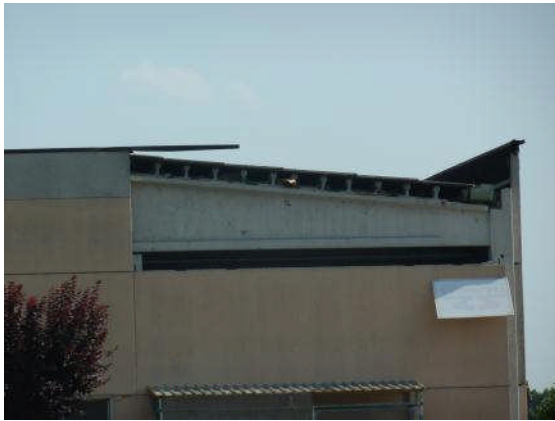
Figure 4.53 – a) Failure of roof, column and masonry and RC panel infill in a warehouse at San Giacomo Rancole. b) Failure of precast RC panels in an industrial building in Casumaro.

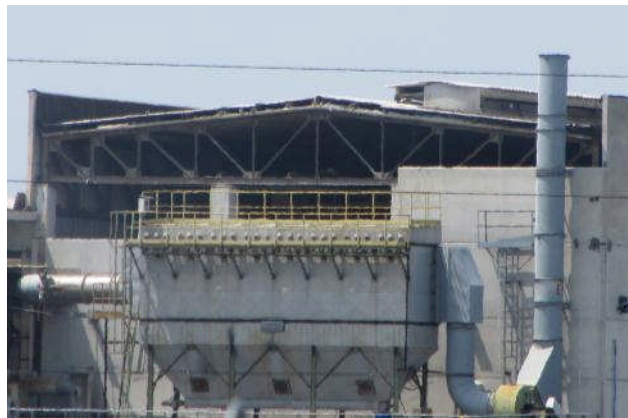
Figure 4.55 - Steel truss as the transverse support in a precast warehouse system close to San Felice sul Panaro.

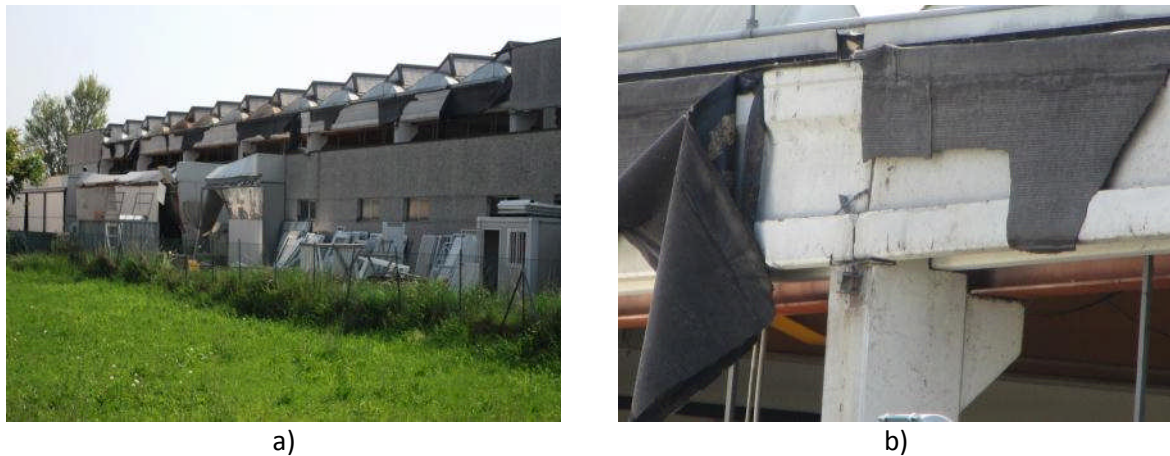
Figure 4.56 - a) Warehouse structure with H-section longitudinal beams in Mirandola detail of the b) H-section with the column shear key.

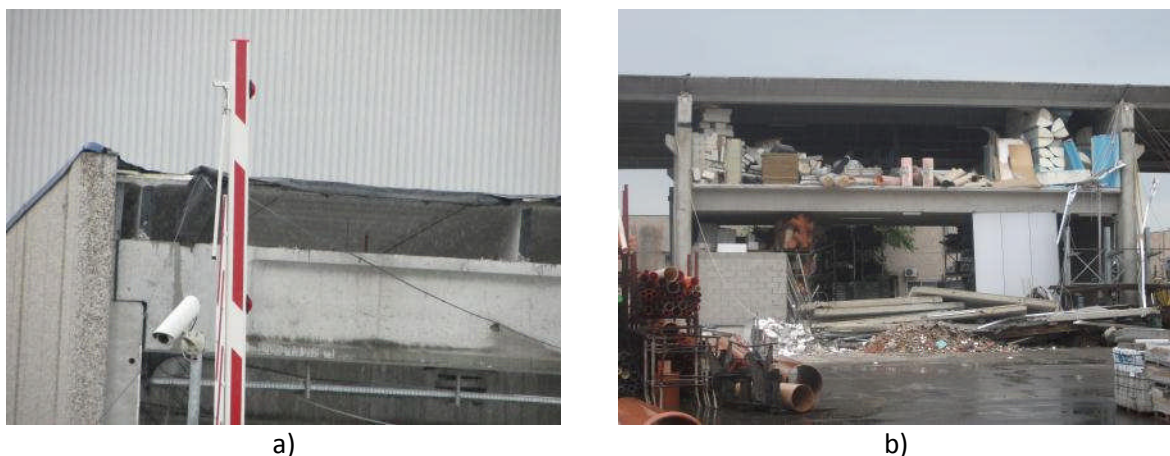
Figure 4.57 – a) Detail of a transverse double T-beams as a roofing system of a warehouse in San Giacomo Rancole b) Corrugated precast RC sections as roofing system for a warehouse in San Giacomo Rancole.

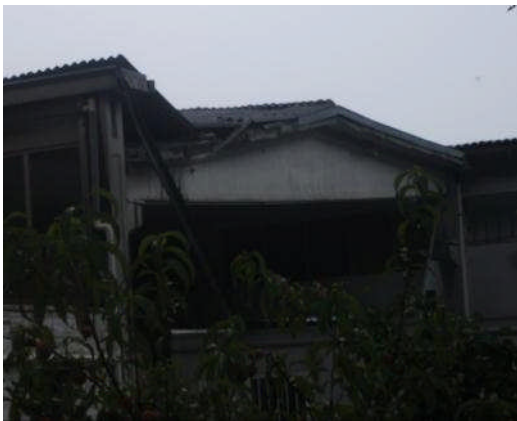
Some precast systems did not experience complete collapse of the roofing system after the failure of the transverse beam (Figure 4.59). This was because the transverse beam was partially supported by the corbel at intermediate levels of the column. This phenomenon was only observed in multi-bay warehouse structures with short transverse spans. This prevented the columns from developing large permanent rotations in opposite directions.

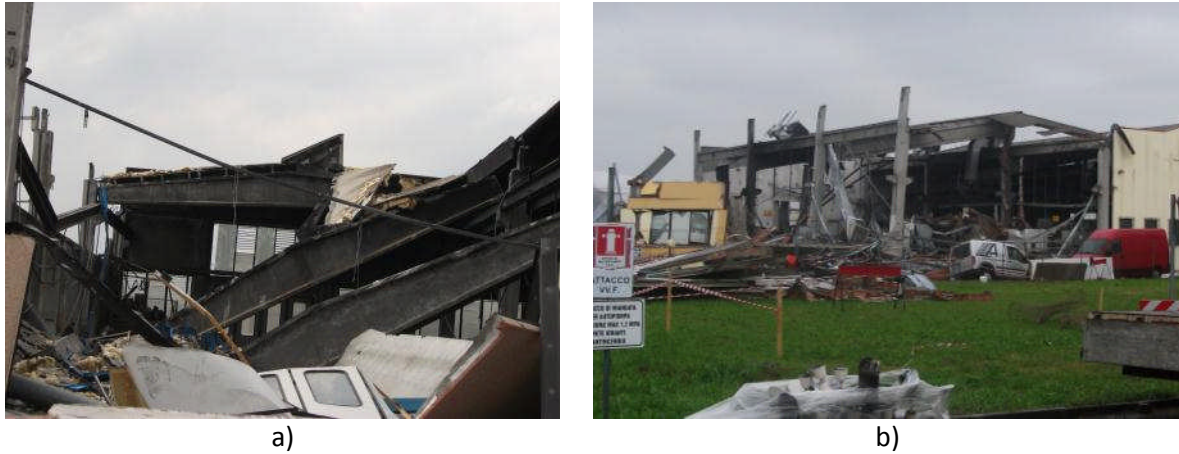
Figure 4.60 – Failure of warehouse industrial facility due to earthquake loading and followed by fire
 a) in Casumaro b) in San Giacomo Rancole

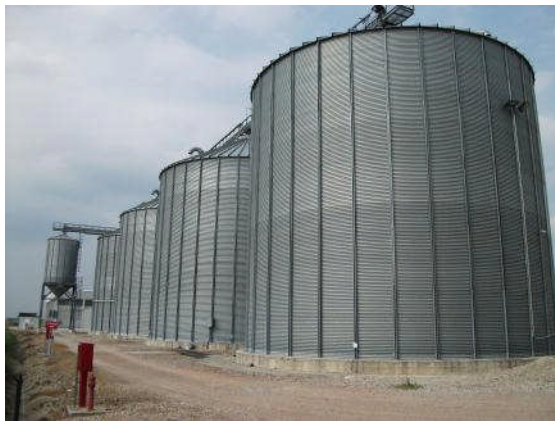
Two silo facilities were observed (Figure 4.64). The first one was on the outskirts of Finale Emilia. It is a recent construction and no damage was observed. The second was part of an industrial complex in San Giacomo Rancole. This was partially damaged as a consequence of pounding with the portal frame of the adjacent warehouse, and the collapsed cladding of the same warehouse.

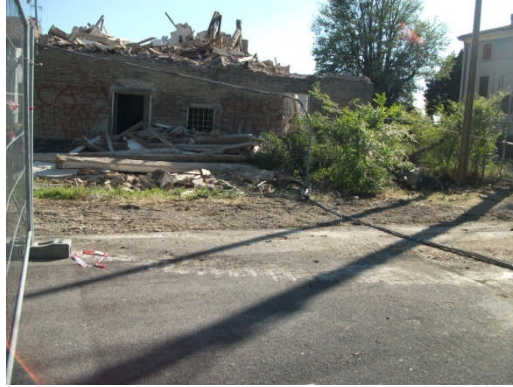
Figure 5.1 – Road closure due to fallen electricity cable.
