The 29th May 2012 Emilia Romagna Earthquake

EPICentre Field Observation Report

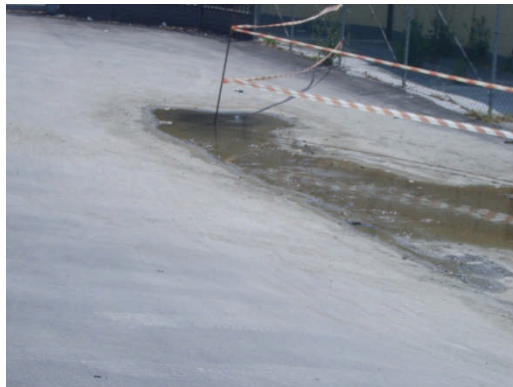
Figure 5.2 – Ponding of sewage at foul manhole in San Felice sul Panaro.

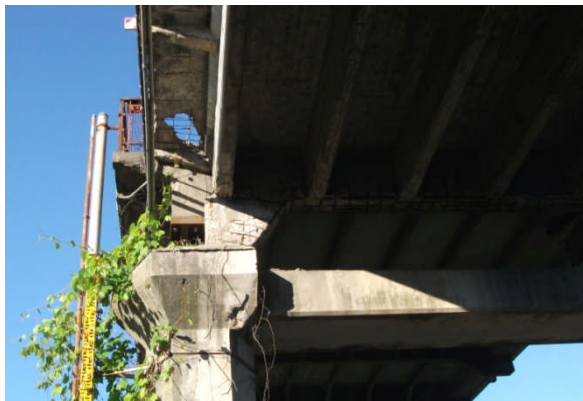
Figure 5.4 – Existing rusted rebar exposed prior to earthquake (Bomporto Bridge).

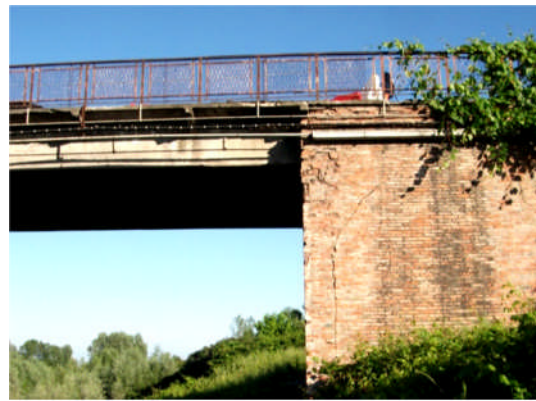
Figure 5.5 – Typical cracking in the brickwork bridge abutments of Bomporto Bridge.

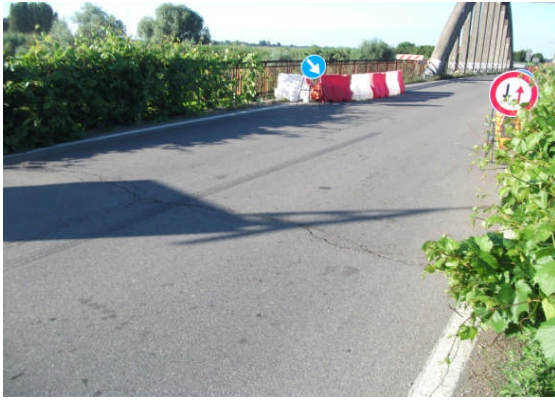
Figure 5.6 – Minor cracks in road surface due to damage to masonry abutments beneath.

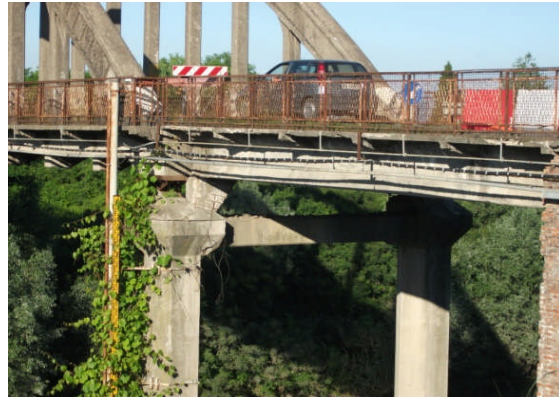
Figure 5.7 – Bomporto Bridge (reinforced concrete and masonry) open to traffic.

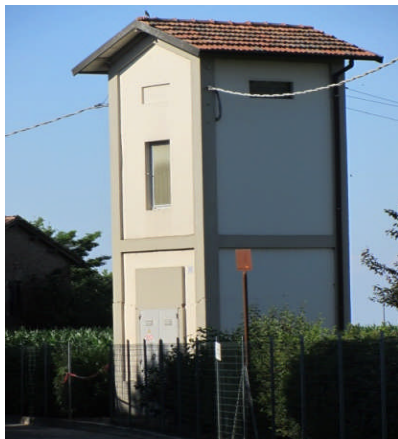
A number of surveyed electrical substations were found to have suffered slight damage (see Figure 5.8). These buildings are unusually tall and slender masonry structures. One large horizontal crack in the masonry was visible in a substation in Disvetro, extending from the lintel above the door running fully around the building.

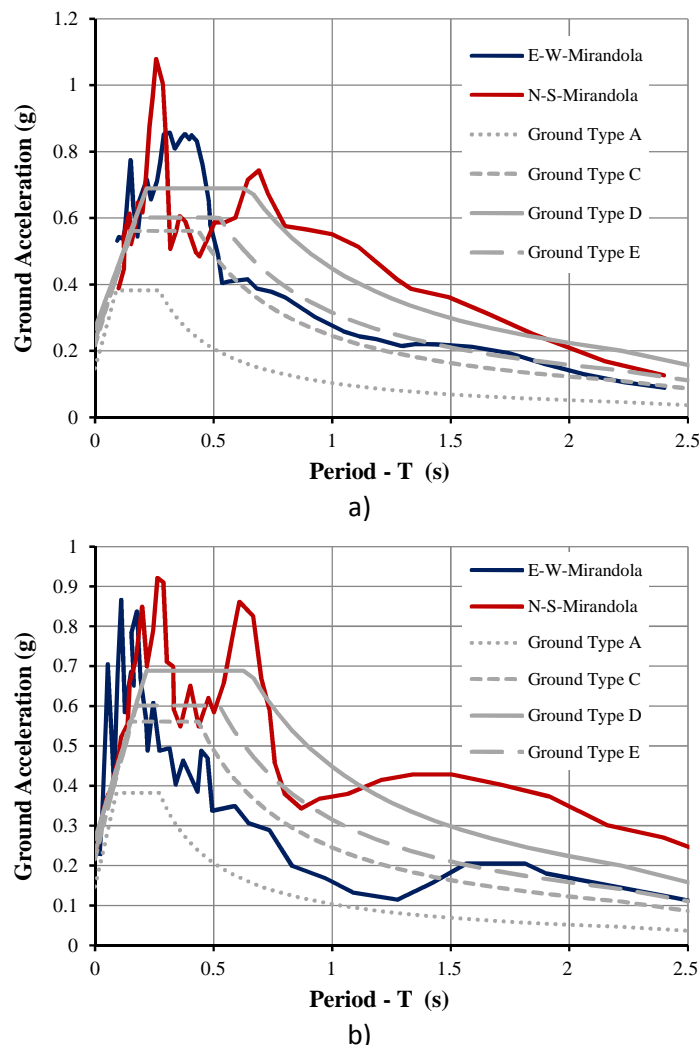
Figure 6.3 - Comparison of the response spectra at 5% damping for different ground typologies with the response spectra derived from the acceleration history measured at Mirandola for: a) the 20th May, 2012 event and for b) the 29th May, 2012 event.

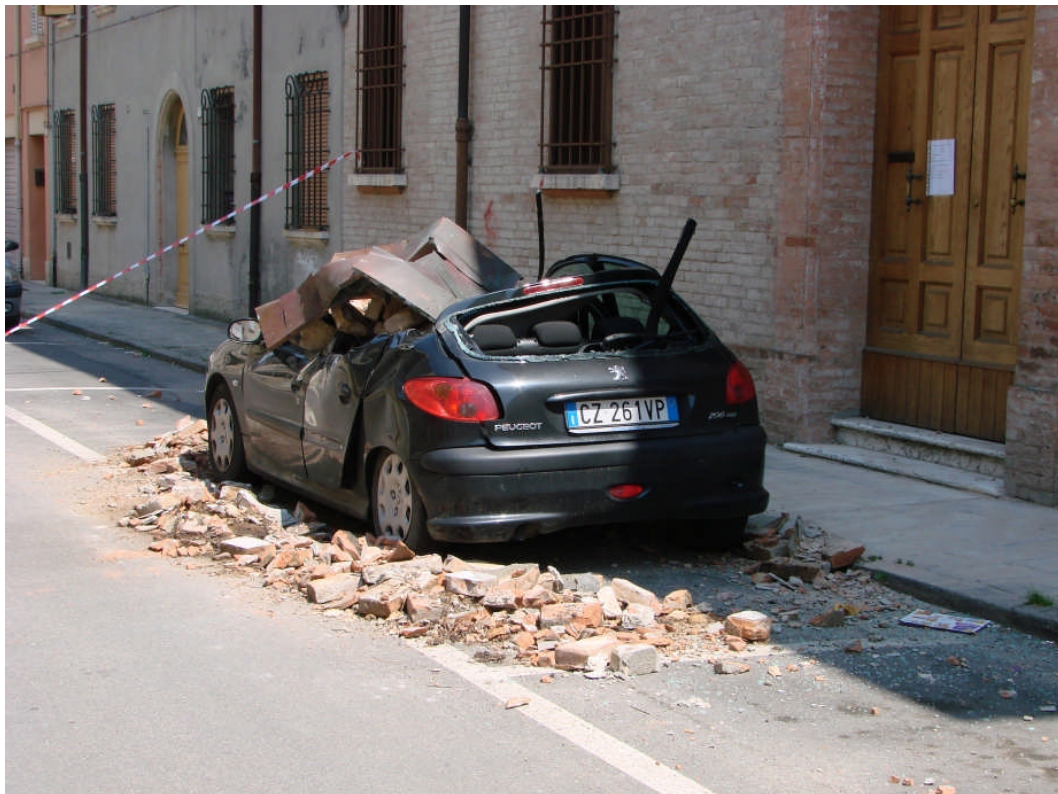
Figure 7.1 Car crushed by falling chimney, Finale Emilia.

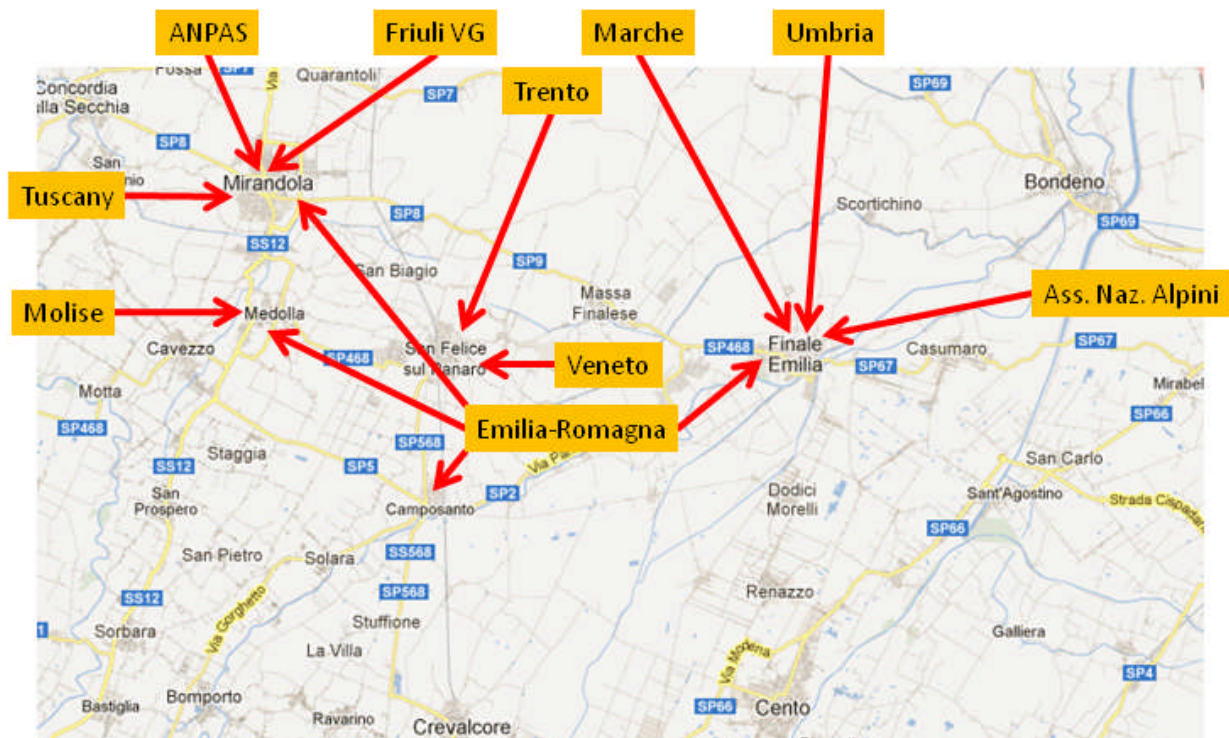
Figure 7.4. Division of competencies for tent camps after the 20th May earthquake.

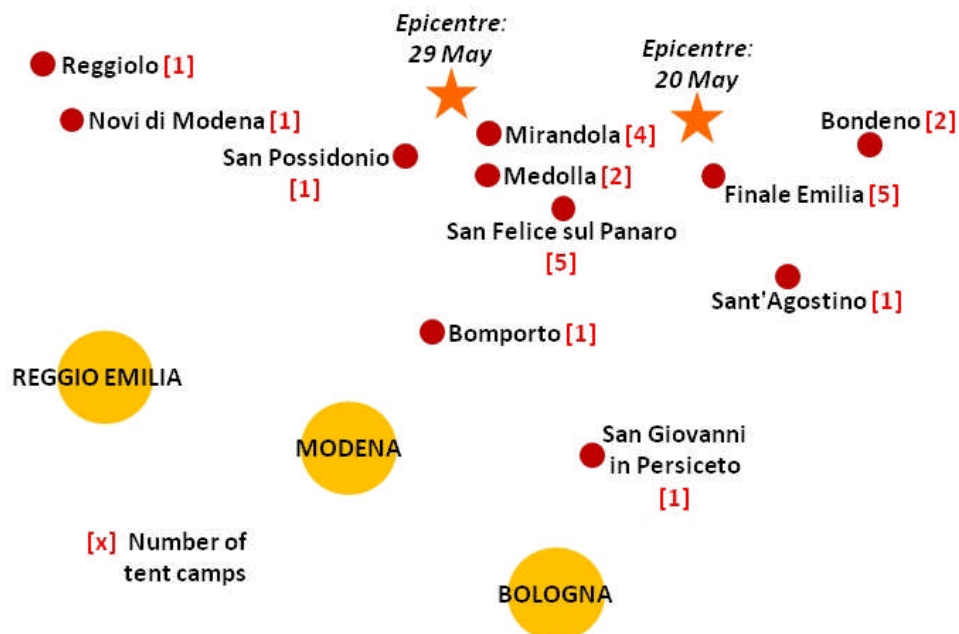
Figure 7.5. Location of tent camps open on 31 May 2012.
