The 20th May 2012 Emilia Romagna Earthquake

EPICentre Field Observation Report

01/06/2012

EPICentre Field Observation Report No. EPI-FO-200512

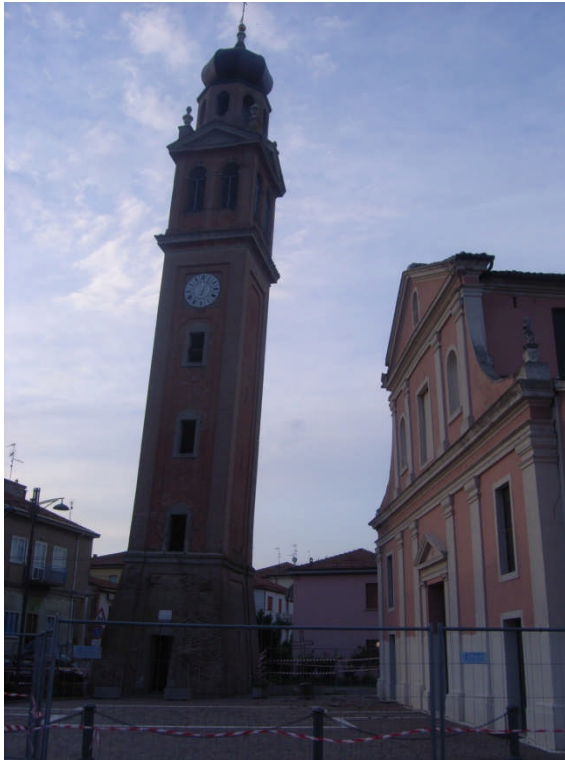
Figure 3.2 - Damage to the Church of Nativita' di Maria and Clock tower in Vigarano Mainarda

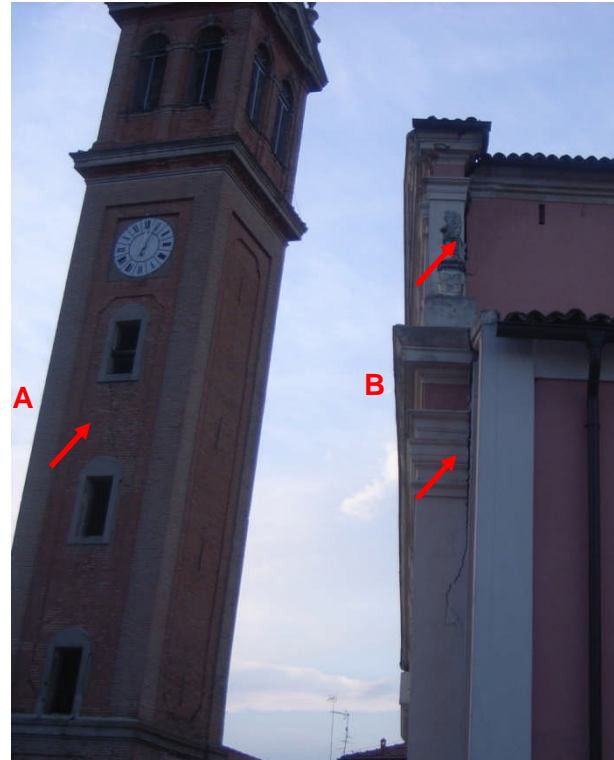
Figure 3.3 - Detail of the fractures lines in the top half of the clock tower (A) and detachment and rotation of the church facade (B).

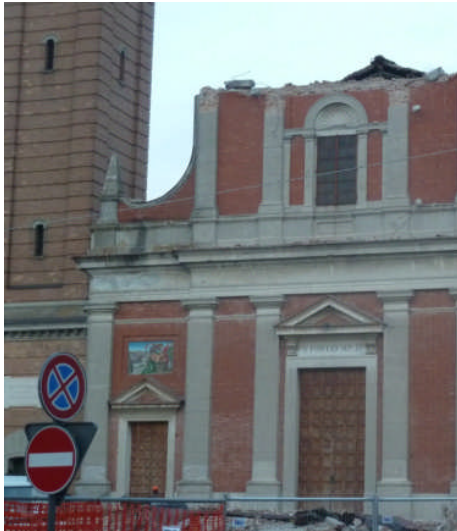
In the town of Mirabello, the church sustained a partial collapse of the facade and total collapse of the transept and apse (Figure 3.4 and 3.5). The bell tower of the church did not sustain structural damage and was declared salvageable (Online Newspaper Estense.com – 23 May 2012 <http://www.estense.com/?p=221642>). Locals also reported that the bell tower foundations had been strengthened in the past.

Figure 3.4 - Damage to facade of the Church of Mirabello (front view).

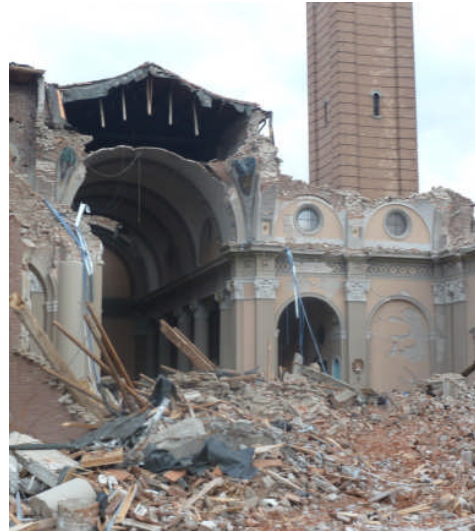
Figure 3.5 - Damage to cupola of the church of Mirabello (back view).

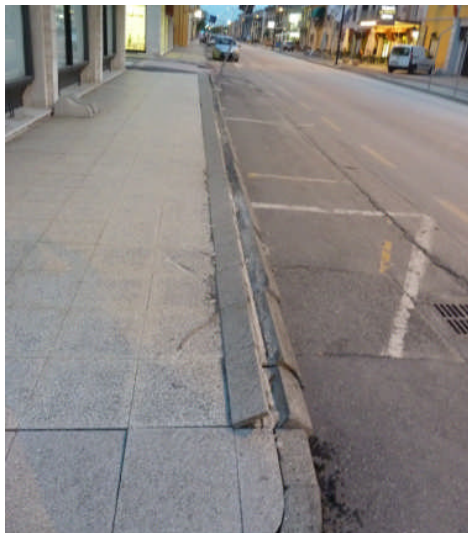
In Mirabello, significant evidence of lateral spread due to liquefaction of soil at relatively shallow depth were found. These caused movement of buildings lining the main street as rigid bodies down-slope. This was visible as uplift of the pavement stones and the presence of separation cracks between the buildings moving down-slope and those attached to them further up-slope (Figure 3.6, 3.7 and 6.8). Measurement of the cracks indicated overall movements in the range of 0.5-2.5cm. Locals in the town of Mirabello told the team that the street interested by the lateral spreading was originally a small river (likely an affluent of Reno River). According to locals the river was running in the direction of S. Carlo and S. Agostino, where further evidence of lateral spread and liquefaction, were found. In Mirabello, damage to residential structures outside the main street, was minor and mostly concerned non-structural elements. New reinforced concrete low-rise residential houses were undamaged and were inhabited at the time of the mission. Locals reported there had been damage to gas pipes which would take a week to repair, and that electricity was unavailable for 4 hours after the earthquake. Despite the limited amount of damage to residential buildings, many locals were voluntarily sleeping in tents and in their own cars. Shelter was provided at the local school for people whose houses were damaged.

Figure 3.6 - Evidences of lateral spreading in the street of Mirabello.

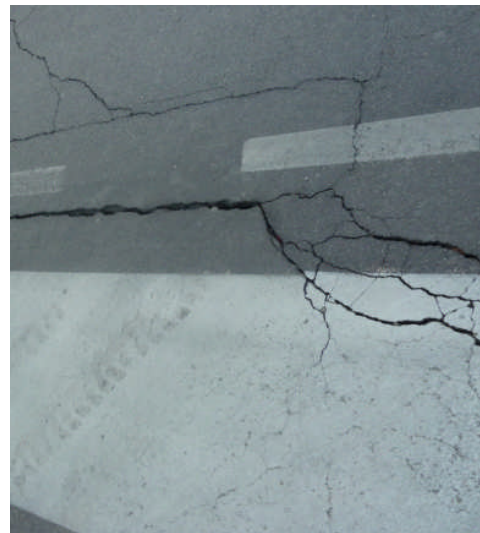
Figure 3.7 - Detail of lateral spreading in the street of Mirabello.

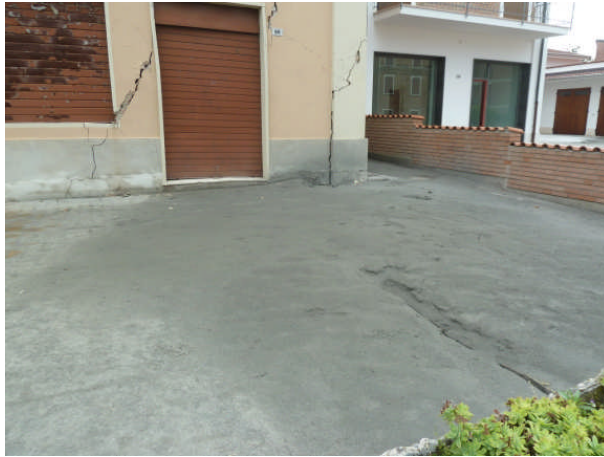
Figure 3.8 - Damage to a residential building in S. Carlo. The picture shows clear evidences of liquefaction.

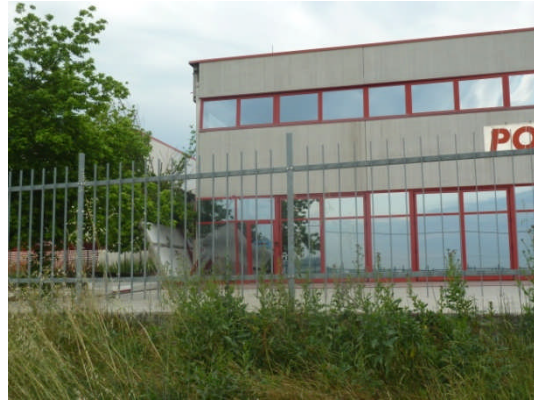
In S. Carlo, damage to industrial facilities was also observed (Figure 3.9.). All the collapsed structures were built with pre-cast reinforced concrete elements (see Section 4).

Figure 3.9 - Damage to industrial facilities in S. Carlo.

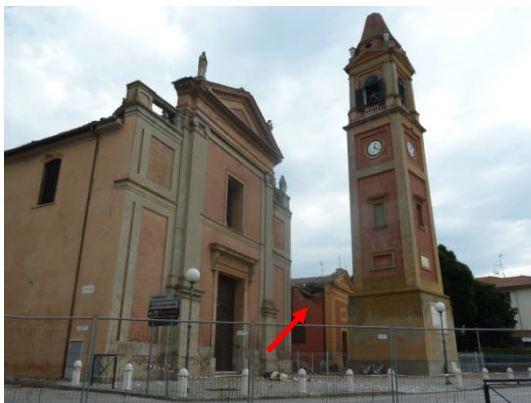
Figure 3.10 - Damage to the church of S. Agostino

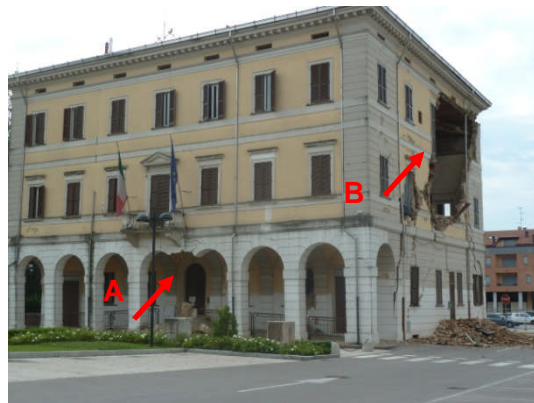
Figure 3.11 - Damage to the town hall of S. Agostino. Detail A – Fallen column. Detail B – Collapse of the external wall.

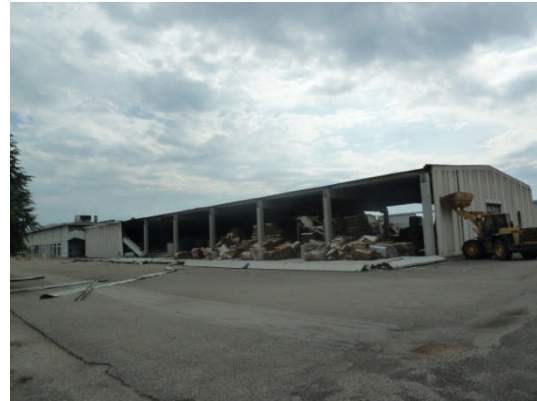
Figure 3.12 - Another warehouse in the near proximity of S. Agostino Ceramic. Name and usage of the warehouse is unknown.

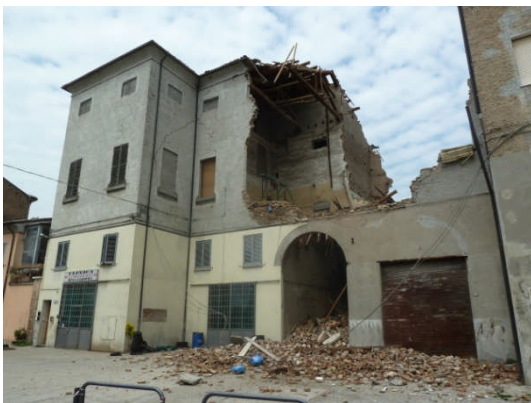
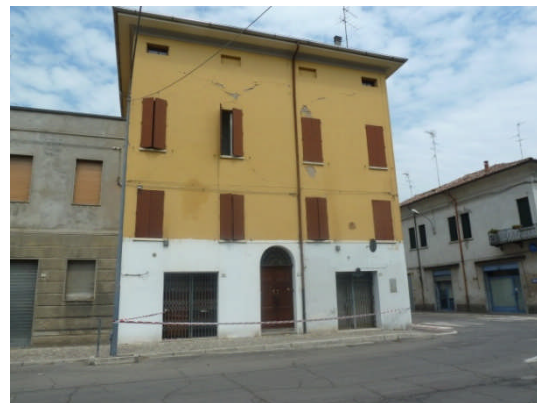
Figure 3.13 - Different degree of damage to residential building were observed in Finale Emilia. Damage was particularly evident for old and poorly maintained masonry structures.

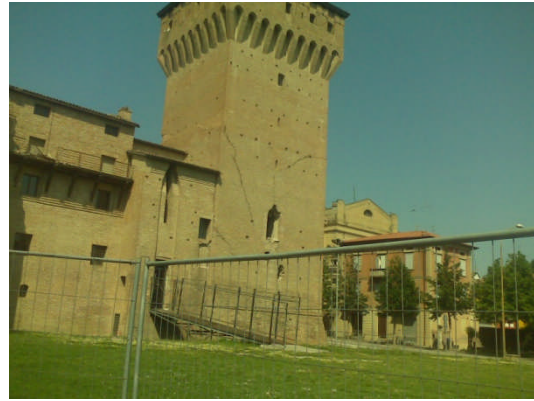
Figure 3.14 - Damage to historical buildings in San Felice sul Panaro. The ancient tower is collapsed and the castle presents fractures lines.

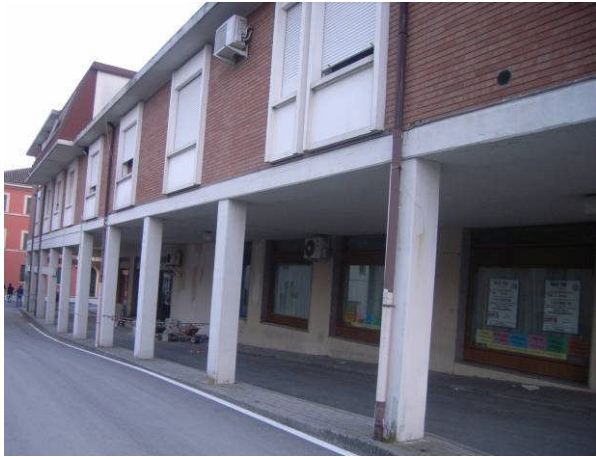
Figure 4.1 shows residential buildings in Mirabello without damage. Only pounding between the buildings was observed.

Figure 4.1 Residential buildings in Mirabello: a) overview of the RC buildings; b) pounding observed between the buildings.

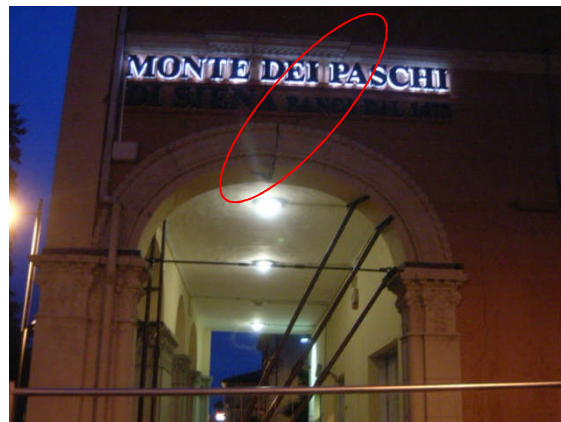
Figure 4.11 - Stabilisation to prevent overturning of the corner of a masonry building in Mirabello.

The top of the column in Figure 4.11 seemed to have swayed away from the building and a stabilisation system was fitted under the arch to prevent its collapse.

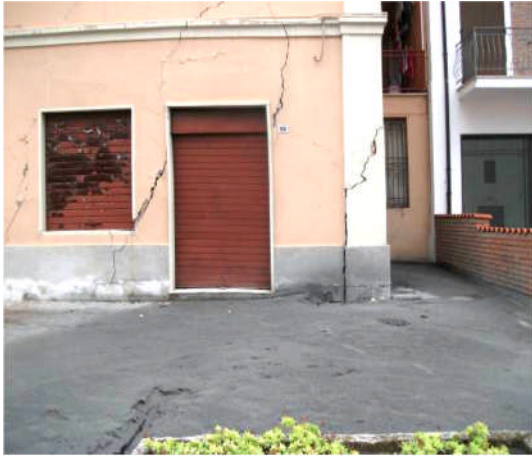
In San Carlo, the extensive liquefaction near the school caused significant damage on two adjacent buildings. In Figure 4.12, a 3 storey unreinforced brick masonry building located next to the school is shown to have suffered large cracks on its front façade. A similar building with timber roof (see Figure 4.13) located in a different street was also found to have suffered moderate damage (DS3 in EMS98) with large cracks in its two walls. The damage seems to be concentrated to this building since adjacent buildings (see Figure 4.14) of similar size were not damaged.

Figure 4.12 - Large and extensive cracks due to differential settlement on a residential house in San Carlo.

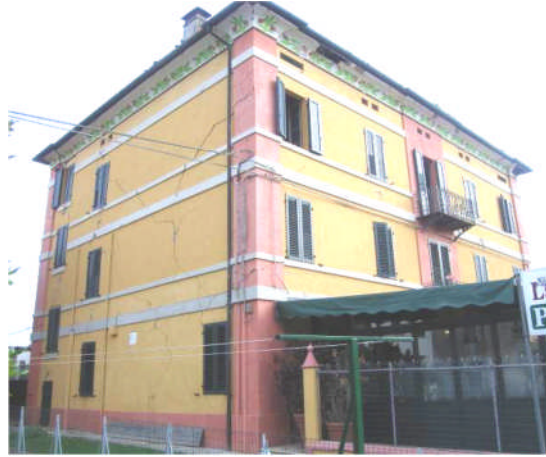
Figure 4.13 - Moderate damage of a commercial/residential building in San Carlo.

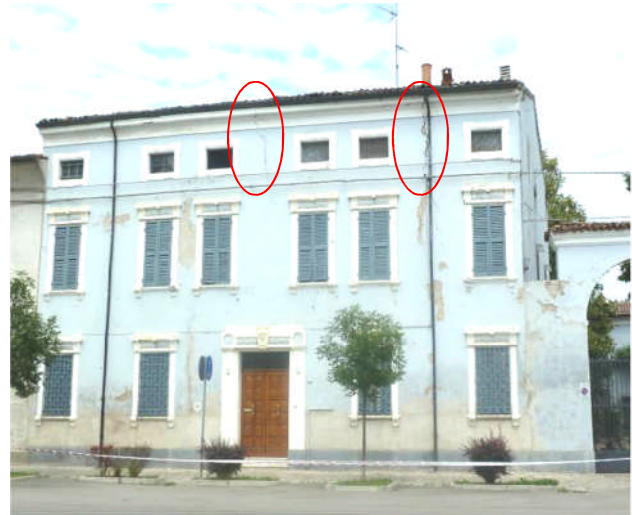
Figure 4.16 - Cracks on the wall of the 3rd floor in a residential building via Cesare Frassoni.

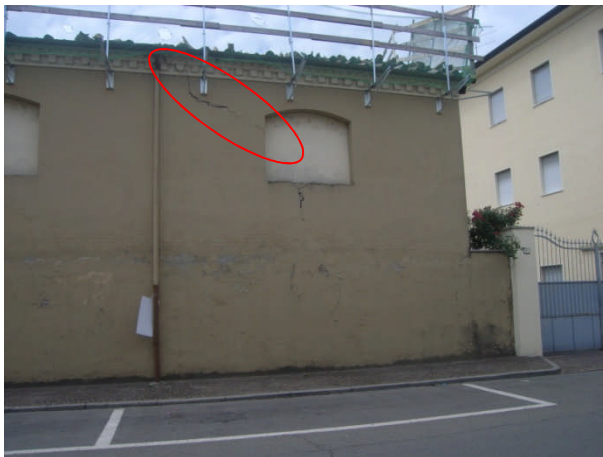
Figure 4.17. – Dislodged ceramic tiles from the roof and Shear crack on the wall of a residential building in Finale Emilia.

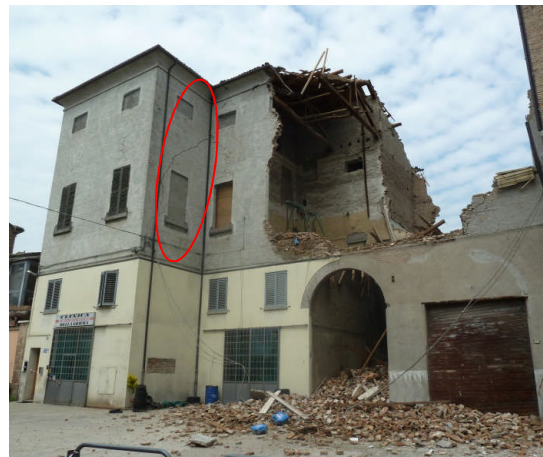
Figure 4.18. - Partial collapse of a commercial building in via Cesare Frassoni in Finale Emilia.

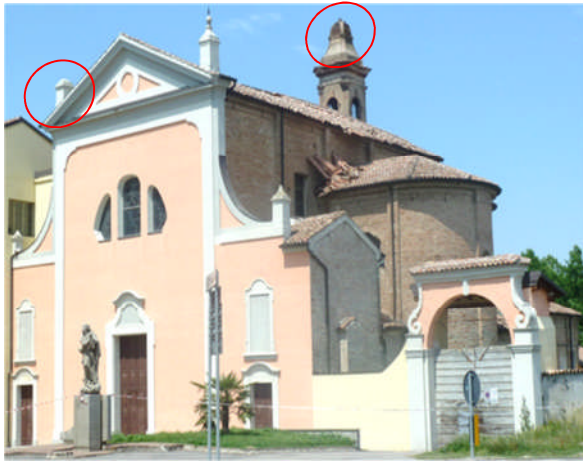
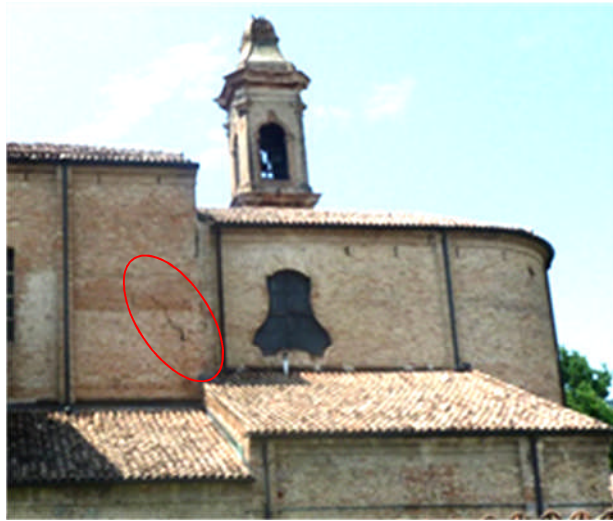
Figure 4.21 - Church outside San Felice sul Parano: a) dislodged decorations; b) crack on the external wall of the facade and the south wall; c) long crack on the south transept.

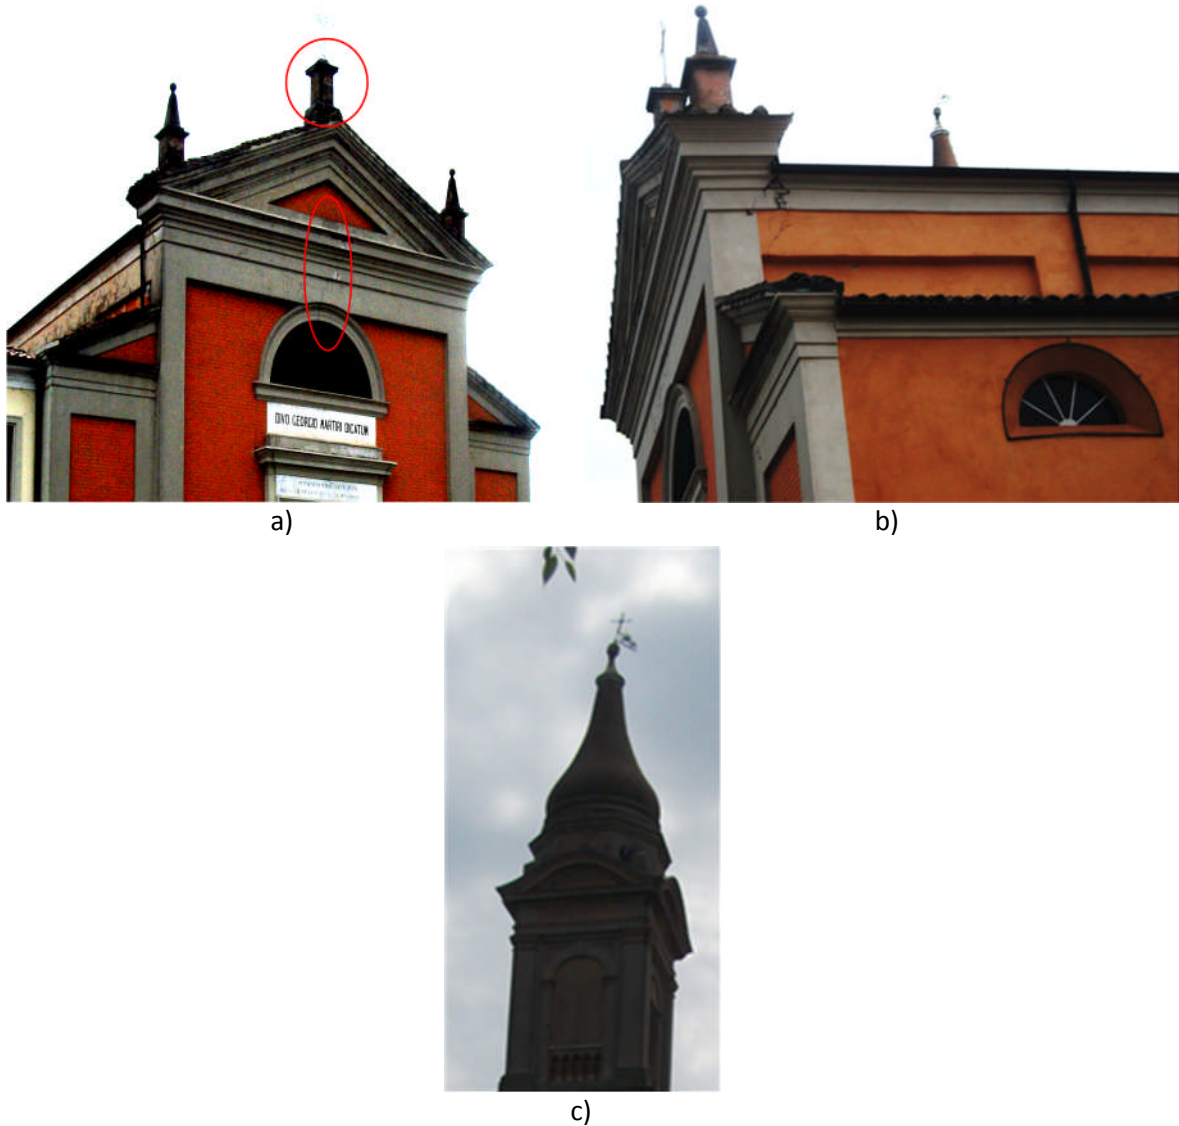
Figure 4.23 - Church of Divo Georgio Martiri Dicitum in Corpo Reno: a) dislodged decoration and a large crack on the façade; b) out of plane failure of the façade; c) dislodged cross on top of the leaning bell tower.

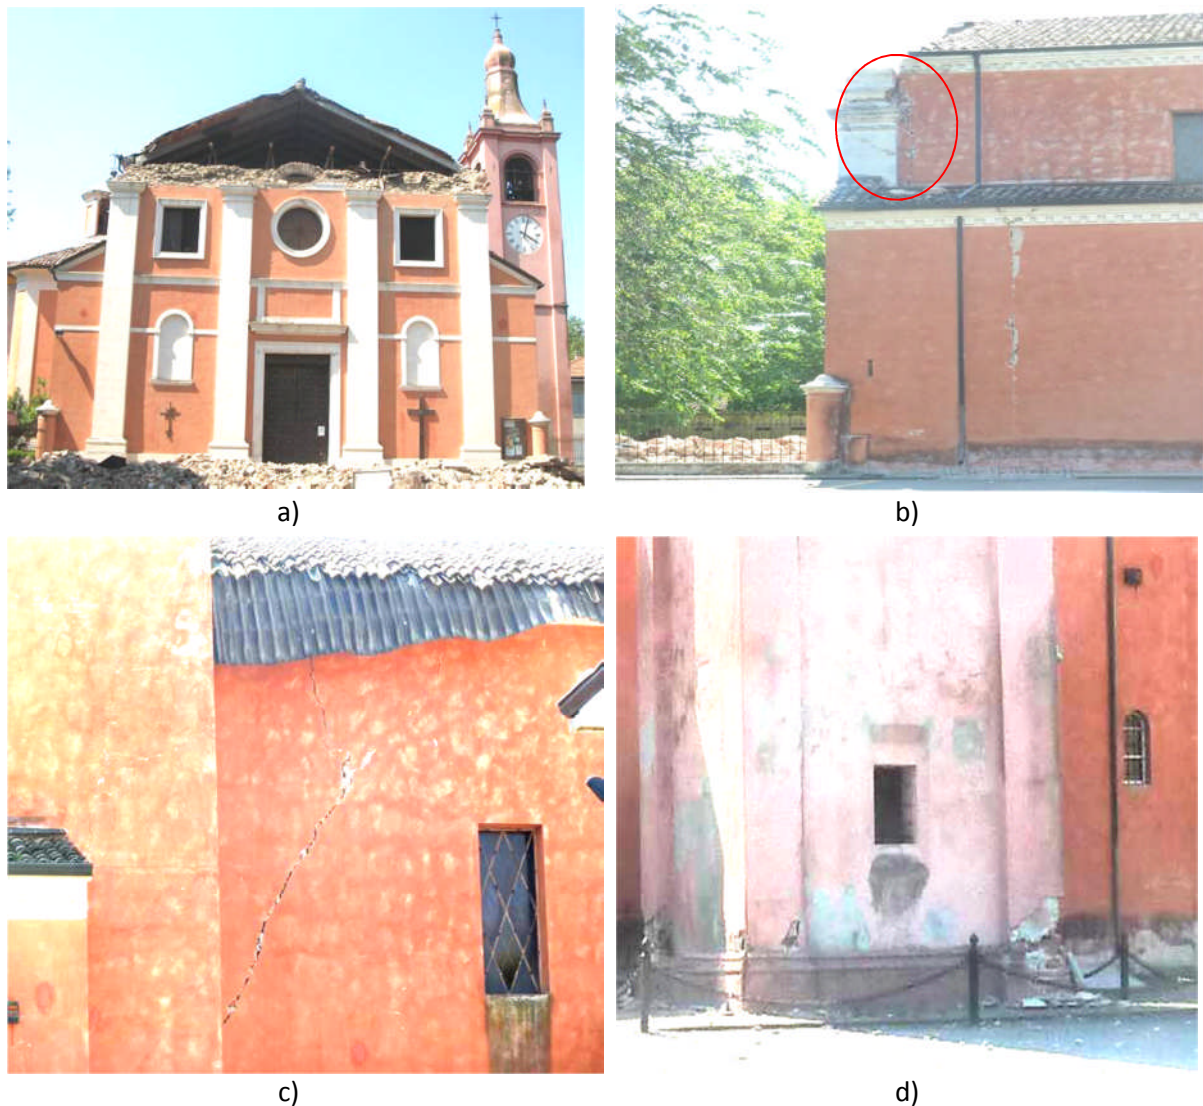
Figure 4.24 - Church on via degli Estensi in San Felice sul Panaro: a) Collapse of the top façade of the church on via degli Estensi; b) Cracks on the external wall of the façade and the south wall of the church on via degli Estensi; c) Large and extensive crack on the north side of the church on via degli Estensi; d) Spalling at the bottom of the bell tower of the church on via degli Estensi.

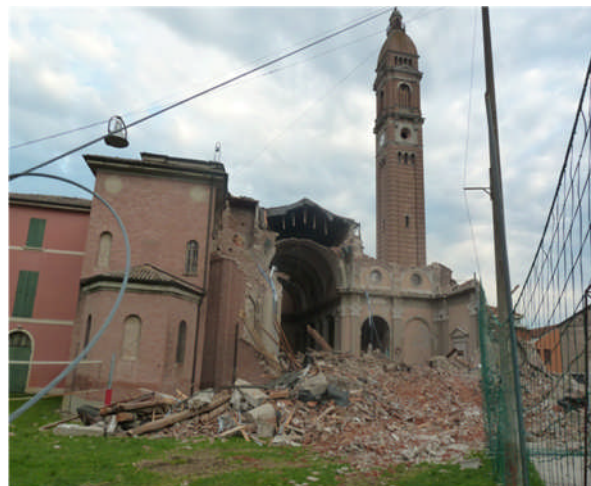
Figure 4.26 - Church of San Paolo in Mirabello: a) partial collapse of the; b) out of plane failure of the facade; c) collapse of east side and part of the north transept.

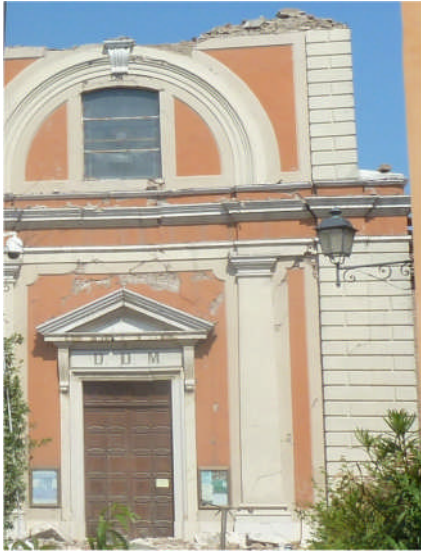
Figure 4.27 - Partial collapse of the façade of the church of D.O.M. in San Felice sul Panaro.

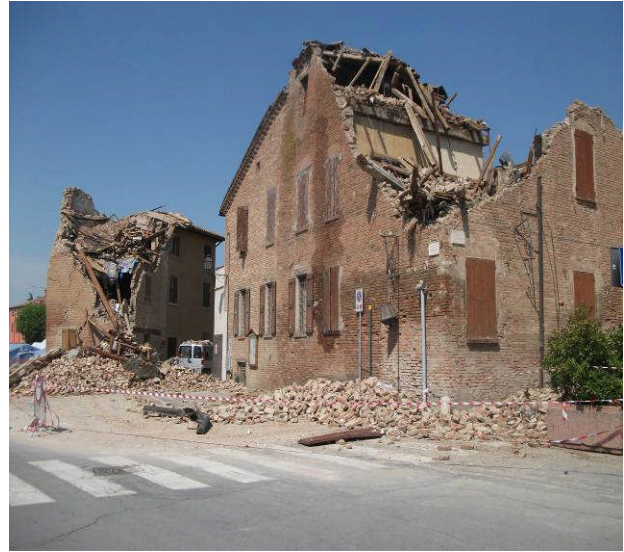
Partial collapse was also noted for the two church buildings used by the D.O.M. (Figure 4.28). The smaller building's failure mechanism seems to involve the formation of two large diagonal cracks, which led to the overturning of the corner, resulting in the collapse of the structure. Similarly, the collapse of part of the first floor of the larger building seems to have also been caused by the overturning of the corner (also induced by diagonal cracks). The walls of the ground floor for this building, however, seem undamaged.

Figure 4.28 - Partial collapse of the church buildings next to the church of D.O.M.

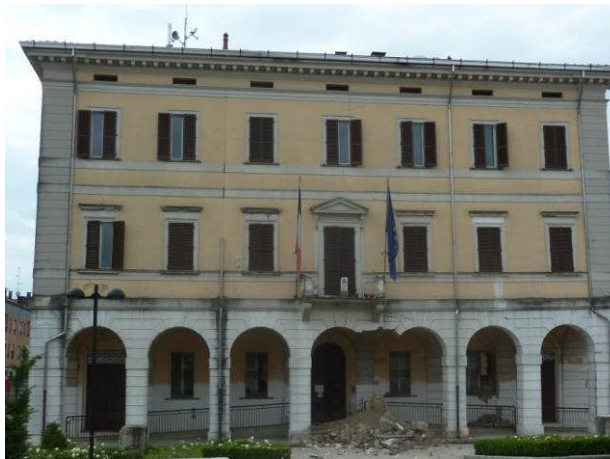
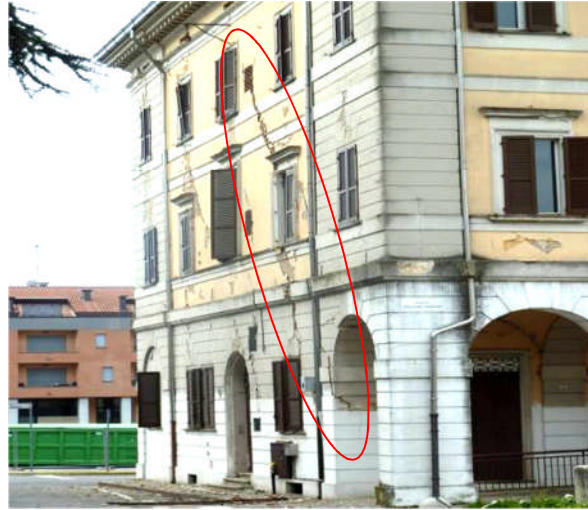
The town hall of San Agostino is made of unreinforced brick masonry with timber floors. This building suffered severe damage to its structural components. Figure 4.29a shows the collapse of a middle column from the façade's portico. In Figure 4.29b, the external wall suffered partial collapse due to insufficient out-of-plane resistance. This can be attributed to the small thickness of the wall, i.e. one brick thick, which extends to two floors without being supported by a floor slab. There are also extensive diagonal cracks in both side walls (see Figure 4.29b,c) indicating the loss of connection of the side walls with the front wall. This forms a wedge which caused the out-of-plane failure of the portico.

Figure 4.29 - Town hall in S. Agostino: a) Collapse of the middle column of the facade; b) partial collapse of a side wall and loss of connection of the external wall in the front; c) large and extensive cracks in a side wall.

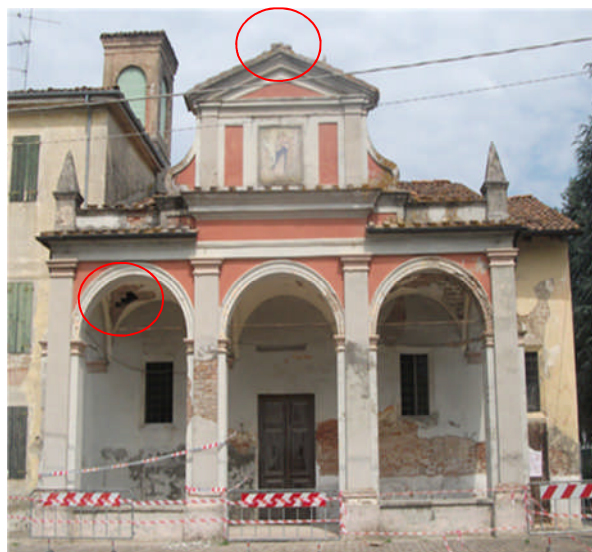
The portico of the Oratorio in Corpo Reno, built in 18th century, was found to have suffered slight damage by the earthquake. A dislodged decoration from the facade and slight damage in the arches were noted (see Figure 30).

Figure 4.30. – Slightly damaged façade of the Oratorio in Corpo Reno.

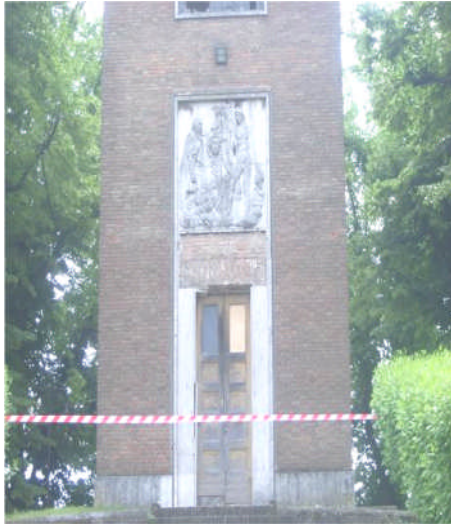
Figure 4.31 - Dislodged decorative marble plates from the brick masonry tower in Finale Emilia.

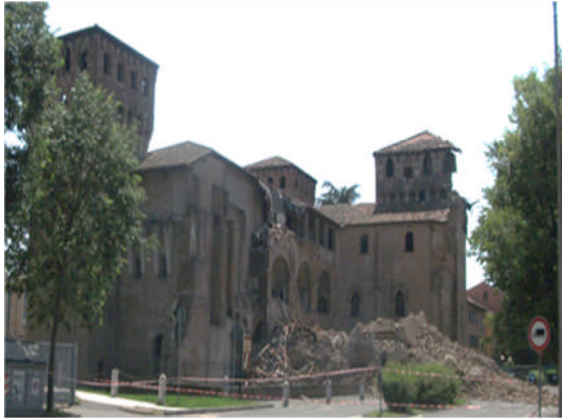
Figure 4.34 - Partial collapse of the east side of the Castello delle Rocche in Finale Emilia.

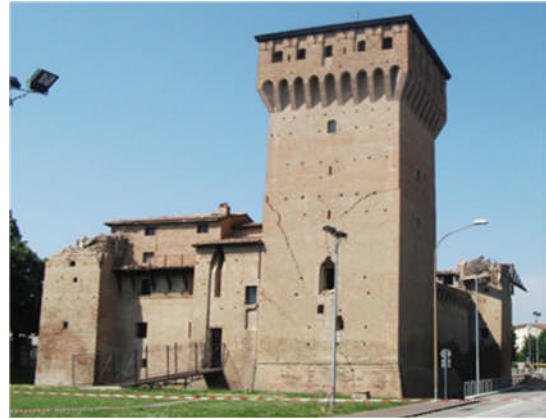
The "Rocca Estense" Castle in San Felice sul Panaro was also inspected. The castle, built in the 15th century, is an unreinforced brick masonry structure with four towers. The castle suffered extensive damage due to the earthquake: three towers partially collapsed (Figure and Figure) and the fourth (see Figure) sustained significant large and extensive diagonal cracks, suggesting loss of connection between the walls. From the debris of a collapsed tower in Figure it can be concluded that one tower at least has been retrofitted with RC beams.

Figure 4.35 - Partial collapse of the two towers and severe damage in the third tower of the Rocca Estense Castle.

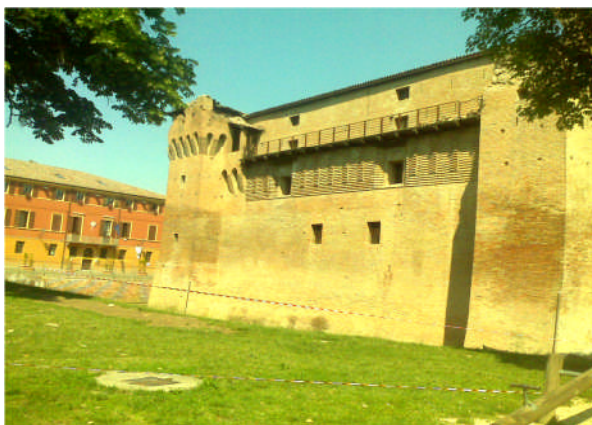
Figure 4.36 - Partial collapse of the fourth tower of the Rocca Estense Castle.

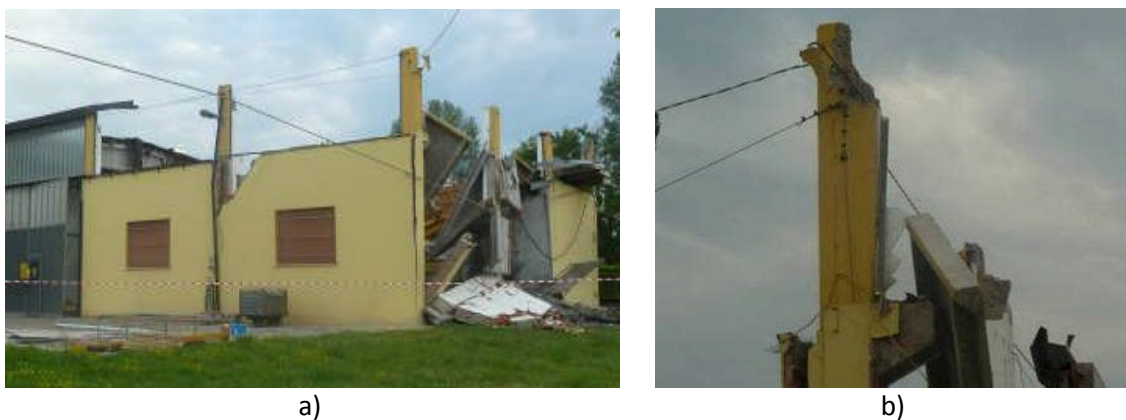
Figure 4.38 - Industrial buildings close to Mirabello: a) overview of the pre-cast structure; b) joint detail.

beam and a thin steel fibre reinforced concrete shell forming the roof of the factory close to Mirabello (Figure 4.38) had a similar failure mechanism to the former. In the industrial structure at Fondo Sabbione, the double T-beam roof structure slid over the transverse beams, causing collapse in some areas and permanent slippage of the slabs in other areas (Figure 4.39). Figure 4.43 shows that the roof did not collapse in the RC and pre-stress pre-cast structure at Sant' Agostino ceramic factory. The height of the structure is however shorter when compared with the other structures with damaged roofs.

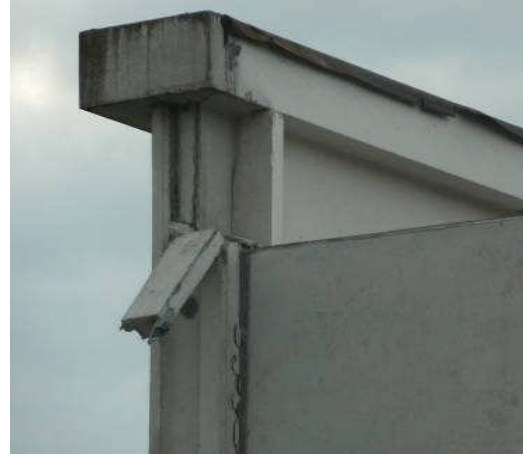
Figure 4.39 - Industrial building in Fondo Sabbione: a) overview; b) joint failed detail.

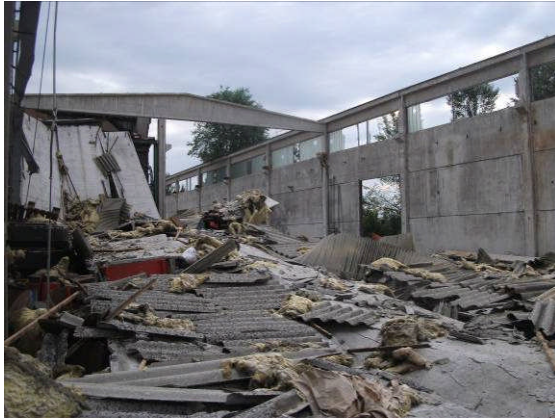
Figure 4.40 - Industrial building in Sant Agostino: a) overview; b) joint failed detail.

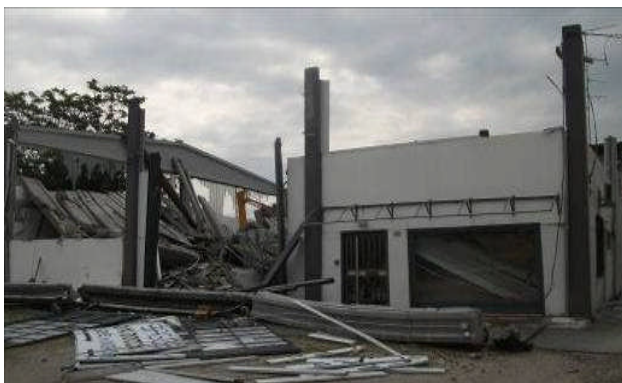
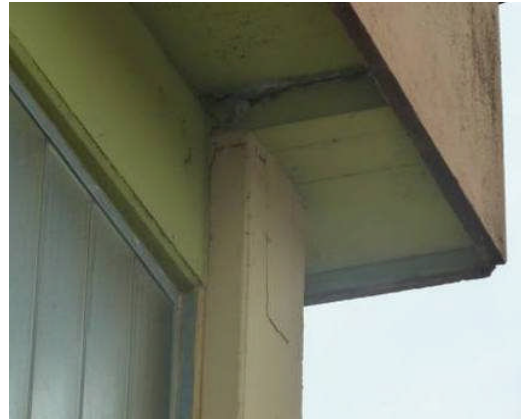
Figure 4.41 shows two industrial structures in an industrial zone close to Corpo Reno. In Figure 4.41a,b the structure exhibits the mechanism described. However, the second structure only exhibits minor damage even though it has the same structural system as the former. The only difference consists only in the latter having longitudinal spans approximately half that of the collapsed structure. The undamaged structure is more integral.

Figure 4.41 - Industrial building close to Corpo Reno: a) overview; b) joint failed; c) pre-cast structure without damage; d) joint with few deformation.

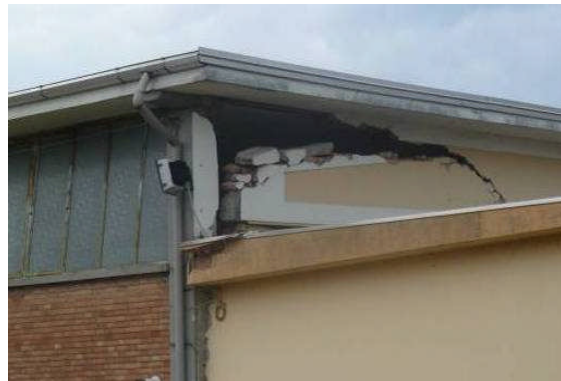
Figure 4.42 - Industrial building close to Sant Agostino: a) overview; b) joint failed.

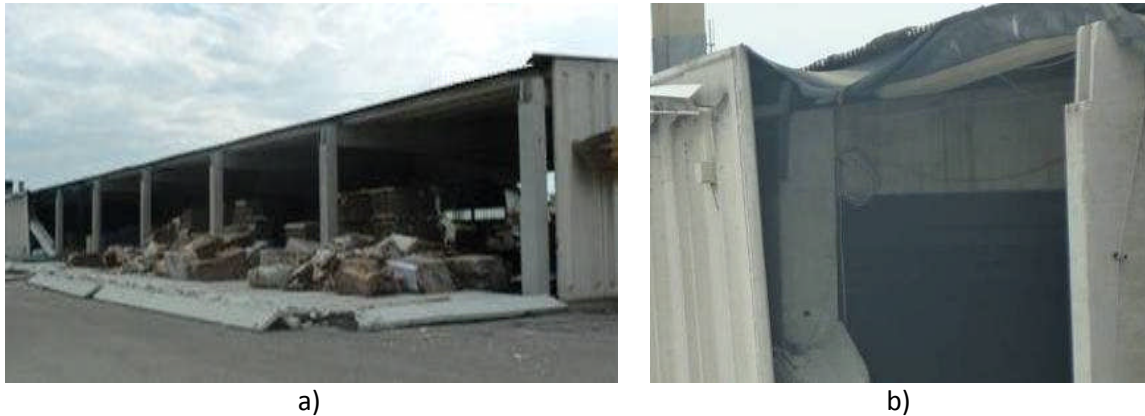
Figure 4.43 - Industrial building close to Sant Agostino: a) overview; b) panel connection failed.

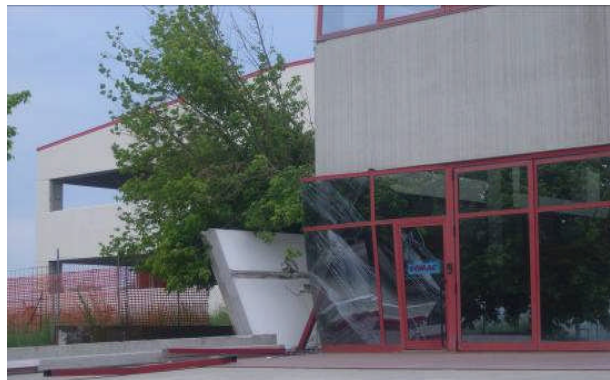
Figure 4.44 - Industrial buildings close to Mirabello: lateral panel failure.

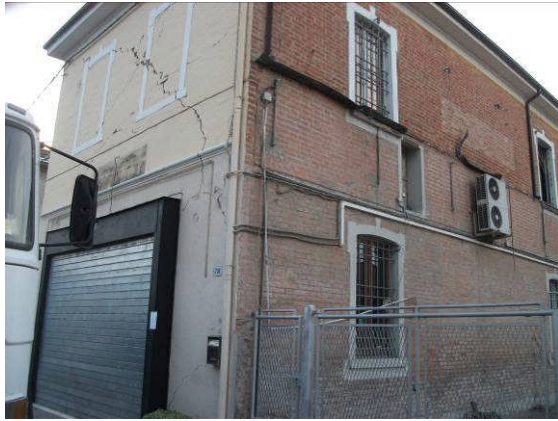
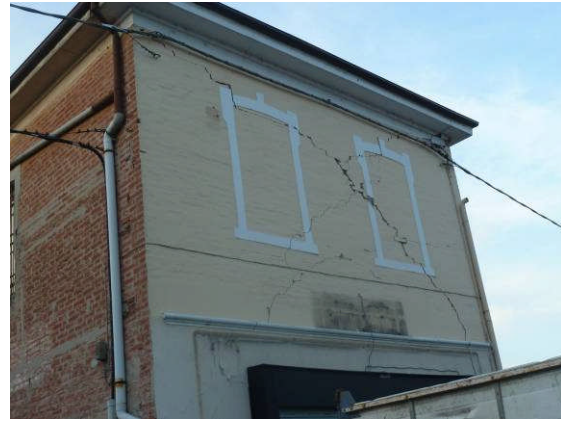
A small warehouse in Vigarano Mainardo was observed to suffer shear diagonal cracks on the facade (Figure 4.47). An abandoned industrial warehouse along a water canal outside Massa Finale experienced partial collapse (Figure 4.48). The structure consisted in masonry walls with RC reinforcements. The roof structure consisted in a wooden truss. A small masonry bridge connecting the two banks of the canal on either side, had a transversal crack in the middle of its arch, hinting that there was minor lateral displacement of the canal bank that may have contributed to the collapse of the warehouse.

Figure 4.47 - Industrial building in Vigarano Mainardo: a) overview; b) shear failed on the front facade.

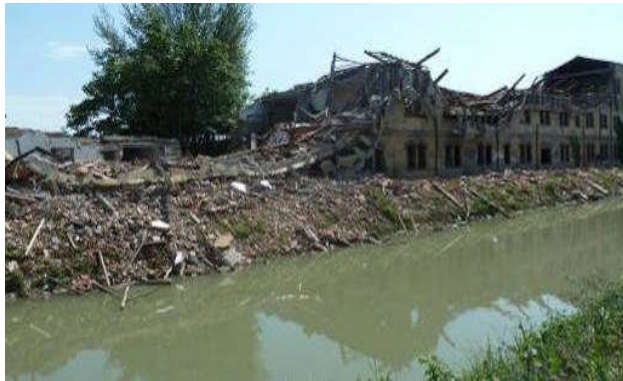
Figure 4.48 - Industrial building close to Massa Finale: a) overview; b) reinforced concrete frame failed.

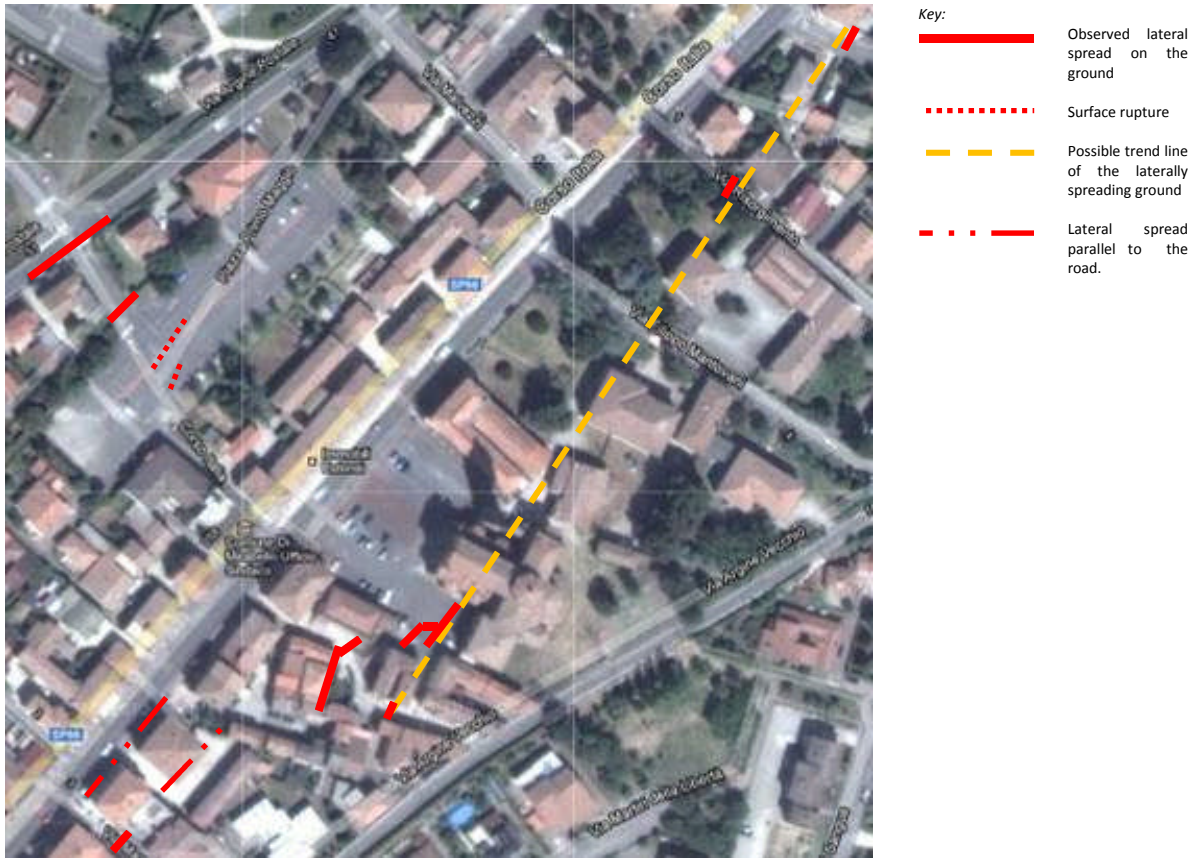
Figure 6.10 - Observed ground surface cracks at Mirabello.

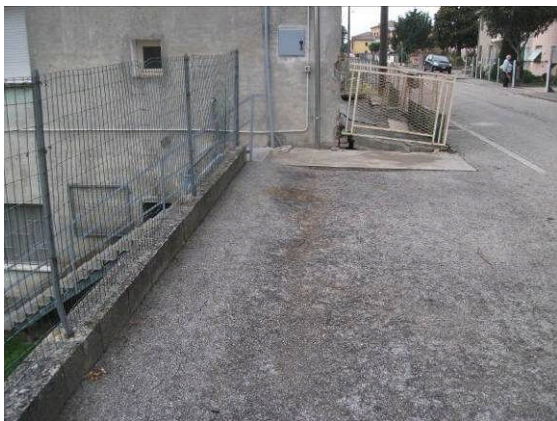
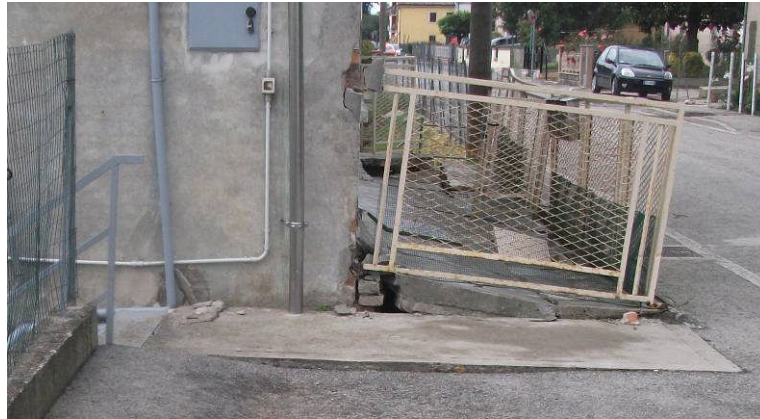
In Via Primo Maggio, San Carlo, a masonry structure having access on two levels was observed to sustain damage due to pounding with the road substructure, causing the pavement in front of the house to fail completely (Figure 6.11). The house sustained minor permanent displacement. The road in front of building also experienced damage due to possible failure of the subgrade. Nevertheless, a buttressed RC diaphragm wall adjacent to the house did not sustain any damage.

Figure 6.11 - a) Damage of house having access from 2 levels; b) Retaining wall adjacent to the house; c) detail of the damage of the pavement in front of the house.

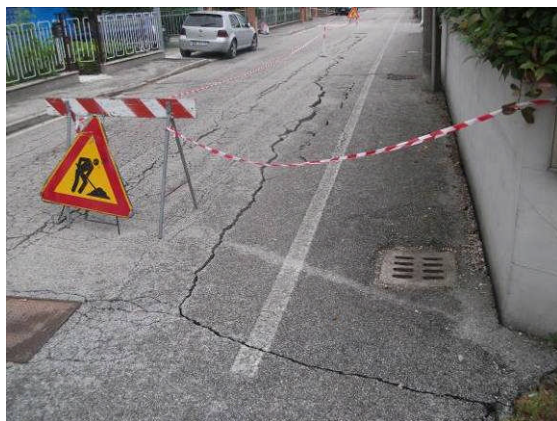
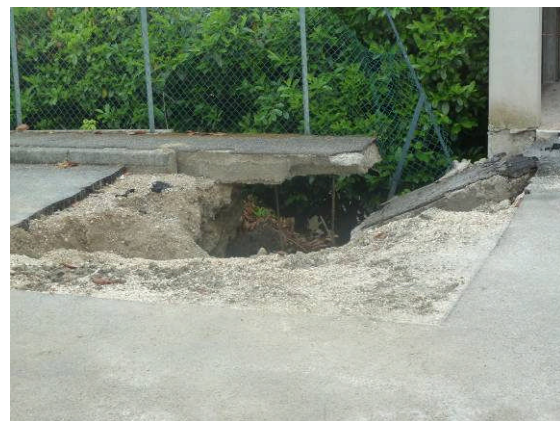
Figure 6.12 - a) Lateral spread and settlement in Via Argine Postale, Mirabello; b) lateral spread and settlement in Corso Italia, Mirabello; c) Surface cracks and damage to trench in Via Primo Maggio, San Carlo; d) Collapse of sub-base and subgrade, San Carlo.

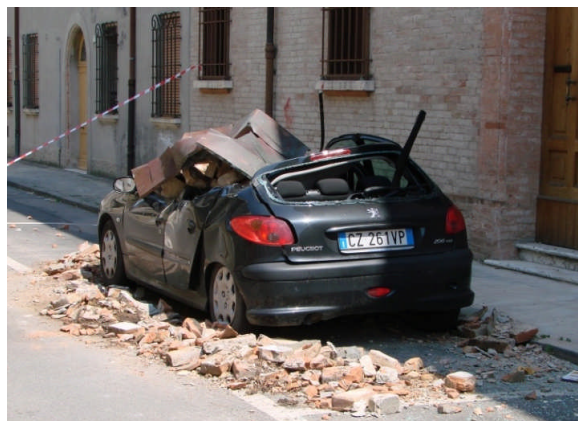
Figure 7.1 - Car crushed by falling chimney, Finale Emilia.
