X International Conference on Structural Dynamics, EURODYN 2017

## Modal testing of offshore rock lighthouses around the British Isles

James Brownjohn<sup>a\*</sup>, Alison Raby<sup>b</sup>, James Bassitt<sup>a</sup>, Emma Hudson<sup>a</sup>, Alessandro Antonini<sup>b</sup>

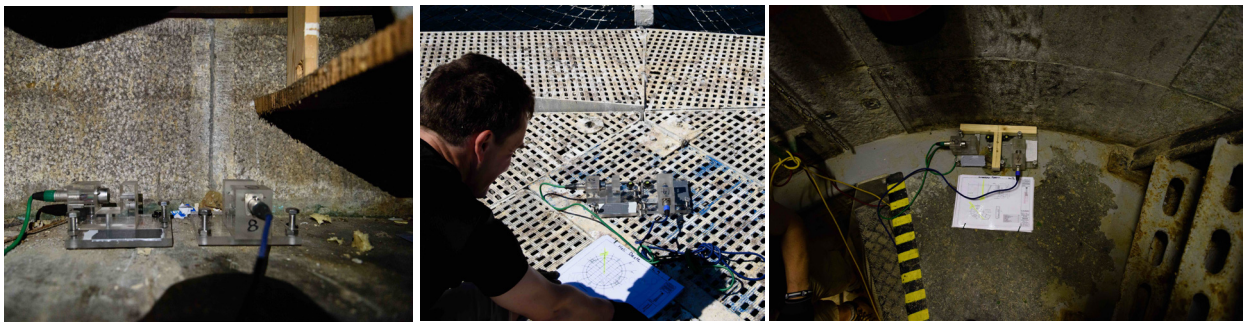
Fig. 2. Wolf Rock: Accelerometers on bedroom floor, on helideck and in service room, with alignment jig.

For each level, accelerometers were positioned in nominal x and y directions using an alignment jig (Fig. 2), at the same circumferential reference point, based on Trinity House drawings showing internal layouts and reference points at each level. Accelerometers locations were at north-east point against the masonry wall at every level, with x-direction to south-west and y-direction to south-east. Data acquisition was set up in level 7 with the shaker at level 8 and for each swipe at least three measurements were made: one ambient, one with shaker in x-direction and one with shaker in y-direction. Table. 1 summarises the sequence of measurements, excluding test runs.

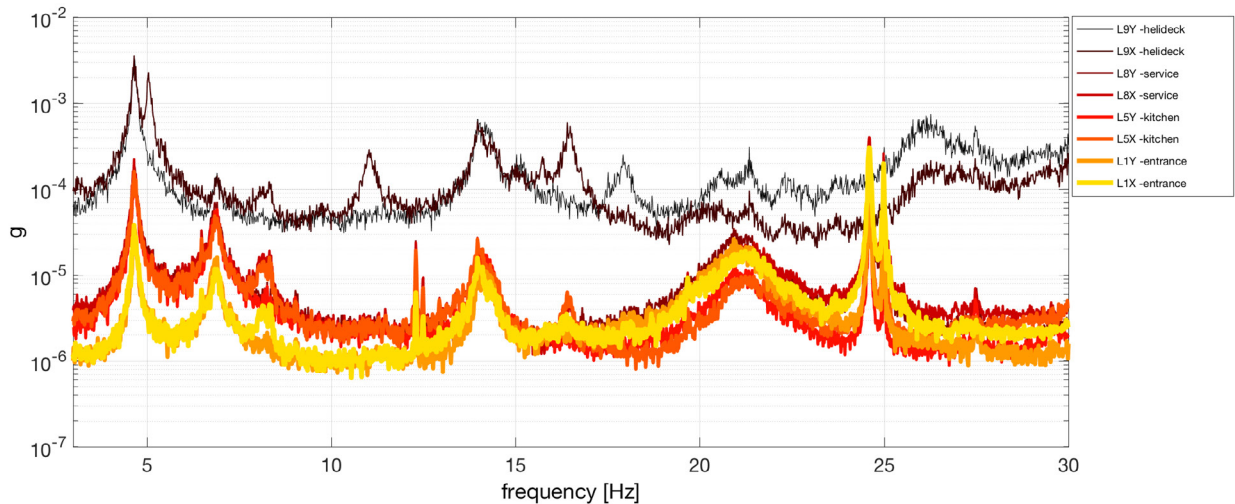
Fig. 3. Wolf Rock: Auto-spectrum for ambient response –all available channels in swipe 1, Run 12.

Auto spectra for selected levels from Run 14 are shown in Fig. 3. System identification on ambient data (eigen-system realization algorithm, ERA) reveals modes at 4.7 Hz and 6.8 Hz as well as at 4.85 Hz and 5.1 Hz. The 4.7 Hz mode involves proportionally very large motion of the helideck while the 4.85 Hz mode seems only to be the helideck moving in x-directions. The 6.8 Hz mode has strong helideck motion, but proportionally less strong than for the 4.7 Hz mode. For the 4.7 Hz and 6.8 Hz modes there are components in the nominal x and y directions; the mode shapes are (later) identified using classical modal analysis using the forced vibration data.

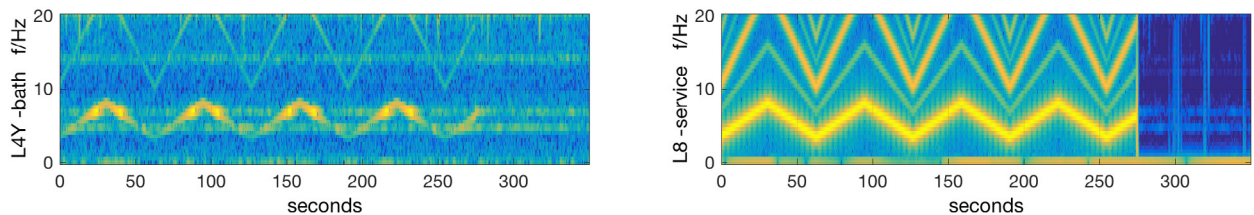
Fig. 4. Wolf Rock: Spectrogram for response and forcing function.

Spectrograms for Run 16 are shown in Fig. 4 that begin with swept sine shaking and end in ambient response after the shaker cuts out. The strong response clear in the masonry structure corresponds to the 6.8 Hz mode, while the helideck channel shows more complex response with both 4.7 Hz and 6.8 Hz modes driven by both wind and shaker. The 4.7 Hz mode responds strongly due to the wind after the shaker stopped. The modal behavior is clear in the spectrogram. The shaker characteristic indicates non-sinusoidal response and a mode around 14 Hz that is driven by wind.

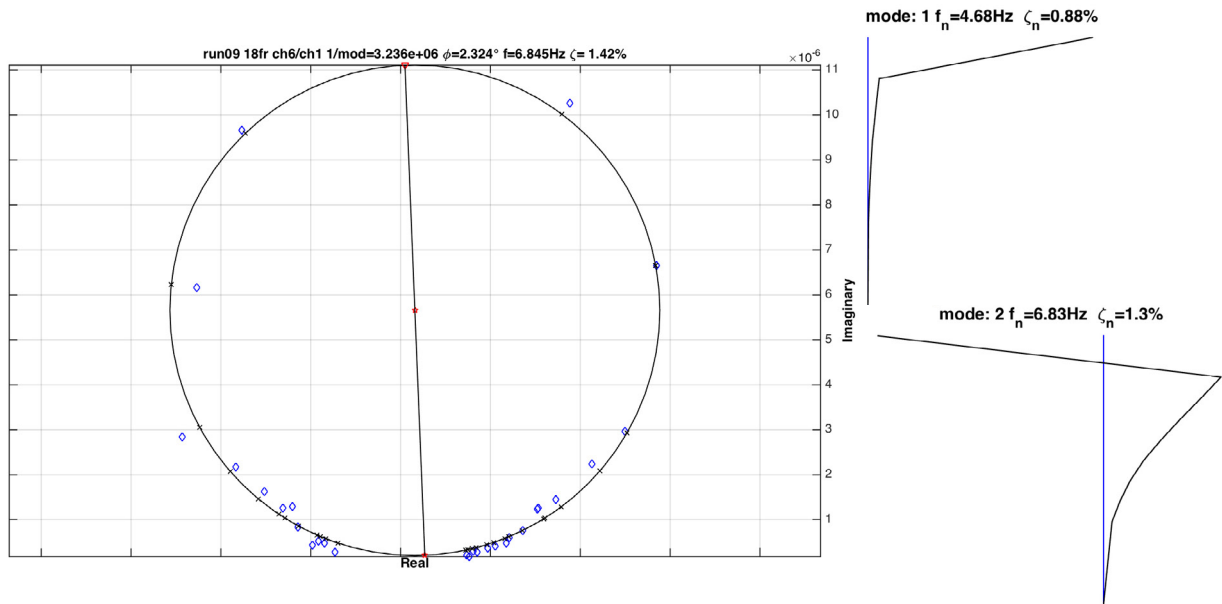
Fig. 5. Wolf Rock: Left: SISO circle fit for x-direction. Right: SIMO mode shapes for y-direction.

Fig. 5 left is a circle fit of the 6.8 Hz mode using x-direction point mobility in the service room at the top of the masonry tower; the modal mass estimate is 330 tonnes (after correction of accelerations to SI units). This is the lowest modal mass measured of any of the lighthouses tested, consistent with the relative small size. The 4.7 Hz mode does not provide a clear circle fit whereas SIMO is more successful and reveals a clean pair of mode shapes for y-direction (Fig. 5, right). Mode shapes were not so clearly identified from ambient data using ERA.

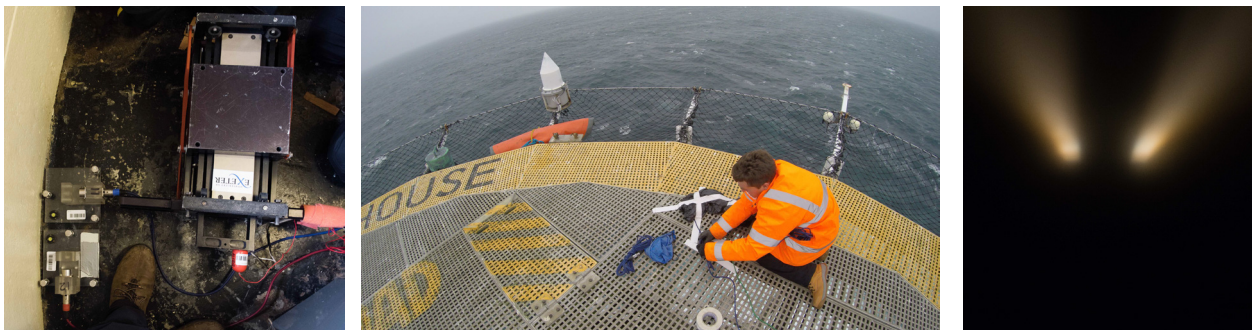
Fig. 6. Bishop Rock: Setting up shaker and accelerometers in battery room; weather protection for helideck sensors; twin beams in foggy night.

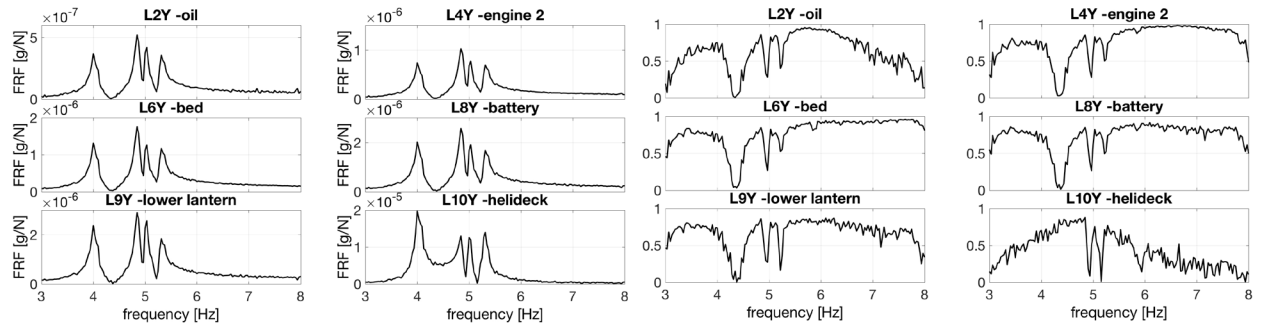
Fig. 7. Bishop Rock: y direction frequency response functions (FRFs) for sweep 1 run 8. H1 FRF (left) and coherence (right).

FRFs are shown in Fig. 7 based on 34 averages of 32-second frames with frequency sweeping (alternately up and down) between 3 and 8 Hz. H1 estimator is used due to the imperfect coherence.

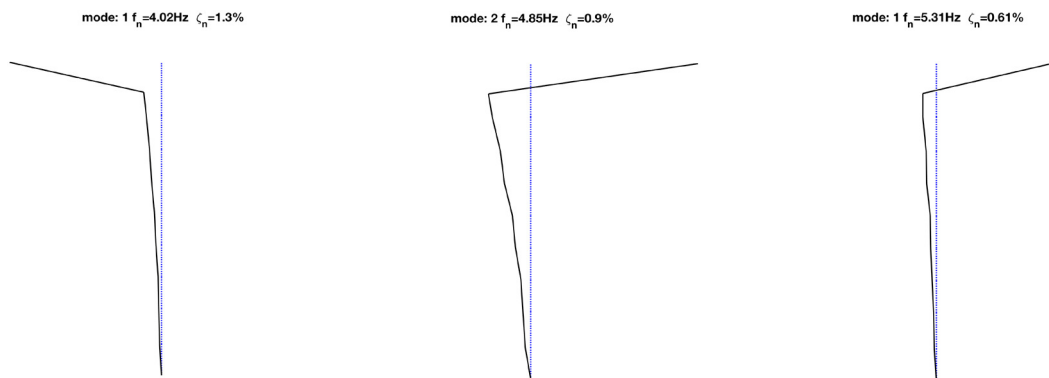
Fig. 8. Bishop Rock: mode shapes.

Mode shapes for three of the peaks in Fig. 7 are given in Fig. 8. Modal mass estimates are 1650 tonnes and 2800 tonnes for the 4.02 Hz and 4.85 Hz modes, considerably larger than for Wolf Rock.
