The 20th May 2012 Emilia Romagna Earthquake

EPICentre Field Observation Report

01/06/2012

EPICentre Field Observation Report No. EPI-FO-200512

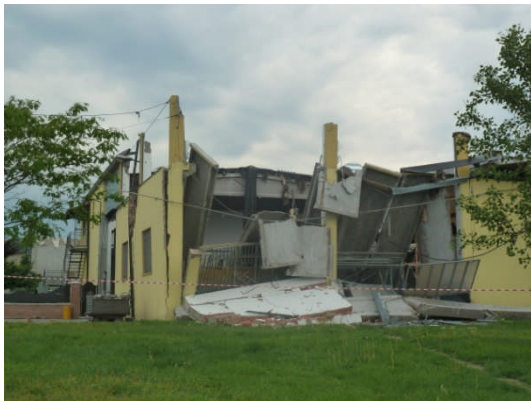
In S. Carlo, damage to industrial facilities was also observed (Figure 3.9.). All the collapsed structures were built with pre-cast reinforced concrete elements (see Section 4).

Figure 3.9 - Damage to industrial facilities in S. Carlo.

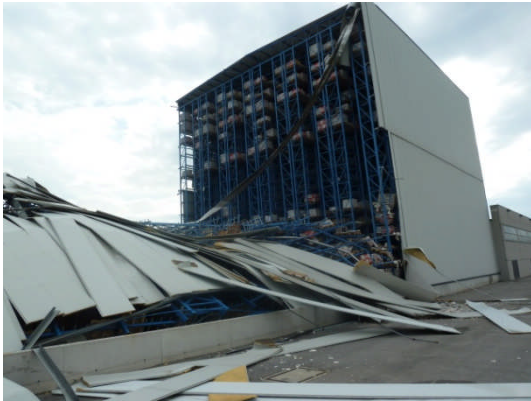
More damage to industrial facilities was found in S. Agostino. The collapse of some of the warehouses of the S. Agostino Ceramic factory was observed, where two night-shift workers lost their lives. Close to the S. Agostino Ceramic factory another factory was damaged (Figure 3.10 and 3.11).

Figure 3.11 - S. Agostino Ceramic – Collapse of a warehouse for the storage of ceramic tiles.

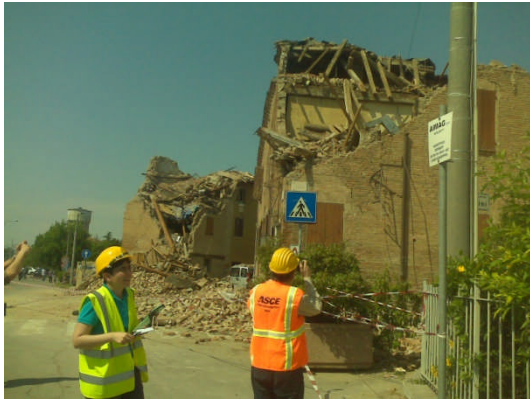
The damage in Felice sul Panaro followed the same pattern as in Finale Emilia. Residential buildings were either not damaged or slightly damaged. Monumental and historical buildings, including the old castle, sustained major damage (Figure 3.14). Industrial and commercial buildings suffered damage when conditions of structural vulnerability were present, but not all the industrial structures performed poorly.

Figure 3.14 - Damage to historical buildings in San Felice sul Panaro. The ancient tower is collapsed and the castle presents fractures lines.

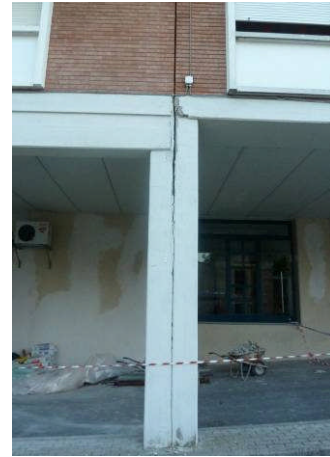
Figure 4.1 shows residential buildings in Mirabello without damage. Only pounding between the buildings was observed.

Figure 4.1 Residential buildings in Mirabello: a) overview of the RC buildings; b) pounding observed between the buildings.

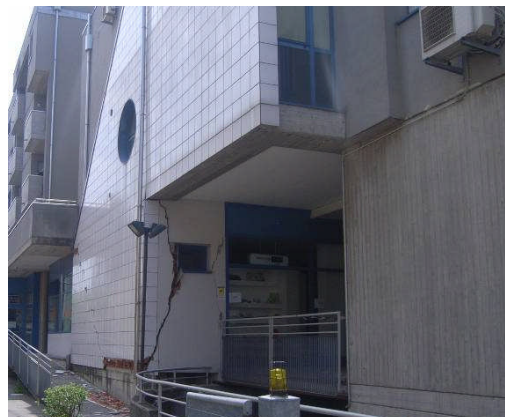
Residential RC buildings without damage in Sant Agostino are shown in Figure 4.2. Figure 4.3 shows a residential RC building in Finale Emilia with damage to its facade. The damage is non-structural and concerns the hollow clay brick infill, which failed in compression and shear.

Figure 4.3 Residential building in Finale Emilia with damage in the hollow clay brick infill.

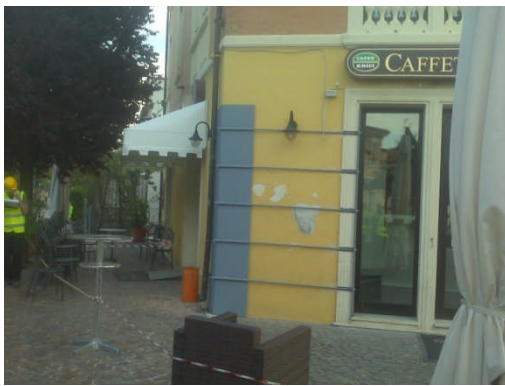
In Vigarano Mainardo, very few buildings were inspected. The most seriously damaged was a three storey masonry building which sustained damage at one corner of the ground storey and was fitted with a stabilization system of steel ties (see Figure 4.4). This building had also suffered a dislodged chimney (see Figure 4.5). The remaining buildings were located very close to the church of Nativita' di Maria and were found to have suffered only light cracking to their façades (see Figure 4.6).

Figure 4.4 - Stabilisation of a commercial/residential building in Vigarano Mainardo.

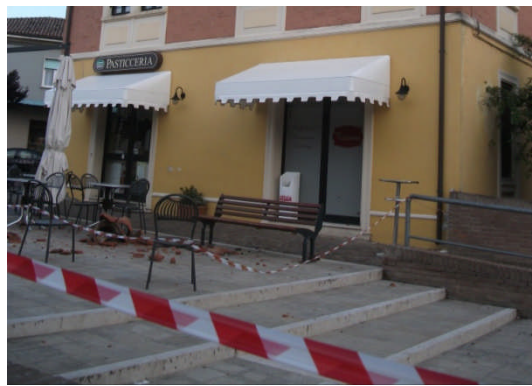
Figure 4.5 - Dislodged chimney of a commercial/residential building in Vigarano Mainardo.

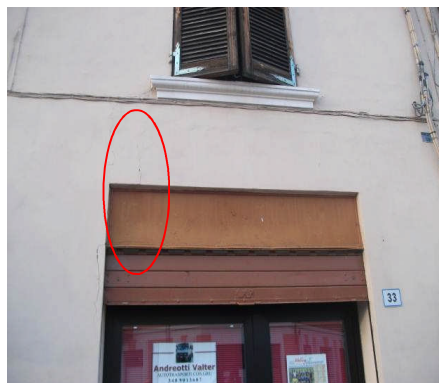
Figure 4.6 - Light damage of a commercial/residential building adjacent to the church of Nativita di Maria.

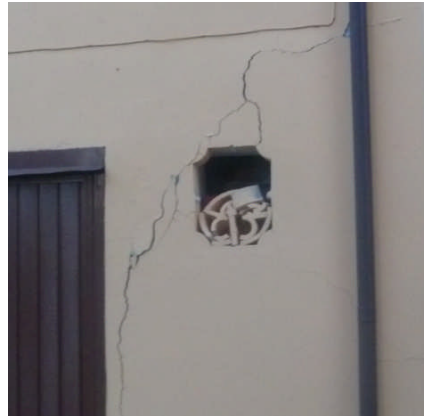
Figure 4.9 - Long crack on a residential house near the church of S. Pavlo.

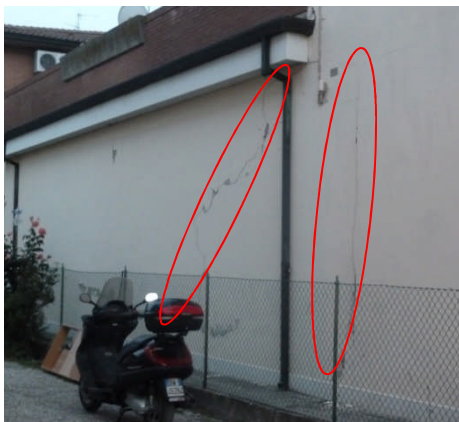
Figure 4.10 - Long cracks on a residential house near the church of S. Pavlo.

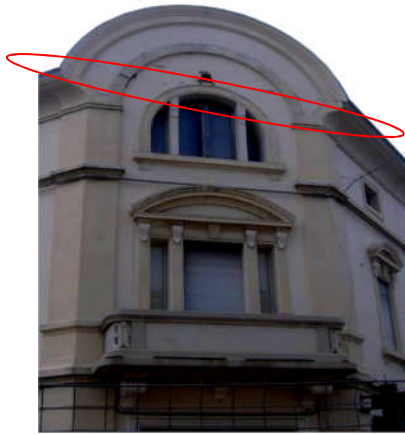
Figure 4.15 - Light damage of a commercial/residential building in piazza Giuseppe Garibaldi in Finale Emilia.

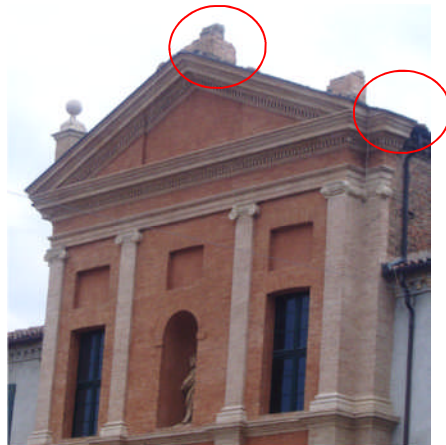
Most churches suffered slight to moderate damage. The least damage seemed to have suffered by the church of San Bartholomew in Finale Emilia, built in 1504. The church sustained dislodged decorations from its façade (see Figure 4.19a). Moderate damage was sustained by the church of San Agostino, the church of Nativita' di Maria in Vigarana Mainarda, the church of Georgio Martiri in Corpo Reno and a church outside San Felice sul Panaro. The structural damage sustained by these churches was due to the out-of-plane failure of the façade (see the vertical cracks in the connection of the side wall to the façade in Figure 4.20b, 4.21b, 4.22b, 4.23b). Shear cracks were noted on the north wall of S. Agostino (see Figure 4.22b) and on the south transept of the church outside San Felice (see Figure 4.3c). Dislodged decorations were a common non-structural damage to the facade. The fall of a decorative statue on the roof may be the cause of damage in S. Agostino (see Figure 4.22a). The bell towers were noted to have suffered non-structural damage, i.e. dislodged decorations (see Figure 4.21, 4.22d, 4.23c). Shear cracks were also noted in the leaning bell tower of San Agostino (see Figure 4.22c) and notably of the Nativita di Maria, whose foundations have been recently strengthened. The decorations at the top of the bell tower of San Agostino seemed to have landed on a church building (see Figure 4.22d) causing localised damage on its north wall such as the collapse of part of the roof and the and an extensive vertical crack on the supporting wall.

Figure 4.19 - Dislodged decorations of the façade in the church of S. Bartholomew in Finale Emilia.

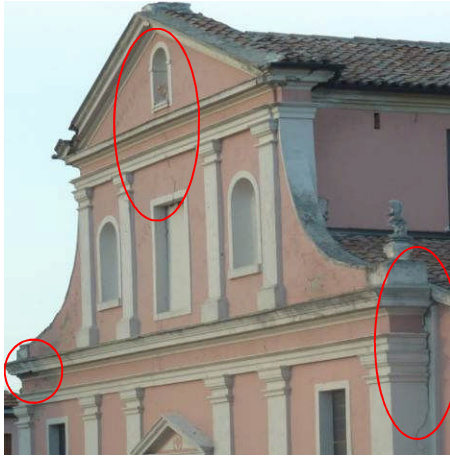
Figure 4.20 - Church of Nativita di Maria in Vigarano Mainardo: a) long crack on the facade and some dislodged decorations; b) failure of the external connection of the facade with the south wall; c) shear failure of the masonry wall between the openings on the bell tower.

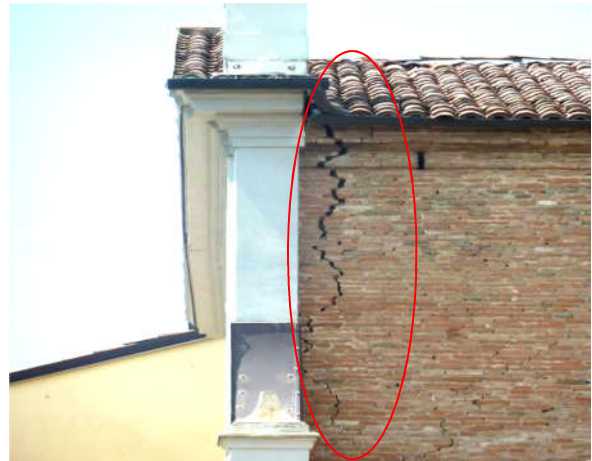
Figure 4.21 - Church outside San Felice sul Parano: a) dislodged decorations; b) crack on the external wall of the facade and the south wall; c) long crack on the south transept.

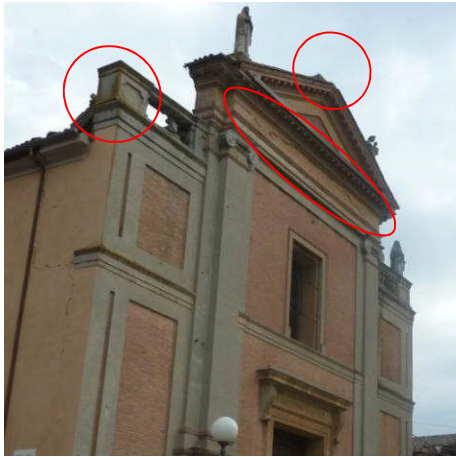
Figure 4.22 - Church of S. Agostino in S. Agostino: a) dislodged decorations and cracks on the plaster of the facade; b) long cracks on the north wall; c) large and extensive cracks on the leaning bell tower; d) localised collapse of the roof and long cracks on the north side.

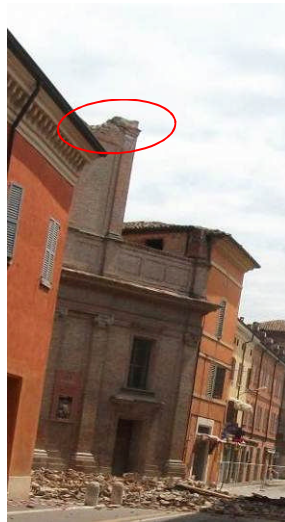
or failure of the support of the roof. It was not possible to walk around the Duomo di Filippo and Giacomo in Finale Emilia for a good damage assessment. Figure 4.25 depicts the collapse of the top end of the façade which was reconstructed in 1807. The church of San Paolo in Mirabello and the church of DOM in San Felice sul Panaro suffered partial collapse. With regard to the bell towers, the tower of San Pavlo, whose foundations had been strengthened, did not suffer damage (see Figure 4.26c). In the tower of the church in San Felice sul Panaro, spalling of the plaster and brickwork was observed along the lower portion of the structure.

Figure 4.25 - Collapse of the top end of the facade of the Duomo in Finale Emilia.

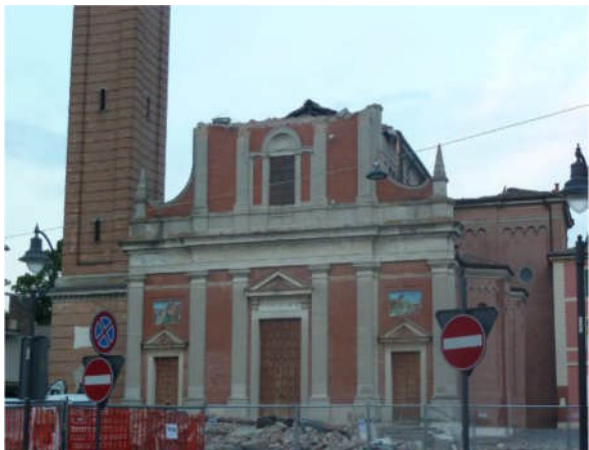
Figure 4.26 - Church of San Paolo in Mirabello: a) partial collapse of the; b) out of plane failure of the facade; c) collapse of east side and part of the north transept.

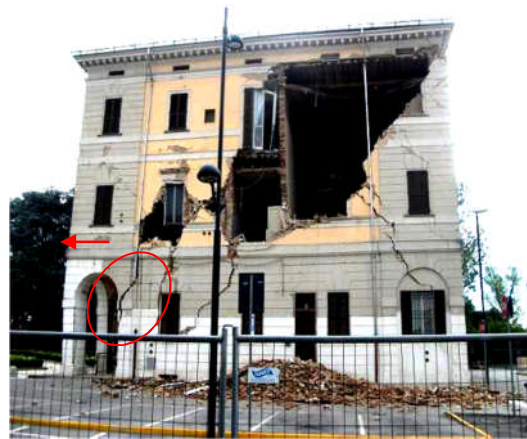
The town hall of San Agostino is made of unreinforced brick masonry with timber floors. This building suffered severe damage to its structural components. Figure 4.29a shows the collapse of a middle column from the façade's portico. In Figure 4.29b, the external wall suffered partial collapse due to insufficient out-of-plane resistance. This can be attributed to the small thickness of the wall, i.e. one brick thick, which extends to two floors without being supported by a floor slab. There are also extensive diagonal cracks in both side walls (see Figure 4.29b,c) indicating the loss of connection of the side walls with the front wall. This forms a wedge which caused the out-of-plane failure of the portico.

Figure 4.29 - Town hall in S. Agostino: a) Collapse of the middle column of the facade; b) partial collapse of a side wall and loss of connection of the external wall in the front; c) large and extensive cracks in a side wall.

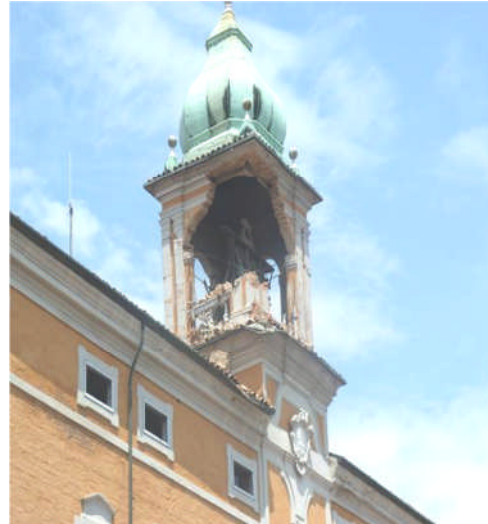
Figure 4.32 - Collapse of a column supporting the bell on a clock tower in Finale Emilia.

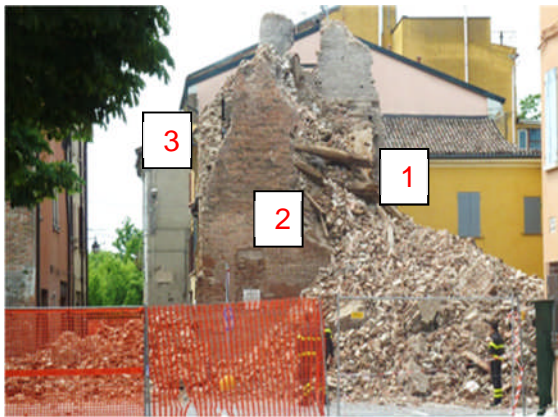
The three inspected unreinforced brick masonry towers in Finale Emilia performed very differently. In particular, the unreinforced brick masonry tower in via Giovanni Zuffi suffered slight damage. The damage consisted of dislodged marble plates, which cladded the wall above the door (see Figure). The bell-clock tower in Figure suffered the partial collapse of one column which supported the roof, perhaps due to excessive compressive loads. The brick masonry clock tower in piazza Alfredo Baccarini in Finale Emilia (see Figure) collapsed.

Figure 4.33 - Collapse of a brick masonry clock tower in piazza Alfredo Baccarini in Finale Emilia.

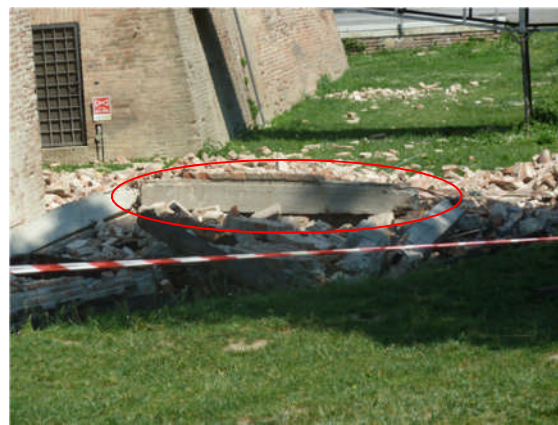
The "Rocca Estense" Castle in San Felice sul Panaro was also inspected. The castle, built in the 15th century, is an unreinforced brick masonry structure with four towers. The castle suffered extensive damage due to the earthquake: three towers partially collapsed (Figure and Figure) and the fourth (see Figure) sustained significant large and extensive diagonal cracks, suggesting loss of connection between the walls. From the debris of a collapsed tower in Figure it can be concluded that one tower at least has been retrofitted with RC beams.

Figure 4.37 - Debris from the partial collapse of the tower of the Rocca Estense Castle.

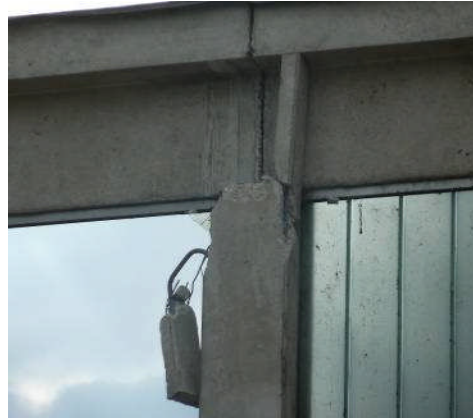
Figure 4.40 - Industrial building in Sant Agostino: a) overview; b) joint failed detail.

Many roofs of the industrial facilities collapsed as a consequence of failure of the transverse and longitudinal beams supporting them. This was observed in the abandoned factory in Sant' Agostino (Figure 4.40), where double T-beams collapsed together with some of the transverse precast RC beams, and in the factory close to Corpo Reno (Figure 4.41) where precast pre-stressed hollow slabs collapsed together with transverse and longitudinal beams. The precast roof of the modern factory observed close to Finale Emilia had a similar collapse mechanism (Figure 4.45a,b). In the older part of the factory, the RC shell roof which was monolithically attached with the RC beams spanning transversely across the column, collapsed with the former (Figure 4.45). The slabs made of a RC ring

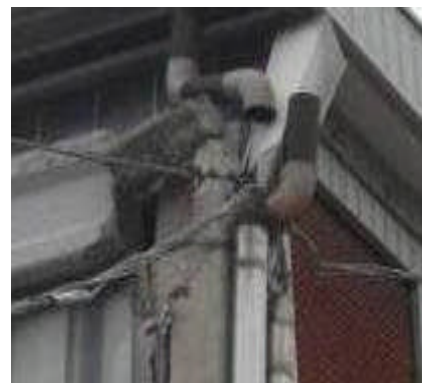
Figure 4.41 shows two industrial structures in an industrial zone close to Corpo Reno. In Figure 4.41a,b the structure exhibits the mechanism described. However, the second structure only exhibits minor damage even though it has the same structural system as the former. The only difference consists only in the latter having longitudinal spans approximately half that of the collapsed structure. The undamaged structure is more integral.

Figure 4.41 - Industrial building close to Corpo Reno: a) overview; b) joint failed; c) pre-cast structure without damage; d) joint with few deformation.

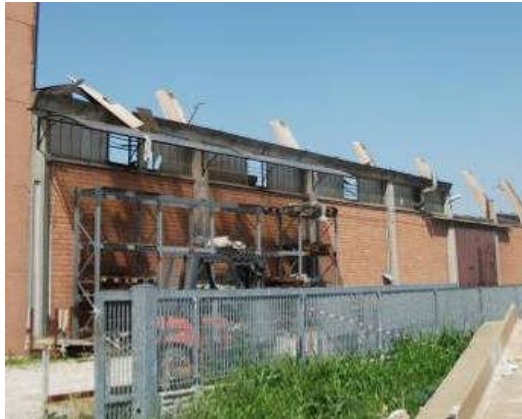
Figure 4.45 - Industrial building close to Finale Emilia: a) overview of new factory; b) plastic hinge on the column; c) overview of old factory; d) collapse of roof.

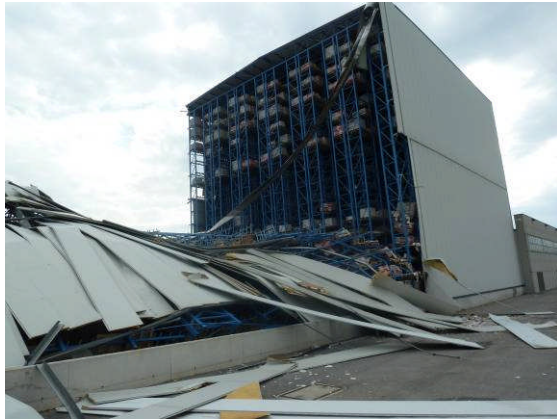
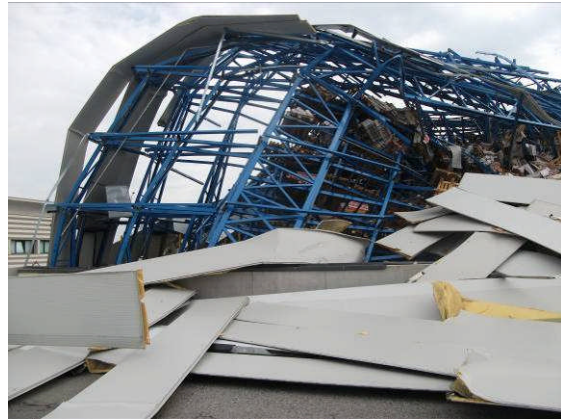
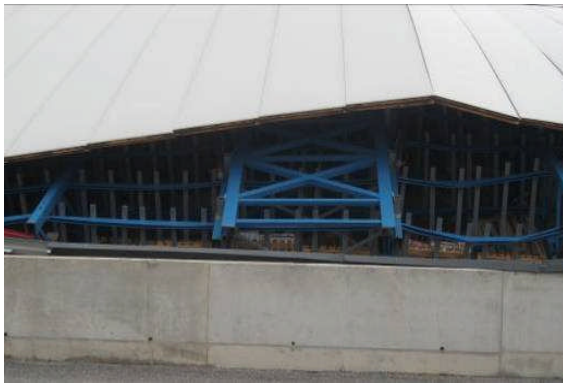
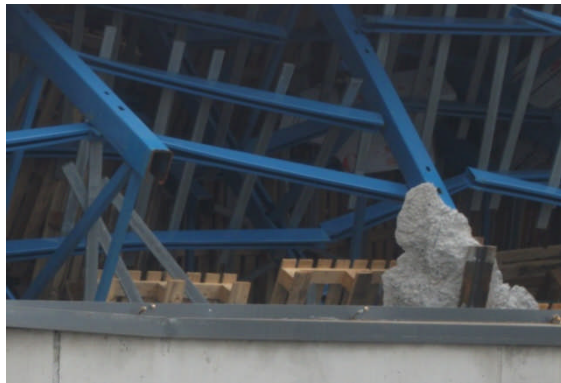
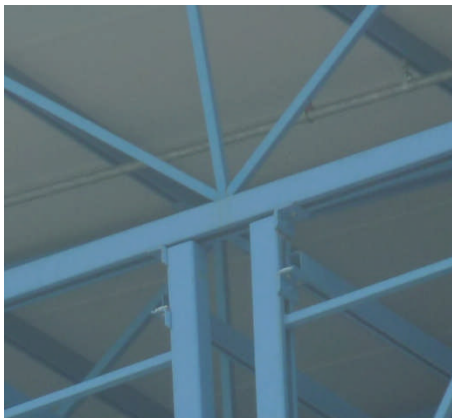
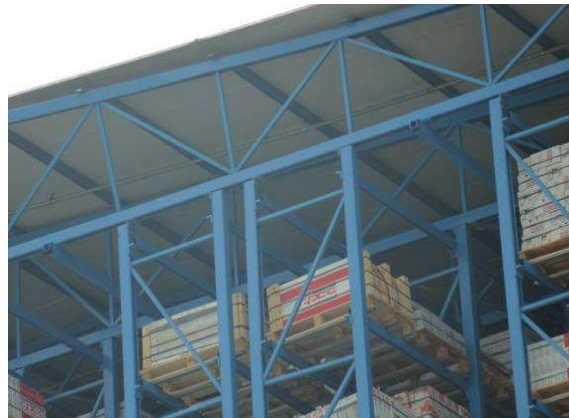
The only steel industrial facility in which we observed damage was the storage warehouse at Sant Agostino ceramics factory (Figure 4.46). The warehouse was a large shelving facility for boxes of ceramic tiles. From visual inspection at a distance, the structure of the shelves also appears to have been the superstructure of the building. There were in total 12 singular rows of shelves. Each shelf seems to have consisted in 2 parallel multi-level frames. The parallel frames were connected transversally with a diagonal truss system. The parallel shelves appear to be connected in the transverse direction with each other at the foundation level and by a truss system at roof level. The structure was enclosed on the sides and the roof by sandwich insulation panels connected directly to external shelving steel frames or to a truss system in the longitudinal direction, which was only at various intervals.

Approximately 70% of the structure collapsed. In the longitudinal direction. The horizontal sections appear to have only been connected with the vertical section by means of an L-Plate and 1 bolt, forming a pivot and providing negligible lateral resistance in this direction. In the transverse direction, the truss system of each individual shelves provided some lateral resistance. Nevertheless, each individual shelf is very slender in this direction, and since the whole system seems only to be connected at the base and roof level, the lateral resistance also appears to be very small in the transverse direction. In the portion of the warehouse still standing, it was observed that only the upper levels of the shelves were filled with heavy boxes of tiles, and hence might have contributed to a larger base shear and overall instability. The connection of the frames with the foundation was also very weak as the vertical elements were observed to fail at the vertical element-foundation interface. The diagonal elements were rectangular in section and welded with the vertical elements, and not observed to experience local damage in many of the sections. Nevertheless, the vertical and horizontal elements consisted in U-shaped sections and in many sections were observed to experience warping failure effects particularly at intersections with other elements.

Figure 4.46 - Factory close to Sant Agostino: a) and b) overview; c) longitudinal frame; d) connection between the frames and the foundation; e) detail of the connection between the frames and the roof truss; f) general detail of the frame system.

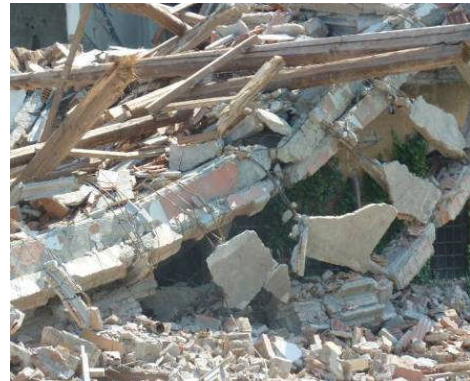
A small warehouse in Vigarano Mainardo was observed to suffer shear diagonal cracks on the facade (Figure 4.47). An abandoned industrial warehouse along a water canal outside Massa Finale experienced partial collapse (Figure 4.48). The structure consisted in masonry walls with RC reinforcements. The roof structure consisted in a wooden truss. A small masonry bridge connecting the two banks of the canal on either side, had a transversal crack in the middle of its arch, hinting that there was minor lateral displacement of the canal bank that may have contributed to the collapse of the warehouse.

Figure 4.48 - Industrial building close to Massa Finale: a) overview; b) reinforced concrete frame failed.

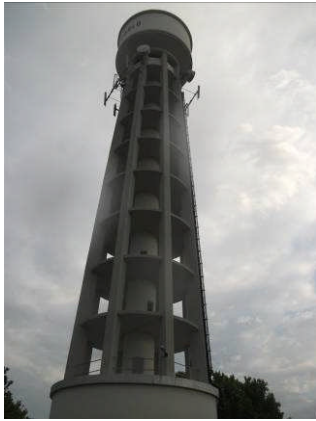
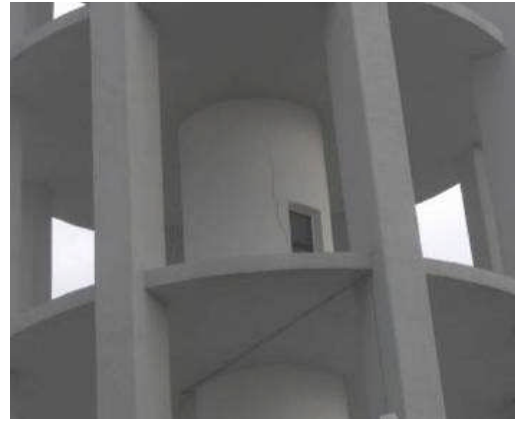
Two water towers were observed. The first one was at San Carlo, consisting in a RC circular core and 6 columns, connected by RC diaphragms at various intervals. In this structure, various vertical cracks were observed on the RC core (Figure 4.49). The other water tower observed in San Felice sul Panaro had more damage (Figure 4.50). The structure consisted in an octagonal RC frame, with masonry infill panels, and only 1 RC horizontal diaphragm. Various masonry panels were observed to have fallen out of plane. Shear failure was observed in various beams at the lower 2 levels of the frame. Plastic hinging was also observed in some of the columns at the bottom.

Figure 4.49 - Water tank in San Carlo: a) overview; b) crack in the interior reinforced concrete core.

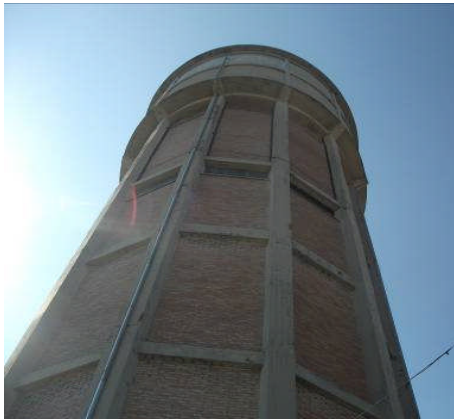
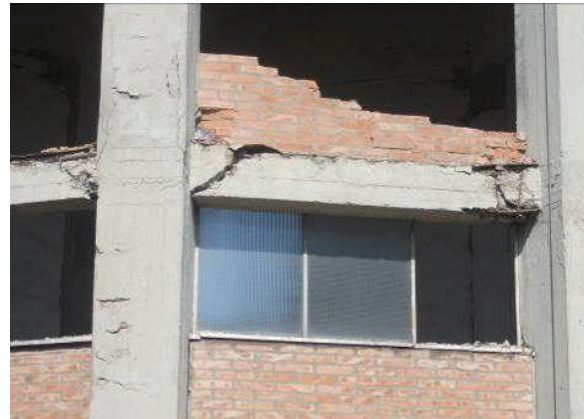
Figure 4.50 - Water tank in San Felice sul Panaro: a) overview; b) plastic hinge in the beams.

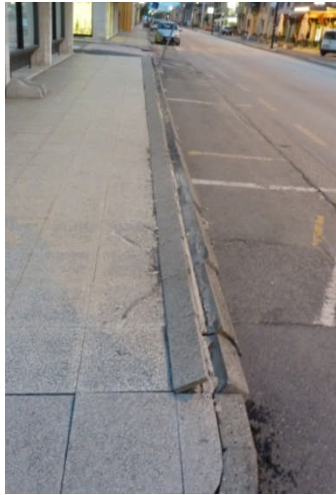
Roads in the centre of San Carlo were damaged by liquefaction of the underlying soil and ground movement. On the main street of Mirabello, lateral movement caused cracking in the road surface and damage to the footpath (Figures 5.1). According to locals, the main street was constructed on the site of an old river. The ground in the damaged area appears to be settlement prone. Settlement cracks which existed prior to the earthquake are evident in roads, car parks and buildings, and were exacerbated by the earthquake.

Figure 5.1 - a) Damage to the footpath in Mirabello due to lateral spreading; b) Typical cracking in roads in Mirabello due to lateral spreading.

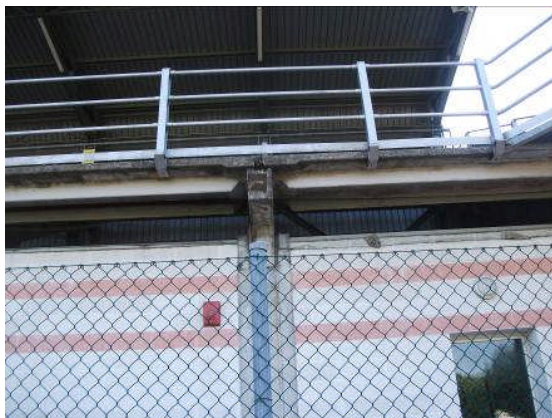
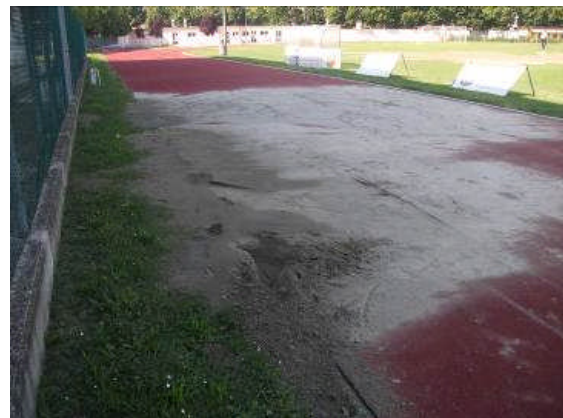
Liquefaction was observed inside the small San Felice sul Panaro football stadium (Figure 6.4). Various patches of liquefied soil of considerable diameter were observed on the pitch. Liquefaction was also observed along the perimeter of the enclosure, lifting a small concrete ground slab. Liquefaction was also further observed around the dressing rooms. Nevertheless, the superstructure of the enclosure looked undamaged from an external visual inspection. Liquefaction also surrounded the athletics track, lifting the rubber track at various intervals. Liquefaction was also observed along the discus, putting the shot and long-jump tracks. A tennis court separating the stadium from the main road did not experience any liquefaction. Nevertheless, liquefaction was observed on the main road.

Figure 6.4 - Liquefaction in the San Felice Stadium: a) Liquefaction on the pitch; b) Liquefaction on the pitch; c) Liquefaction surrounding the foundation of the enclosure; d) Liquefaction surrounding the dressing rooms; e) the superstructure of the enclosure; f) liquefaction around the athletics track.

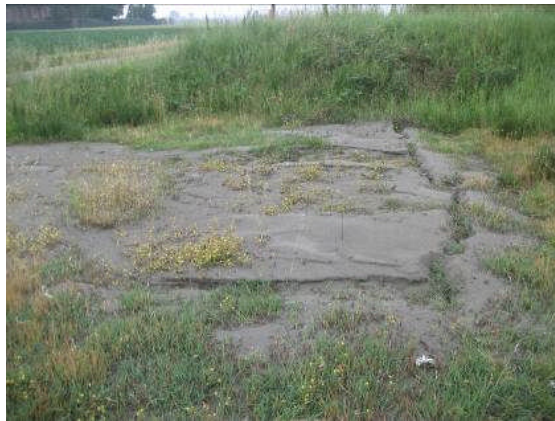
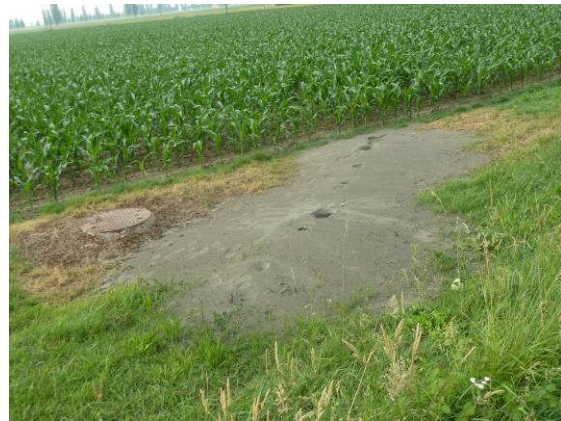
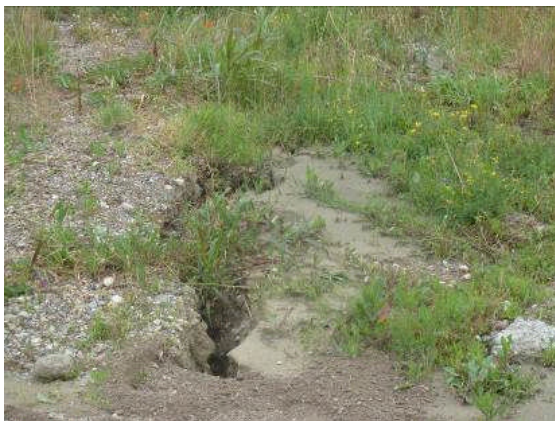
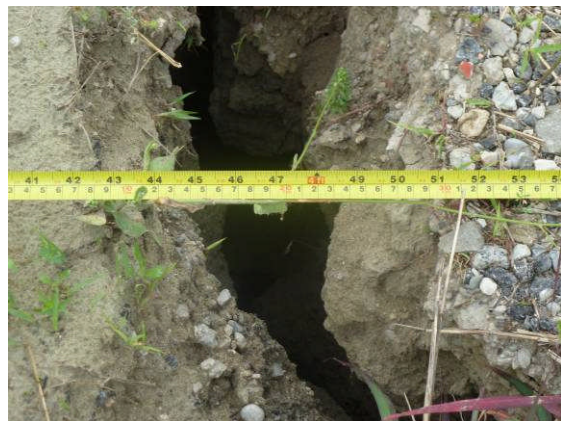
Liquefaction was also observed close to the embankment of the national road 225 leading from Mirabello to San Carlo (Figure 6.5a). Further Liquefaction was observed in the agricultural fields that separate the two villages (Figure 6.5b). Wide surface cracks in the clayey agricultural soil were observed possibly due to ground movement and settlement also associated with liquefaction effects and the densification of lower strata of soil (Figure 6.5c,d).

Figure 6.5 - Liquefaction in rural areas: a) Liquefaction close to the national road 225; b) Liquefaction in agricultural fields outside Mirabello; c) Surface cracks in agricultural soil outside Mirabello; d) Detail and dimension of the surface crack.

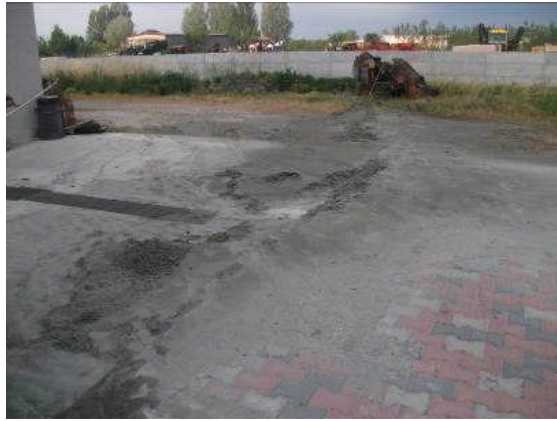
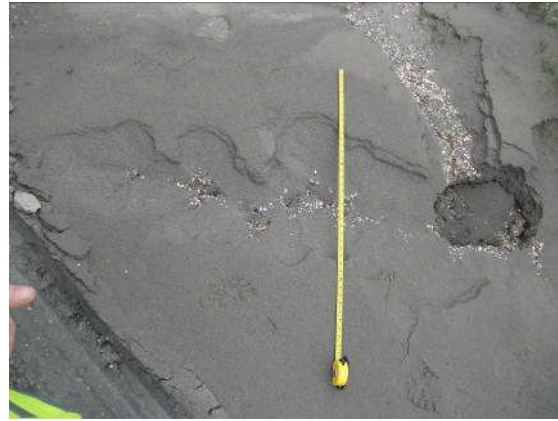
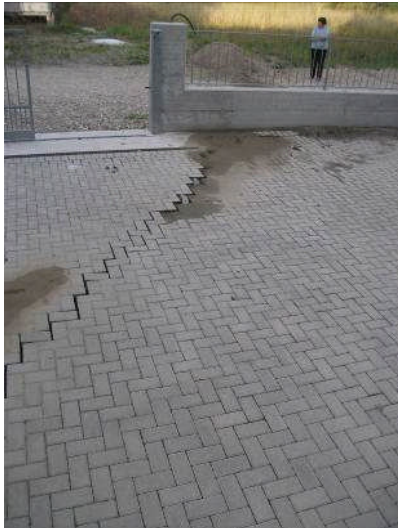
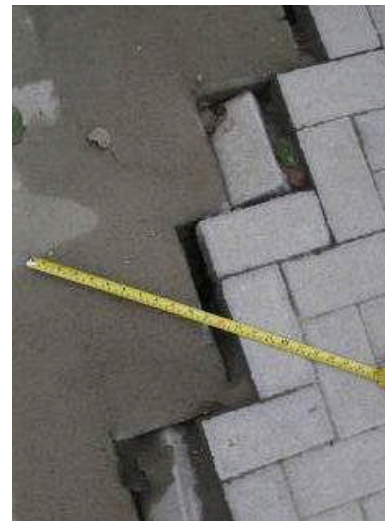
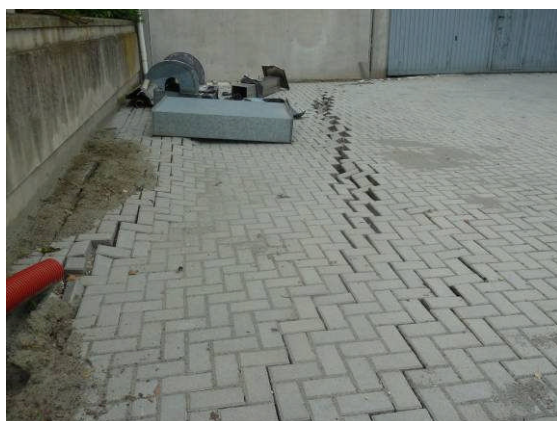
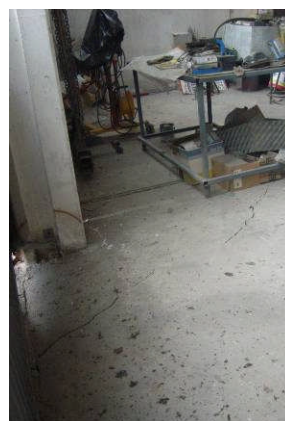
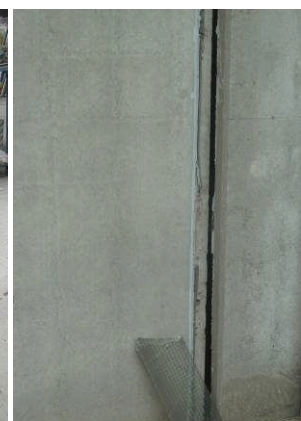
Liquefaction was observed around two industrial facilities off the 255 national road. In the first facility (Figure 6.6a) most of the liquefaction was observed around a concrete platform at the rear of the warehouse. This caused differential movement of the platform relative to the superstructure. This was also the case for the second facility. Furthermore, ground rupture and liquefaction occurring in the service road, extended along the pavement, and inside the industrial facility (Figure 6.6c,f). A small gap was observed between some RC panels and the RC column due to differential movement of the ground (Figure 6.6g). Liquefaction was also observed along the service road leading to the 2 facilities (Figure 6.6b). However, it was also observed that the subgrade of the road was not constructed according to any standards.

Figure 6.6 - a) Liquefaction around platform; b) Liquefaction and settlement on the service road; c + d) damage to the ground pavement from differential settlement; e) Effects of differential settlement on the industrial facility; f) Cracking of the ground slab inside the industrial facility; g) Damage to the

RC panels of the industrial facility.

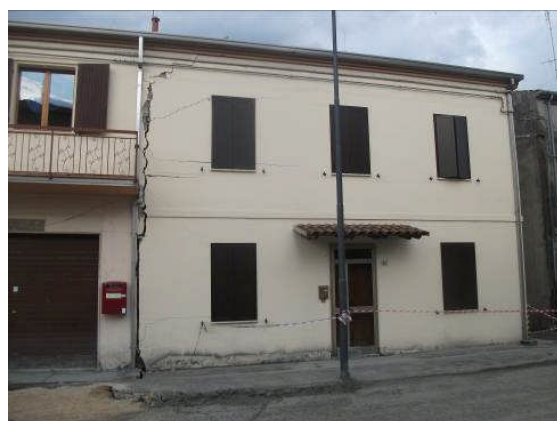
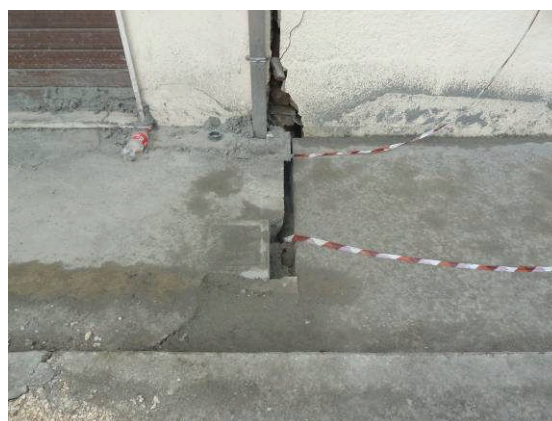
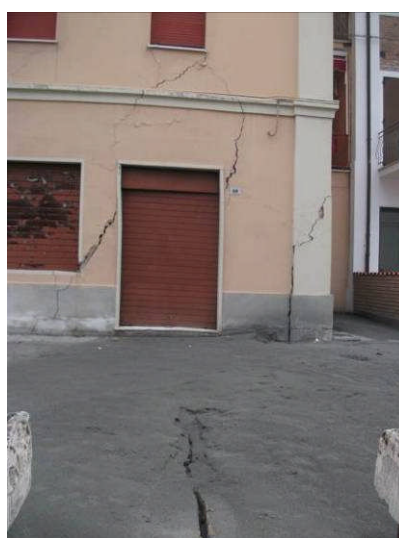
Most of the damage in buildings directly caused by liquefaction effects was mainly observed in masonry buildings. This was very prominent along “Via Risorgimento” in San Carlo (Figure 6.7). Liquefaction fissures were observed along the transverse section of the road, and extending to the foundations of buildings. Consequently differential settlement, uplift, or lateral spread were contributors to damage. Masonry structures were more prone to damage caused by liquefied ground movements, since under such conditions the structure does not behave monolithically.

particularly if the foundation is not so. For one particular house, relative displacement caused by liquefaction resulted in the dislocation of the house from the third party wall separating it from its neighbouring house (Figure 6.7b). In another case, the liquefaction fissure passed close to an aperture causing differential movement to the superstructure supporting the building on either side of the aperture, resulting in severe damage to the whole structure (Figure 6.7c).

Figure 6.7 - Liquefaction along Via Risorgimento in San Carlo: a) Separation of façade from third party wall; b) detail of the differential displacement between the façade and third party wall, including ground settlement; c) Liquefaction fissure through an aperture of a masonry building.

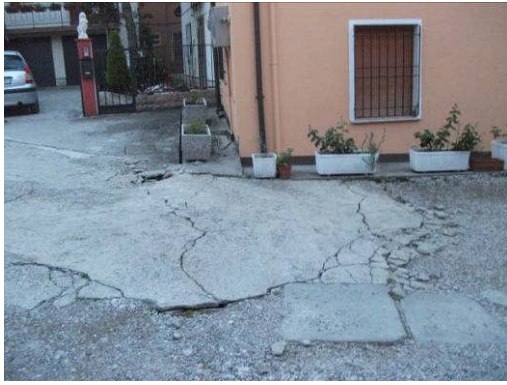
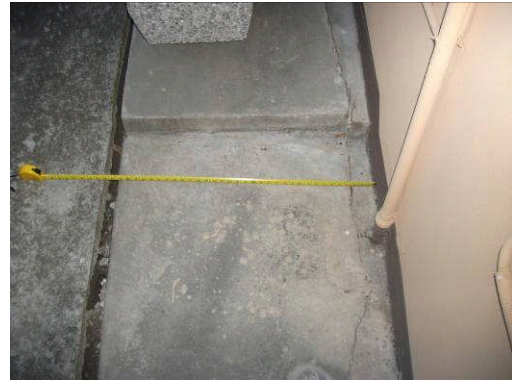
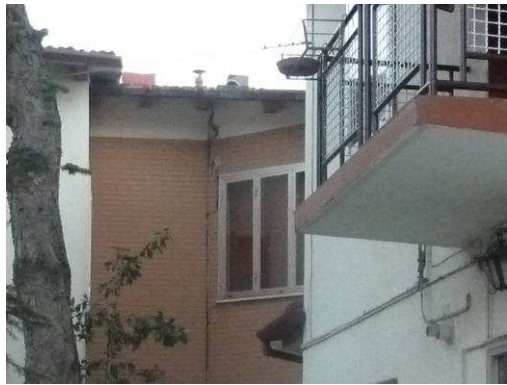
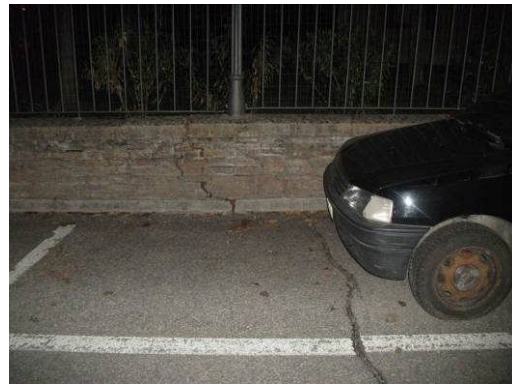
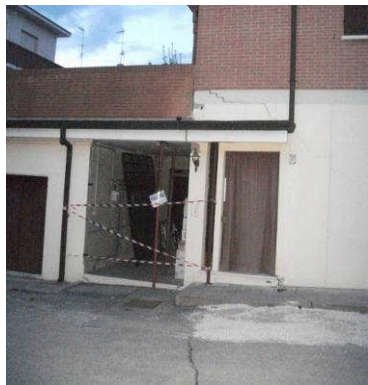
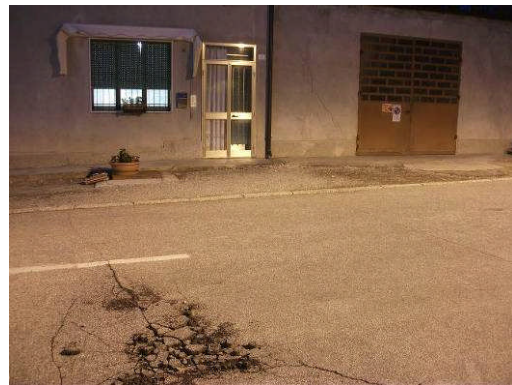
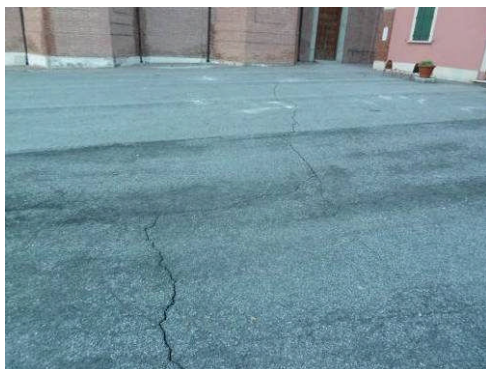
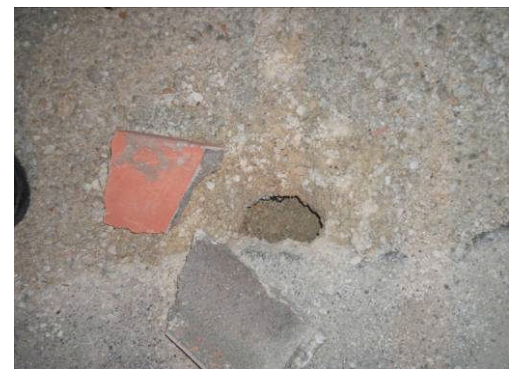
The ground on either side of Via Italia in Mirabello gently slopes towards the main road, where once a stream of the river Reno passed. A masonry house along the alley next to the San Paolo church experienced lateral differential displacement due to lateral spreading of the ground. Settlement was also observed. The masonry structure sustained various shear cracks (Figure 6.8a,b). The failure plain was observed to extend to the adjacent house which experienced differential displacement at foundation level (Figure 6.7c).

Figure 6.8 - Lateral spread in Mirabello: a) Lateral spread of ground under a building; b) lateral spread of foundation. c) damage in masonry building due to differential movement; d) Lateral spread extending into a parapet wall; e) Lateral spread of ground extending into a building in Via Mazzini; f) Lateral spread extending into a house in Via 25 Aprile; g) Lateral spread of ground extending into San Paolo church; h) Densification of soil subgrade.

Lateral spreading was also observed to extend transversely from Via Risorgimento in Mirabello, into a parapet wall. Lateral spreading of the ground was observed in Via Mazzini and Via 25 Aprile (Figure 6.7e,f) Lateral spreading extended transversely from the road into the buildings causing damage due to differential ground displacement.

A rupture in the car-park adjacent to San Paolo church also extends into the structure (Figure 6.8g). Figure 6.10 shows an overall view of the surface ruptures, cracks and lateral spreads that were observed during the trajectory followed in Mirabello. Lateral spread observed at various locations in Mirabello indicate a possible trend forming lateral spread of ground that extends through the centre of the village, and that may have possibly contributed to the partial collapse of the San Paolo church. The damage experienced by the church is further described in Section 4.3.

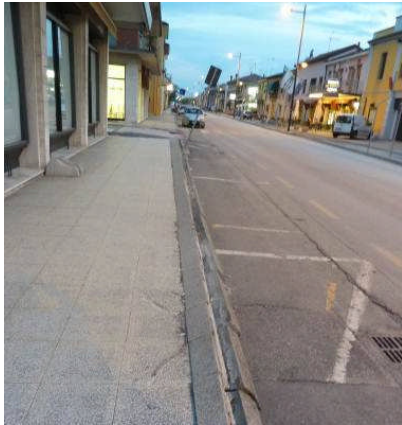
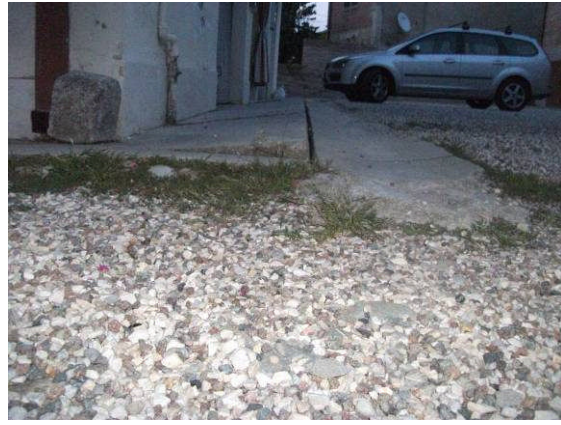
Figure 6.9 - Lateral spreading of the ground parallel to the road a) Via Italia b) behind “Numero 1 Pizzeria”.

Ground rupture showing lateral spread parallel to the road and the façade of buildings was observed in Via Italia and behind the “Numero 1 Pizzeria” (Figure 6.9). This caused uplifting of part of the pavement and kerbs as the ground below the buildings moved against the subgrade and sub-base under the road. Settlement was also observed. Various pot holes were formed along Via Italia showing the densification and possible flowing of soil below ground level.

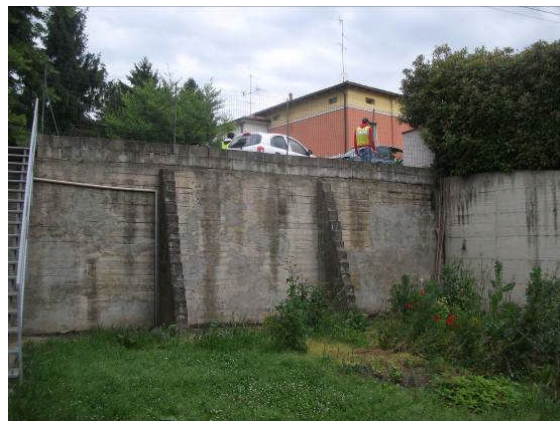
In Via Primo Maggio, San Carlo, a masonry structure having access on two levels was observed to sustain damage due to pounding with the road substructure, causing the pavement in front of the house to fail completely (Figure 6.11). The house sustained minor permanent displacement. The road in front of building also experienced damage due to possible failure of the subgrade. Nevertheless, a buttressed RC diaphragm wall adjacent to the house did not sustain any damage.

Figure 6.11 - a) Damage of house having access from 2 levels; b) Retaining wall adjacent to the house; c) detail of the damage of the pavement in front of the house.

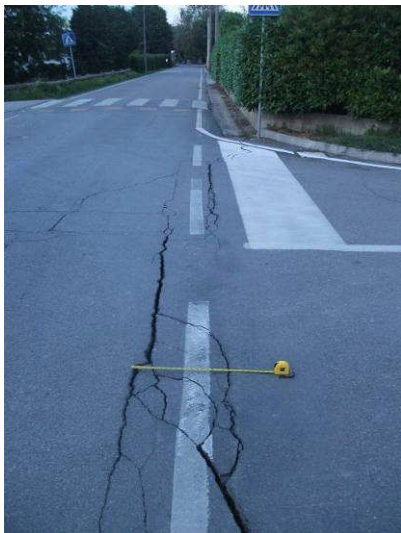
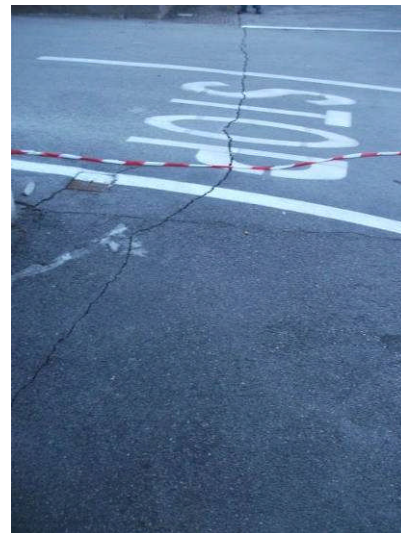
Figure 6.12 - a) Lateral spread and settlement in Via Argine Postale, Mirabello; b) lateral spread and settlement in Corso Italia, Mirabello; c) Surface cracks and damage to trench in Via Primo Maggio, San Carlo; d) Collapse of sub-base and subgrade, San Carlo.

As described in the previous sections 6.2 and 6.3, various roads inside the towns of Mirabello and San Carlo experienced damage due to liquefaction, lateral spread and settlement of the ground substructure. Furthermore, lateral spread cracks were observed in Via Argine Postale and Corso Italia in Mirabello (Figure 6.12a,b). Over 3cm of settlement was observed. The storm water culvert was also damaged. Longitudinal cracks along the asphalt surface exposed the underlying subgrade. According to locals in Mirabello, the gas pipe system in Via Italia was damaged by the earthquake, and closed down for repair. According to the residents, they were given an estimate of 7 days from the event for the repair works to be completed. In the car park in Piazza Primo Maggio, various new cracks were observed on the asphalt surface (Figure 6.10).

Further to what was discussed earlier, Via Primo Maggio in San Carlo was partially closed due to lateral spread. Substantial cracks along the perimeter of service trenches were observed, indicating differential movement or settling. The subgrade and sub-base of part of the road experienced sliding collapse. It is evident that the retaining system was very weak (Figure 6.12c,d).
